Hampton Court Palace The Tiltyard Tower

**Historic Building Recording and
Investigation**

July 2008

Client: Historic Royal Palaces

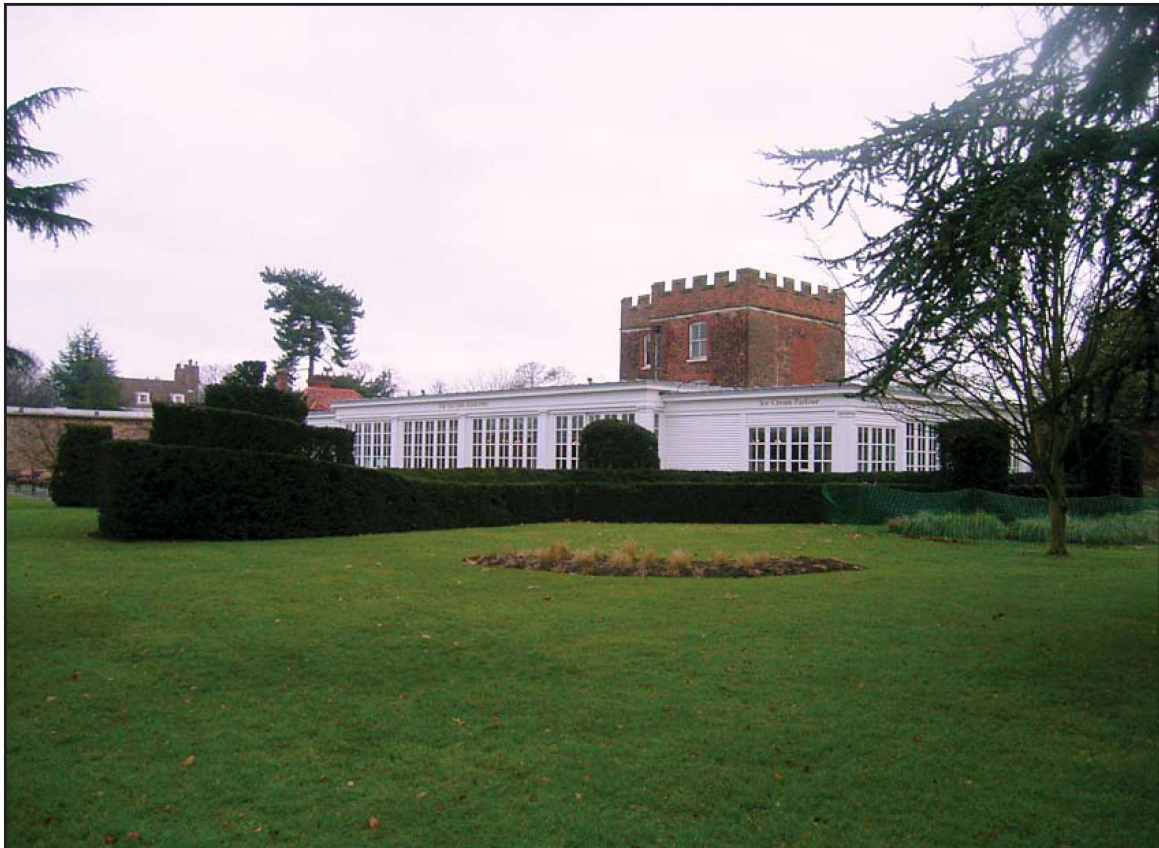
Plate 2: West and south elevations, external view (pre-works)

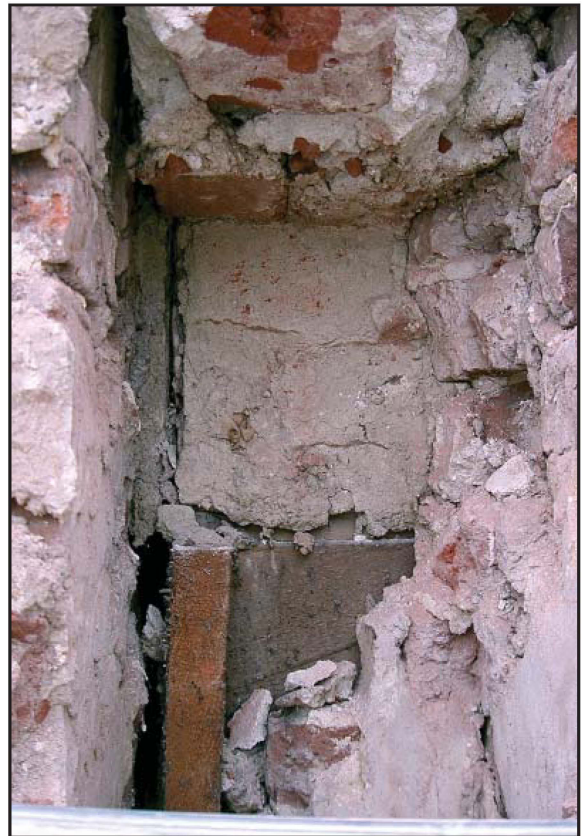
Plate 14: West elevation, external view, illustrating timber elements within vertical shaft
