Stoneleigh Abbey River Landscape Warwickshire

**Archaeological Recording and
Investigation of River Structures**

February 2013

Client: CGMS Limited

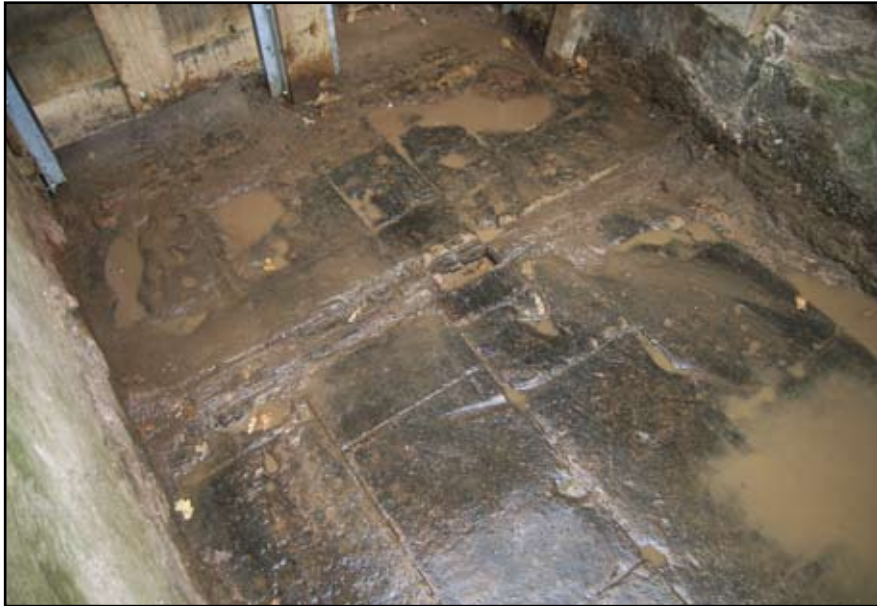
Plate 72: Gazebo Bridge, floor in southern channel beneath bridge

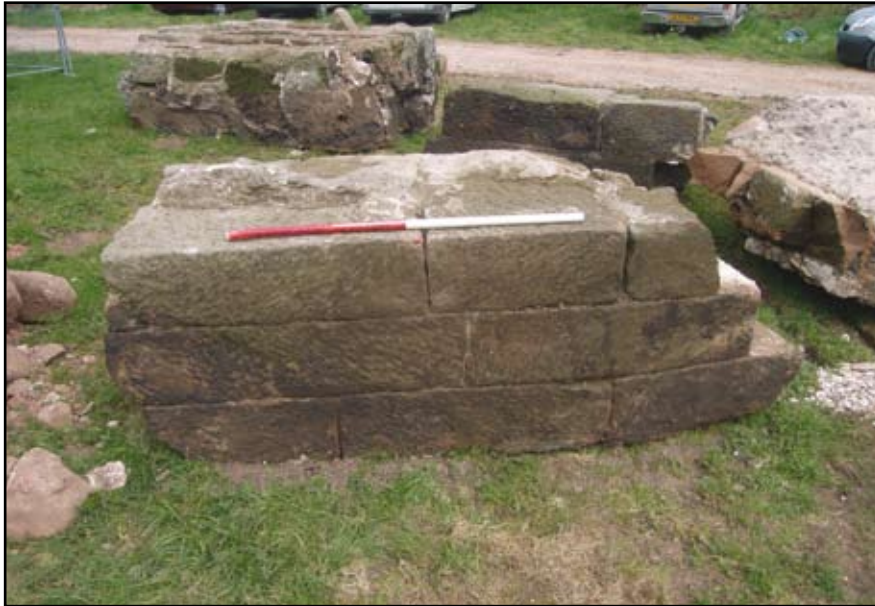
Plate 96: Moulded stone retrieved from West Park Weir pool

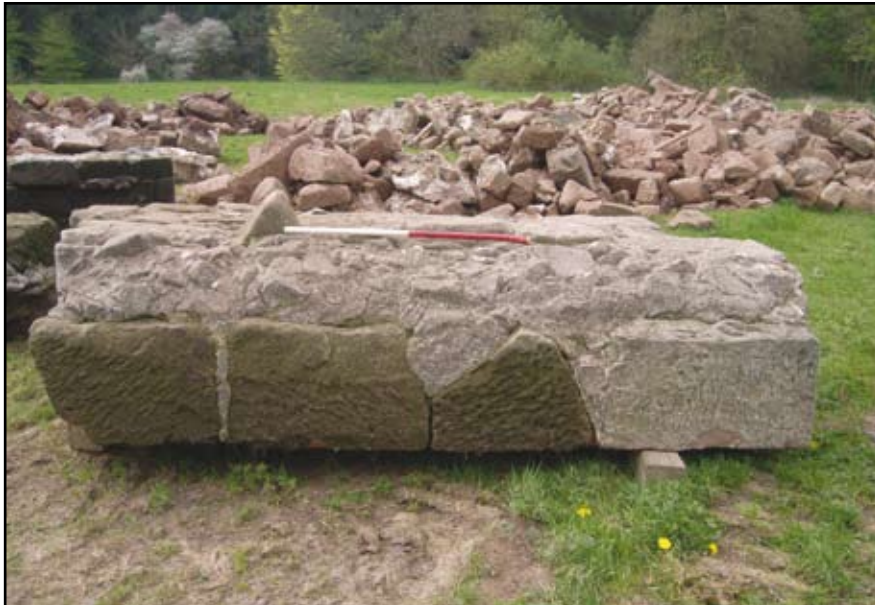
Plate 98: Moulded stone retrieved from West Park Weir pool
