Valentines Park Ilford

London Borough
of Redbridge

**Historic Building Recording and
Archaeological Watching Brief**

April 2009

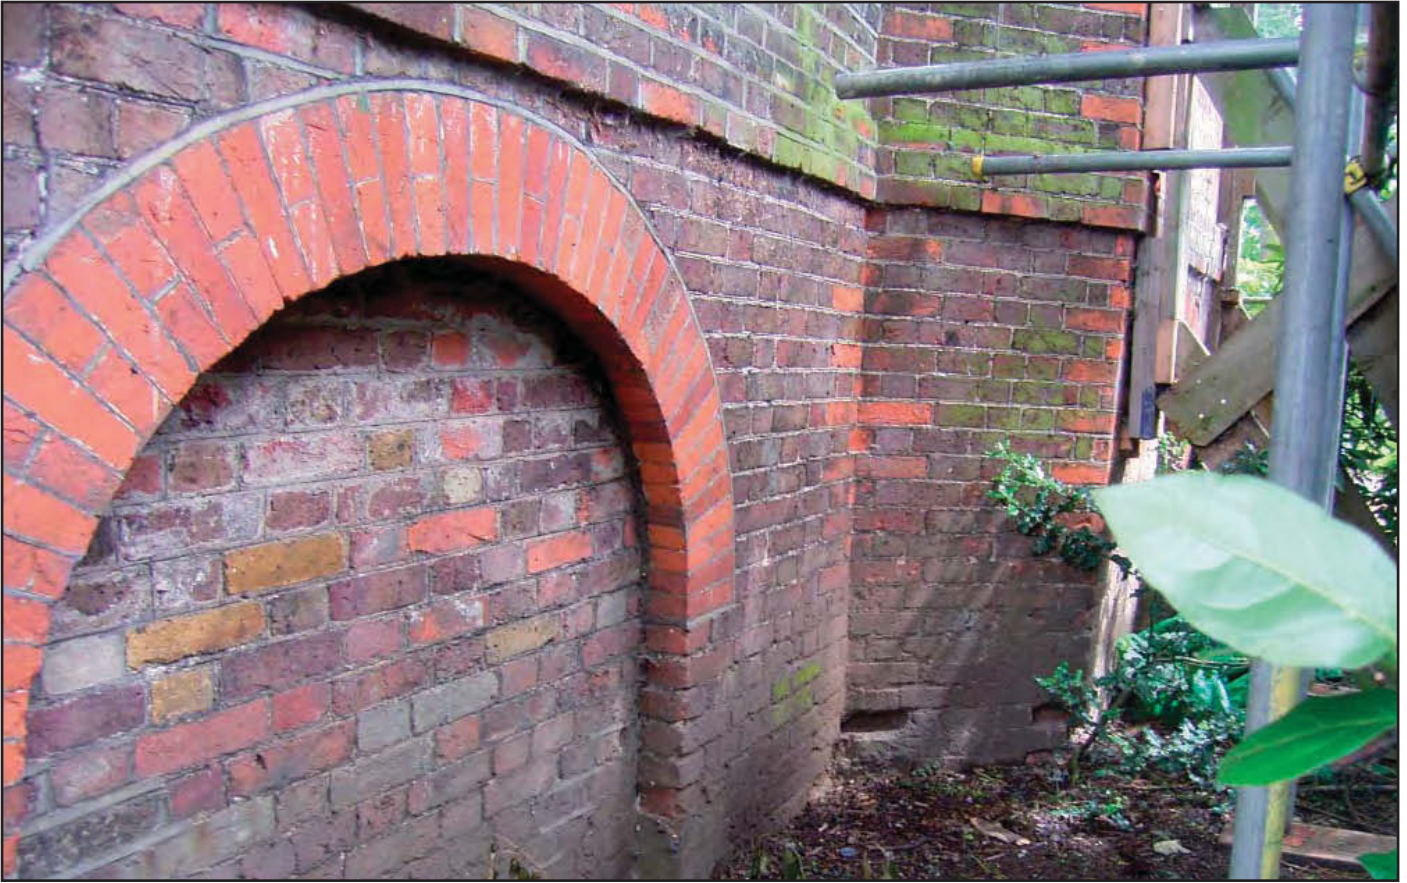
Plate 13: Archway in SW elevation of Dovecote

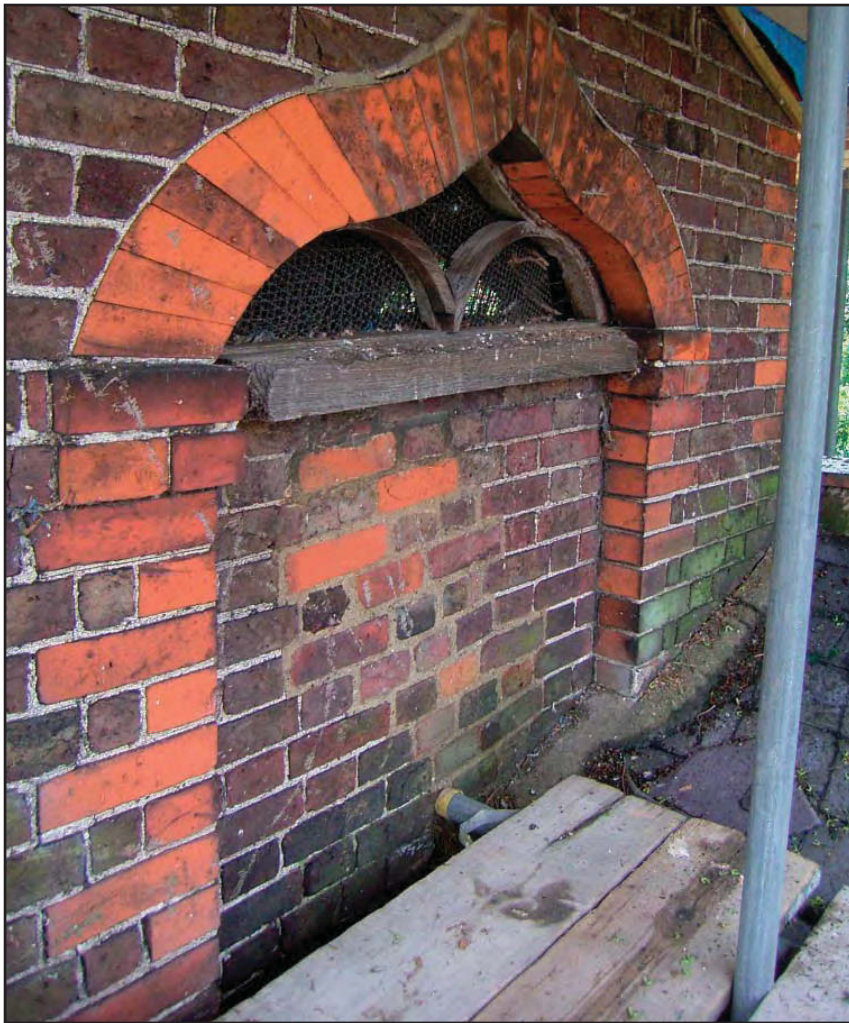
Plate 15: 1st floor blind window in Dovecote with 1864 inscribed on brick

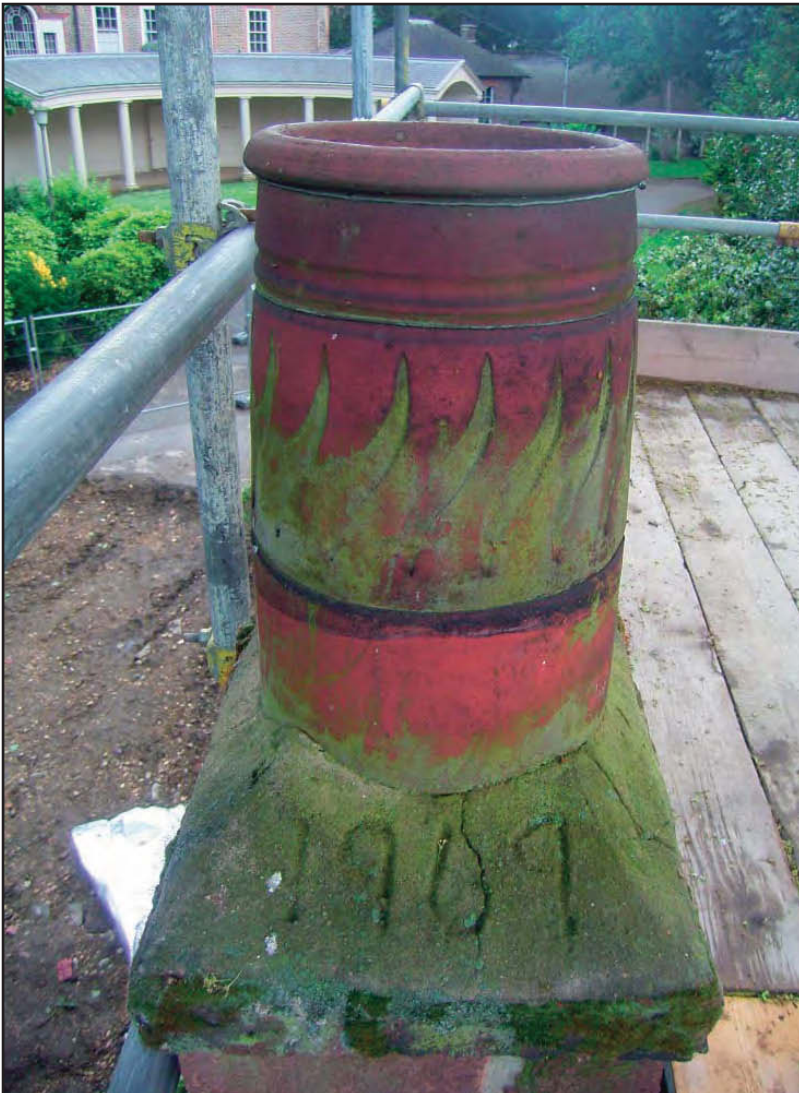
Plate 18: Chimney of Dovecote with 1909 inscribed at base

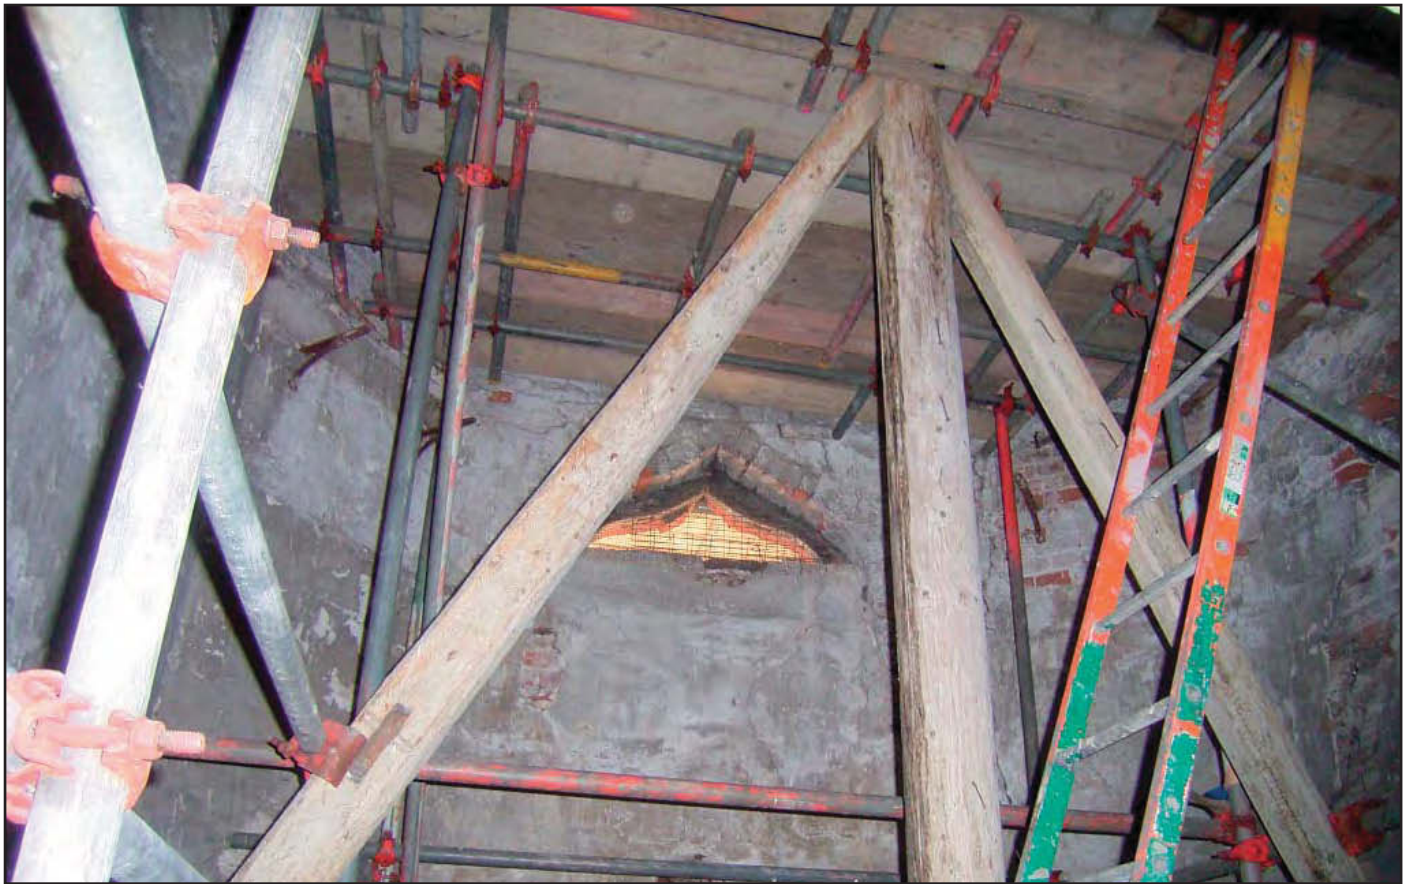
Plate 31: General view in Dovecote

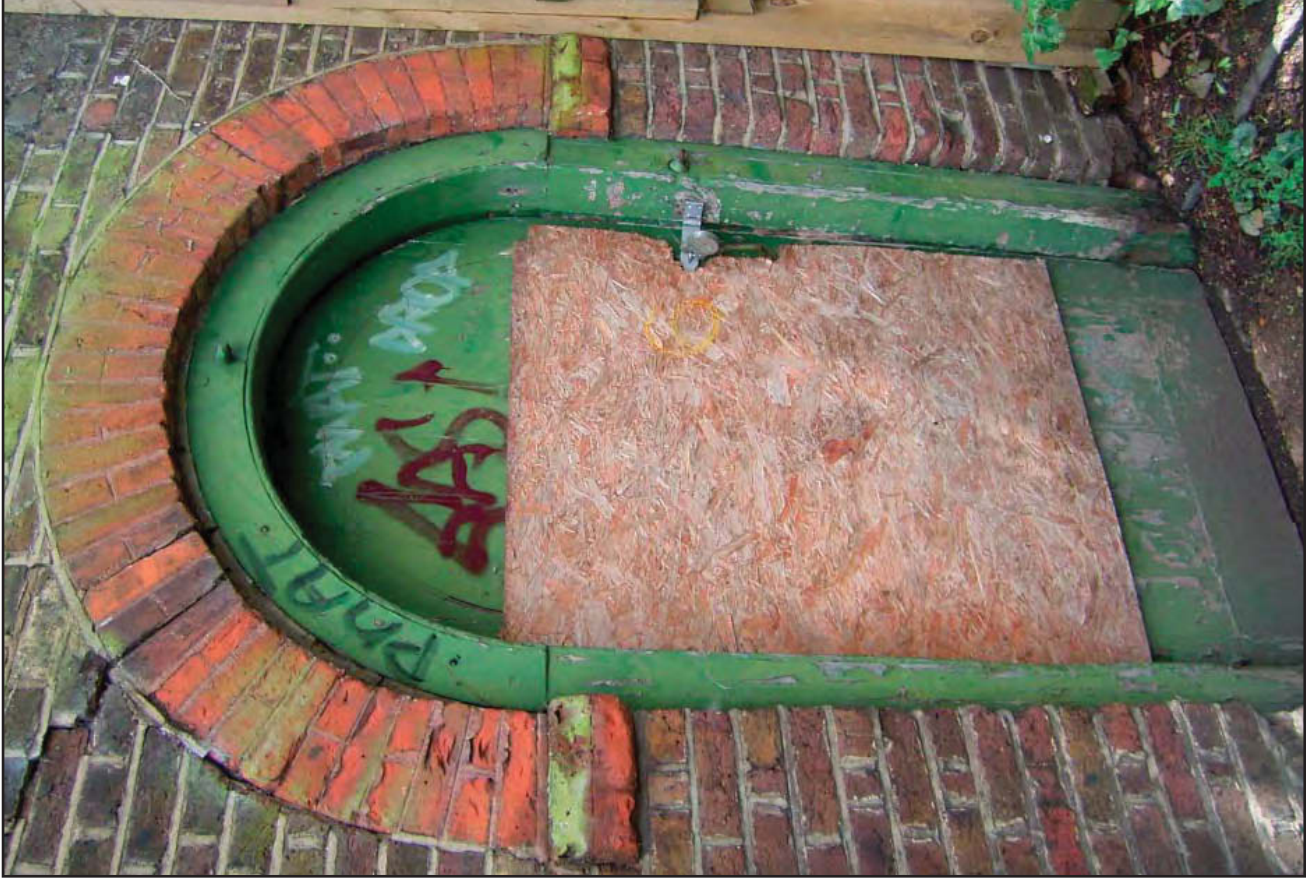
Plate 35: Door in late 19th-century screen wall

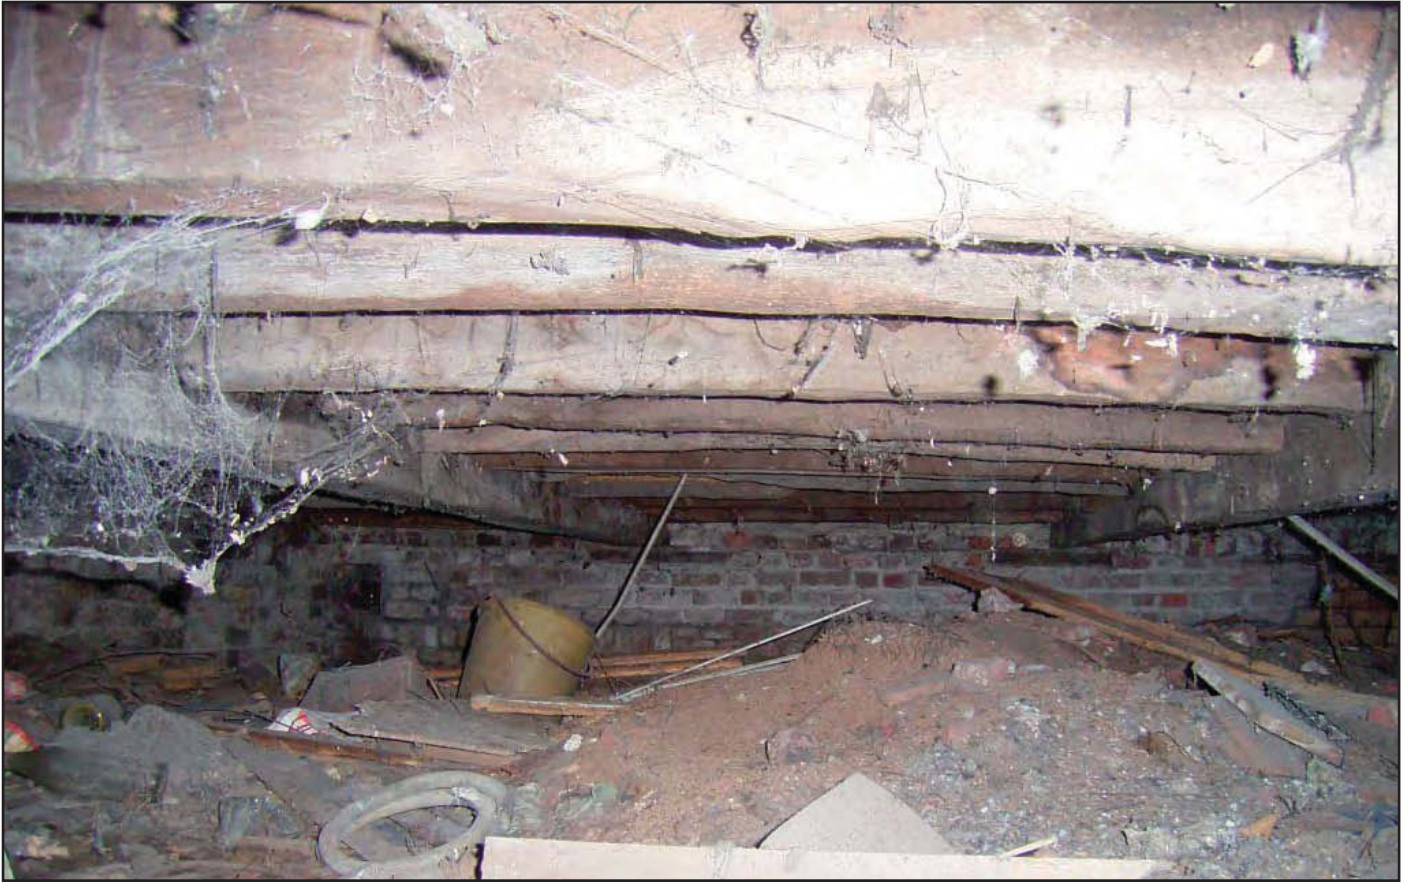
Plate 37: View under Granary

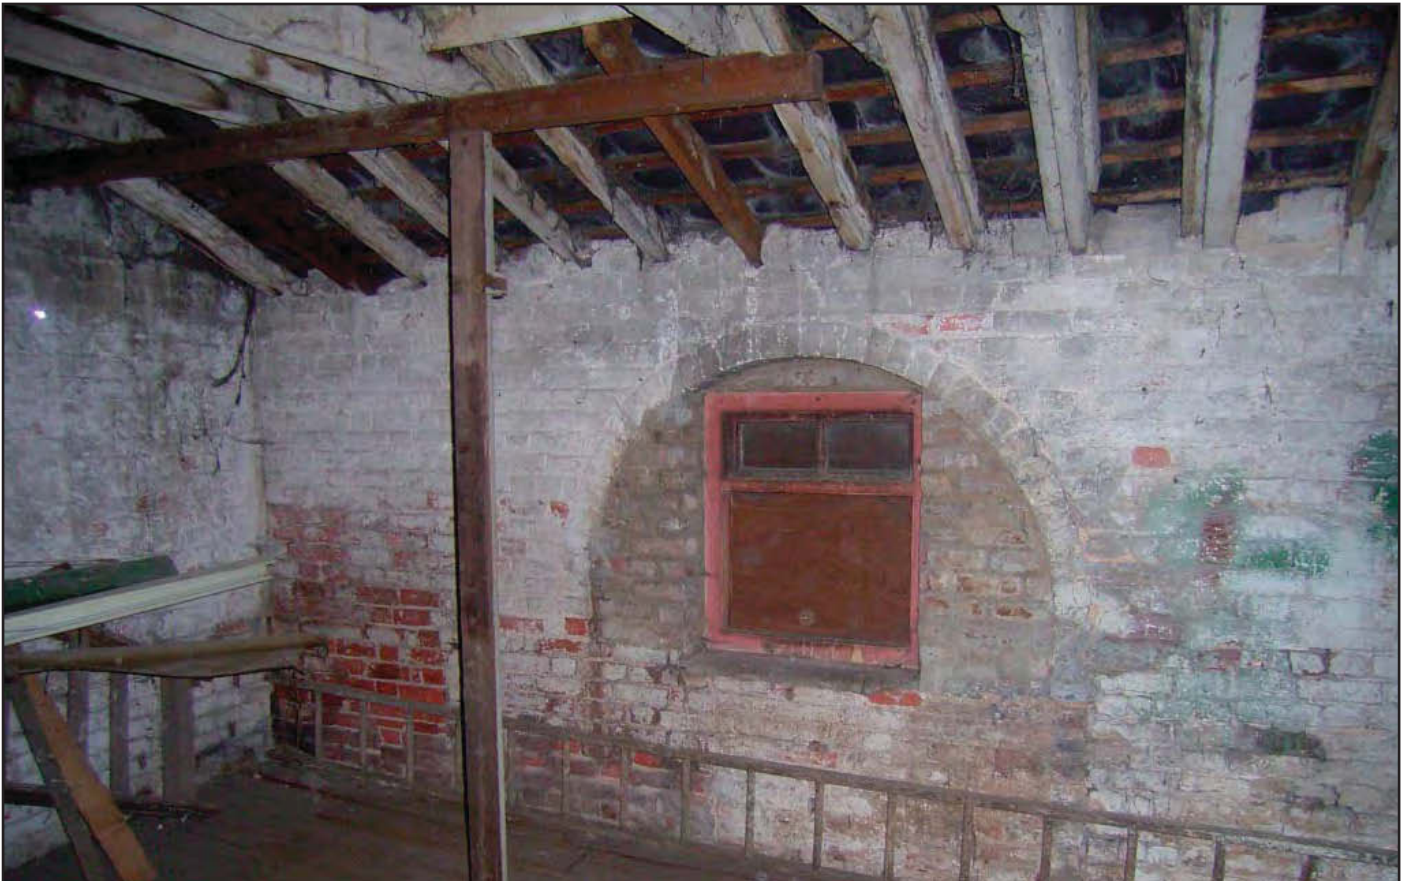
Plate 38: SE wall in Granary

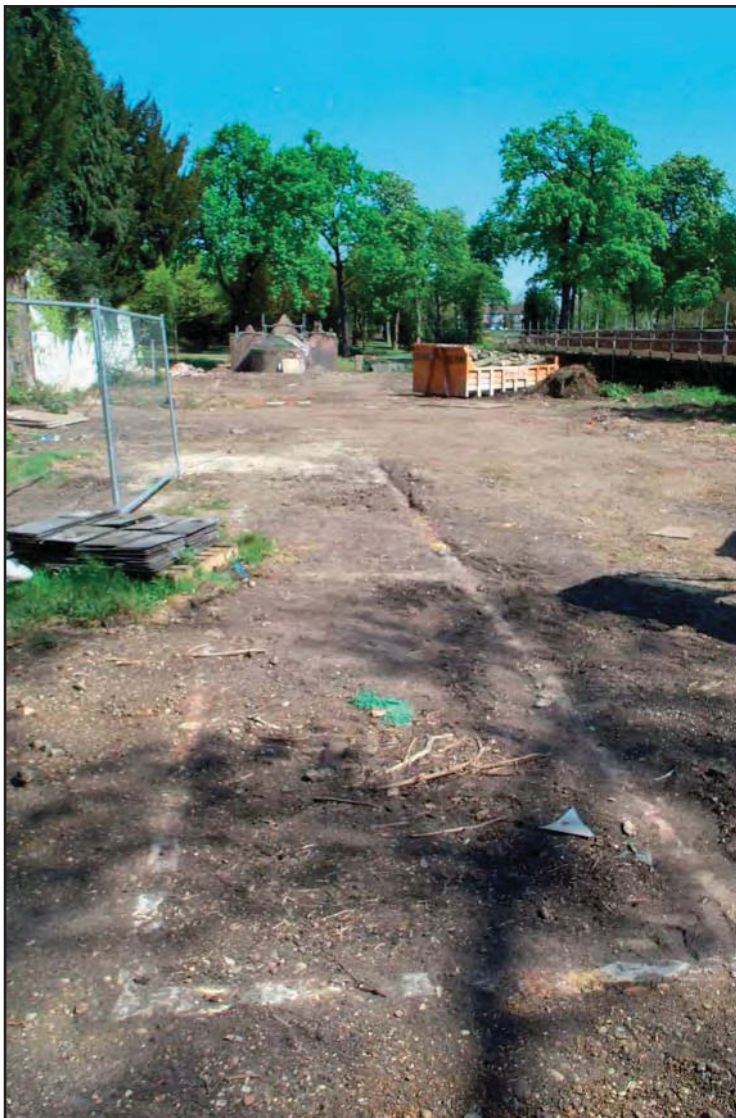
Plate 48: Trace of former structures in Kitchen Garden looking towards NE

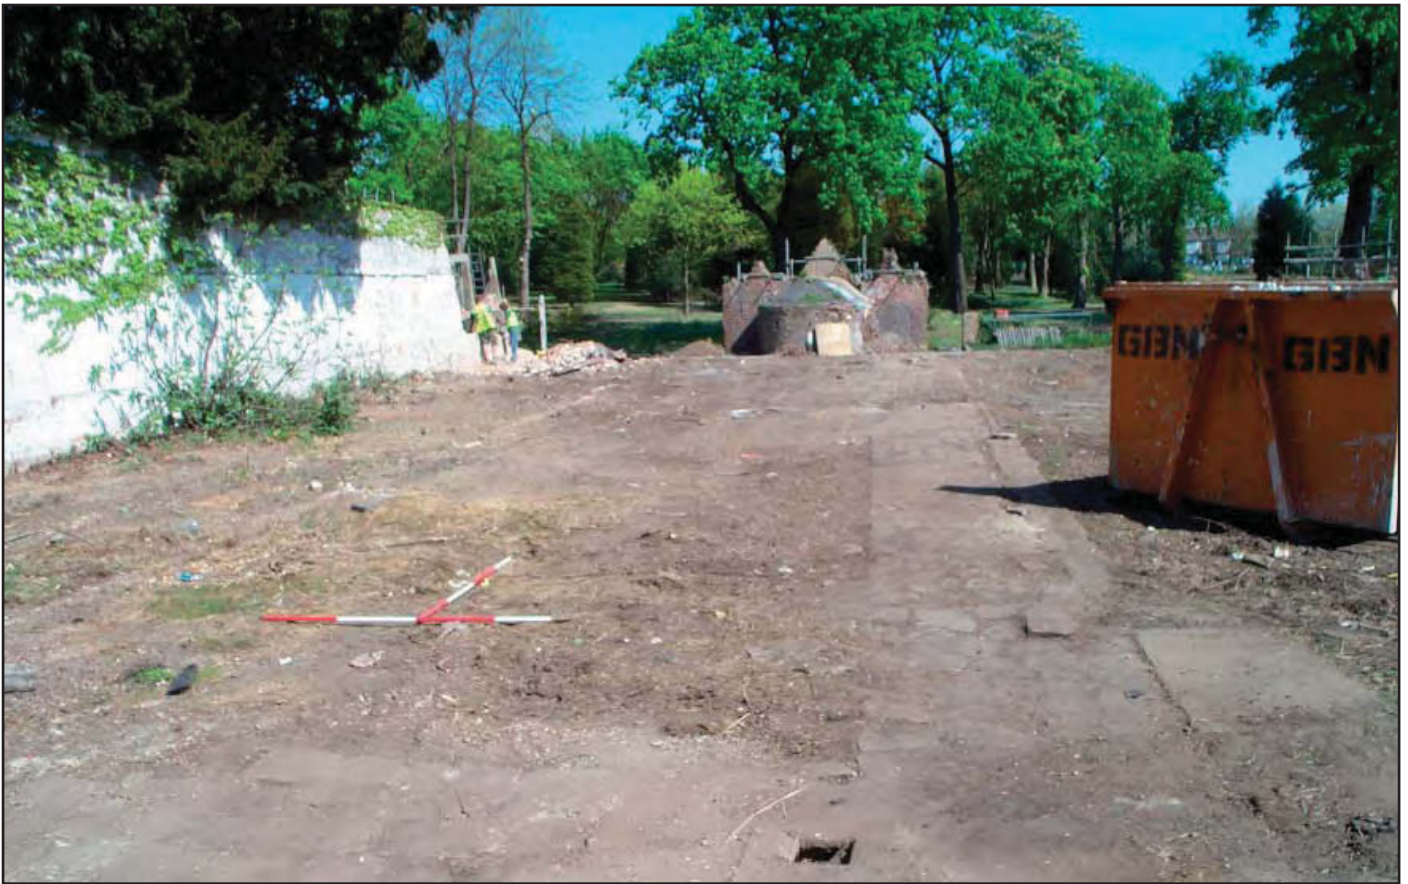
Plate 49: Trace of former structures in Kitchen Garden looking towards NE

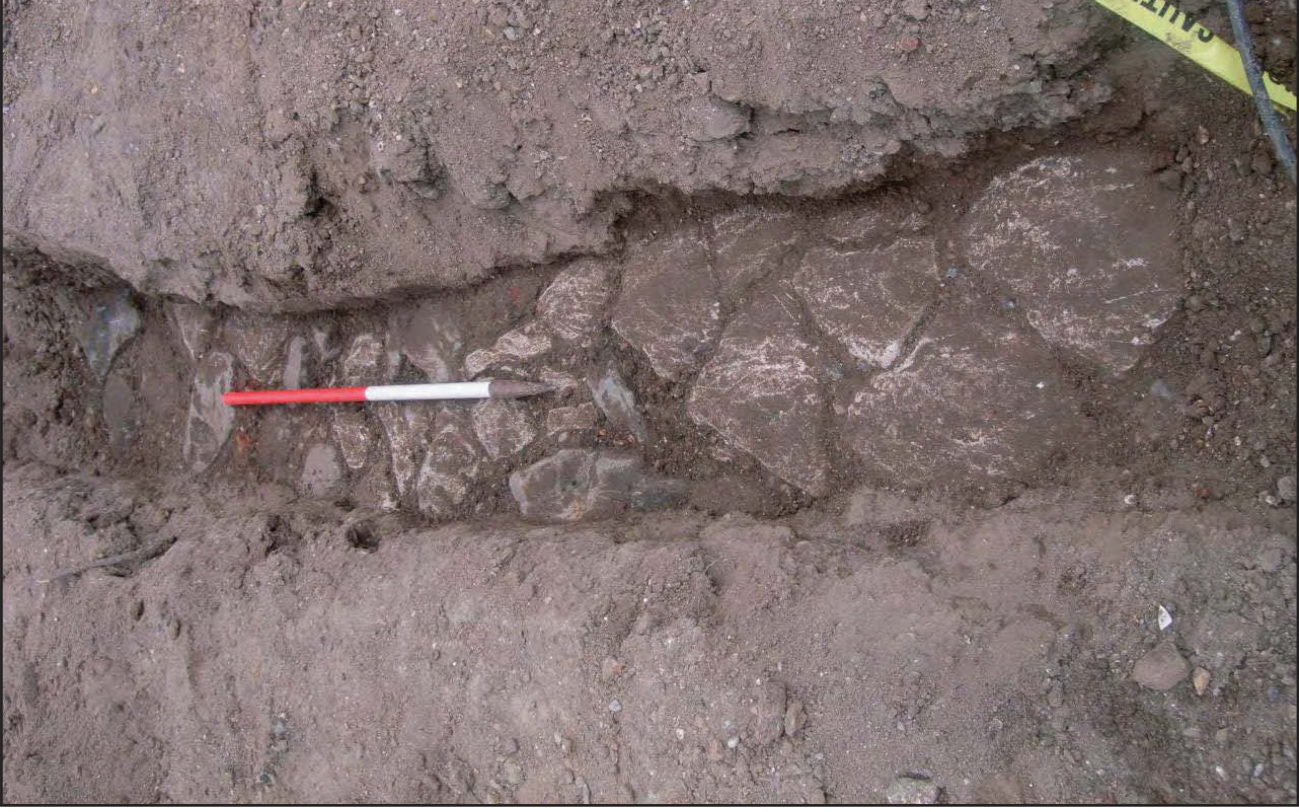
- 6.4.30 **North of the Dovecote** - A cable trench was excavated approximately 8.5 m north west of the Dovecote. Beneath a layer of sandy silt 0.35 m in depth, a surface comprising irregular slabs of limestone and sandstone was exposed (Fig 18, Plate 55). The stones are irregularly shaped (limestone average c.38 cm x 28 cm; sandstone average 30 x 20 cm) This appears to be a yard surface at least 3 m in width and is truncated to the north and south. It is probably of 18th or 19th century date.

Plate 55: Stone laid surface exposed to north of Cottage

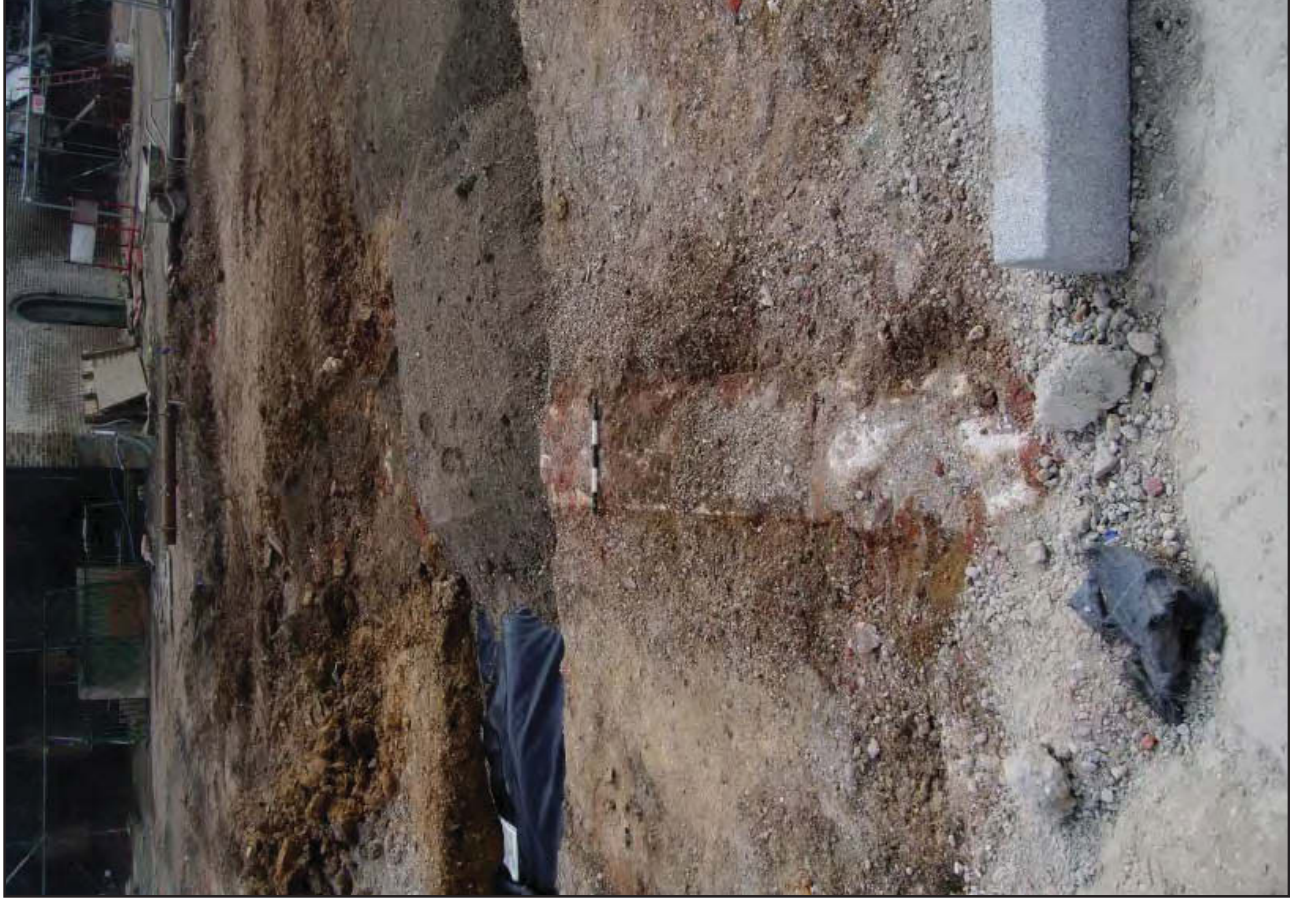
- 6.4.31 In the same general area service trenching revealed the footings from a 6.8 m length of brick wall, 0.5 m wide and 0.4 m tall (Plate 56, Fig. 15). The south-east end of the exposed section of this wall was located c.17 m to the north-west of the cottage and c.10 m north-west from the end of the screen wall adjacent to the cottage. The exposed wall was orientated NW-SE and the fact that it was closely aligned with the straight section of screen wall suggests that it may have been a continuation of this wall. The bricks within the wall were red, 23 cm x 10 cm x 7 cm, and with a coarse light-brown sandy mortar.

Plate 56: Wall exposed by works to north of Cottage/Dovecote
