Barn at Lower Rookes Farm  
Rookes Lane, Norwood Green, West Yorkshire:  
Historic Building Record

July 2014  
NGR: SE 14081 26343  
Historic township: Hipperholme with Brighouse

### Historic Building Record

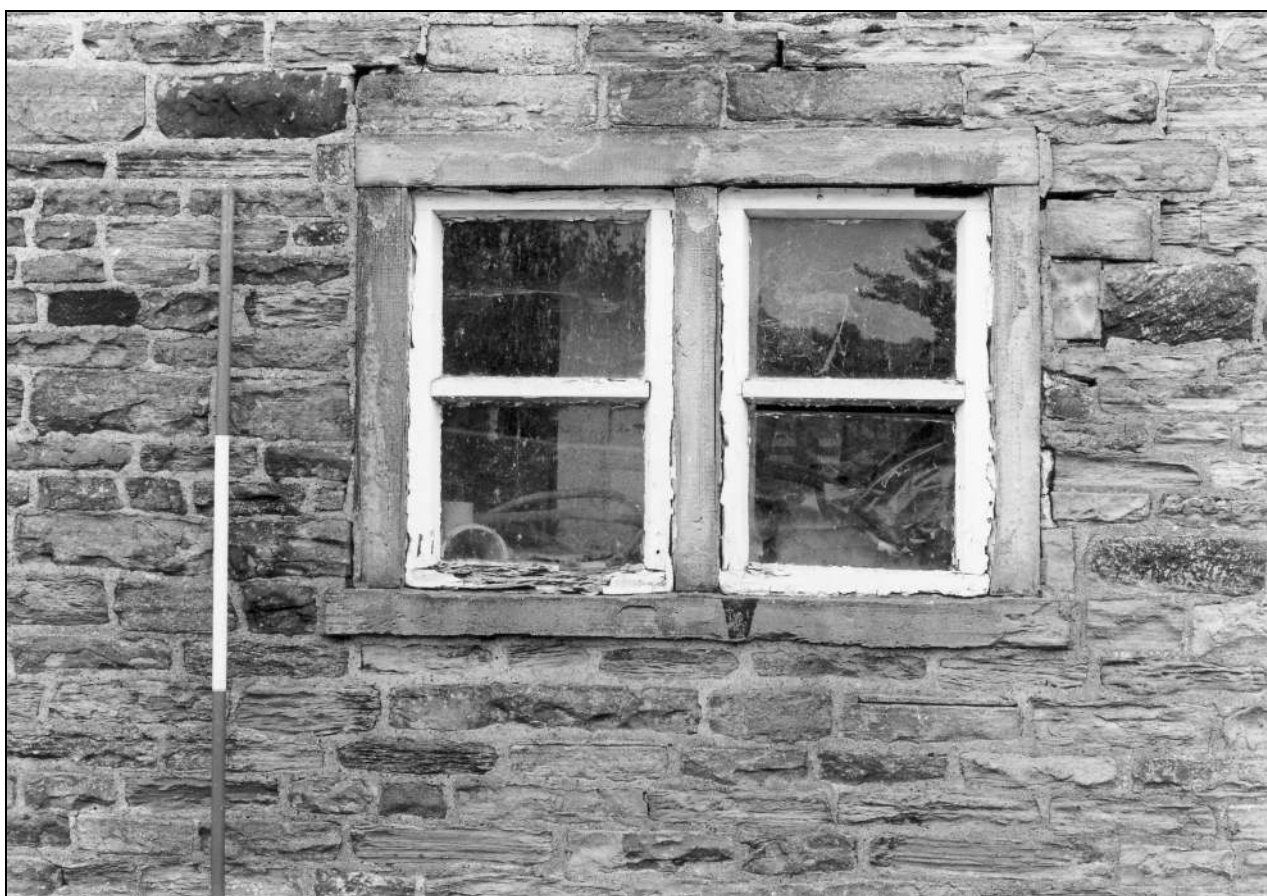
Photo 8: Nineteenth century window in north end of west elevation (film 2, frame 7)

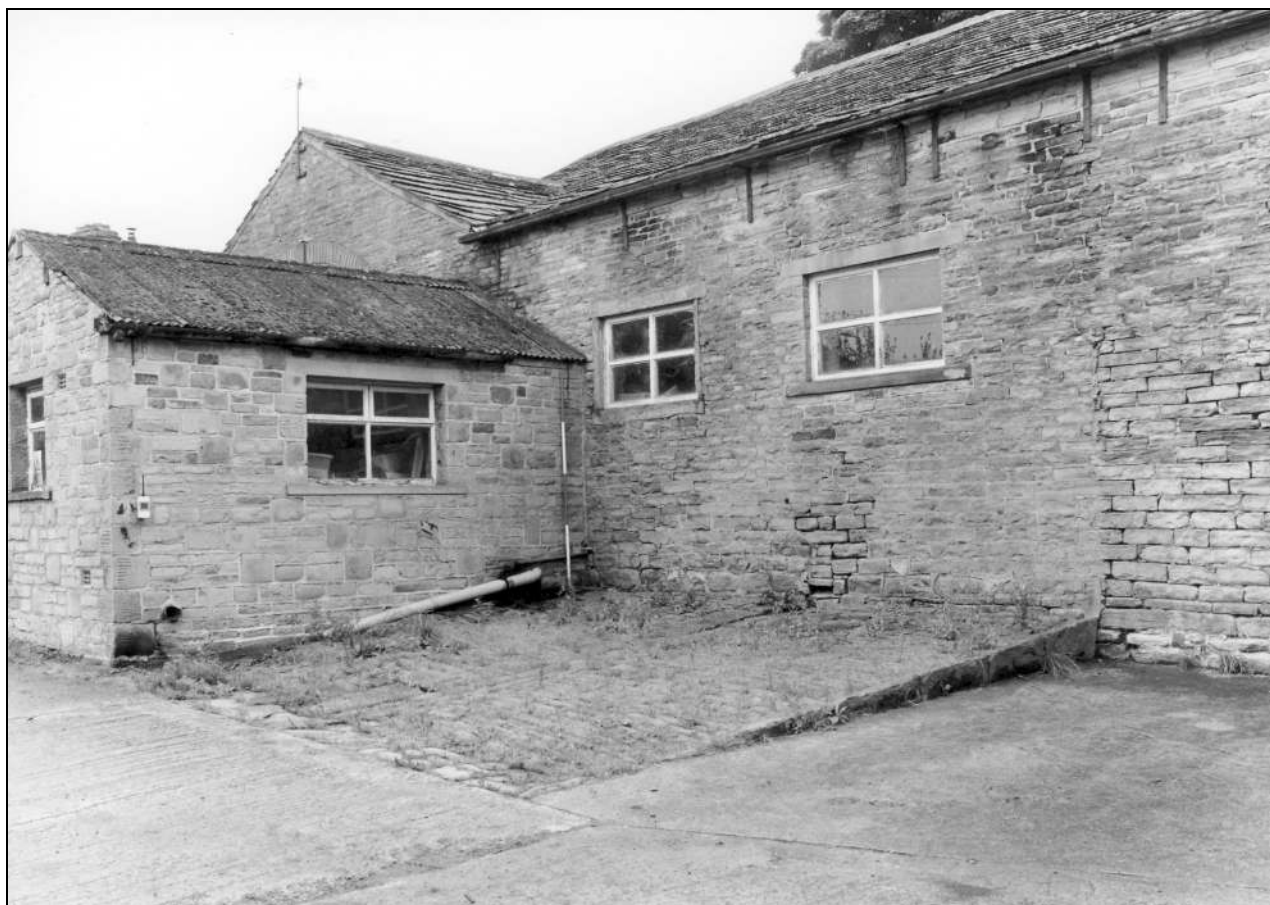
Photo 12: West elevation of barn to south of entrance, with pitched stone surfacing and inserted windows (film 1, frame 15)

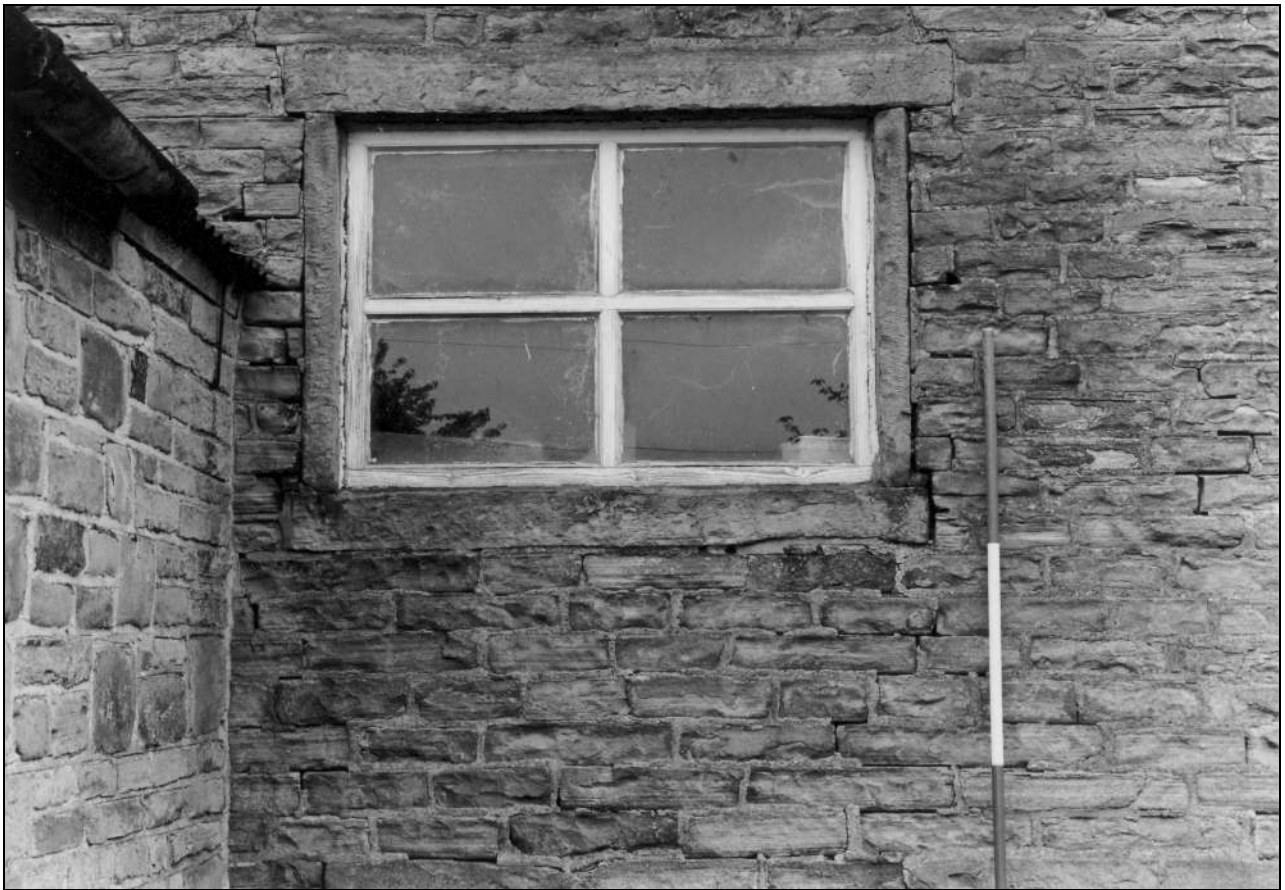
Photo 13: Inserted window in south end of west elevation (film 2, frame 6)

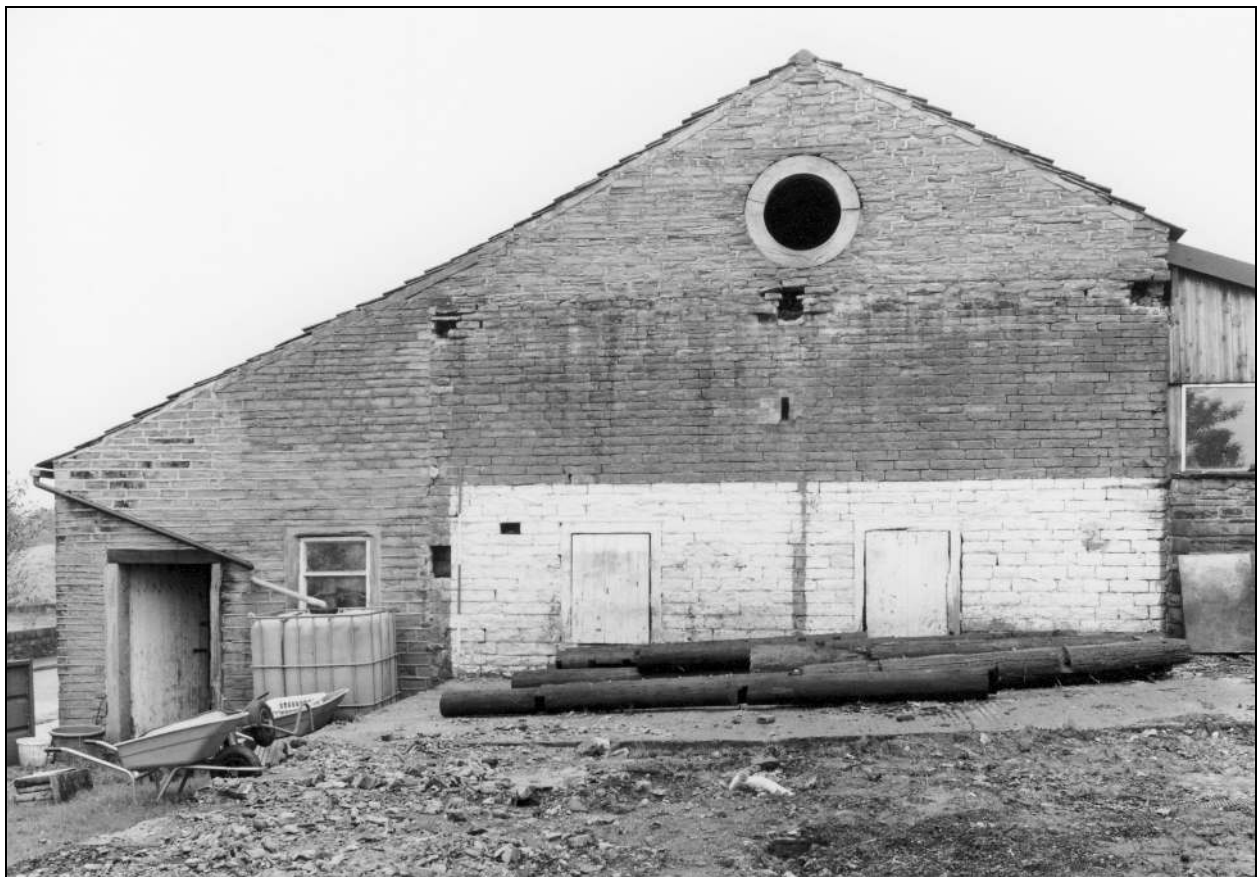
Photo 14: The rebuilt south gable, with nineteenth century openings (film 1, frame 16)

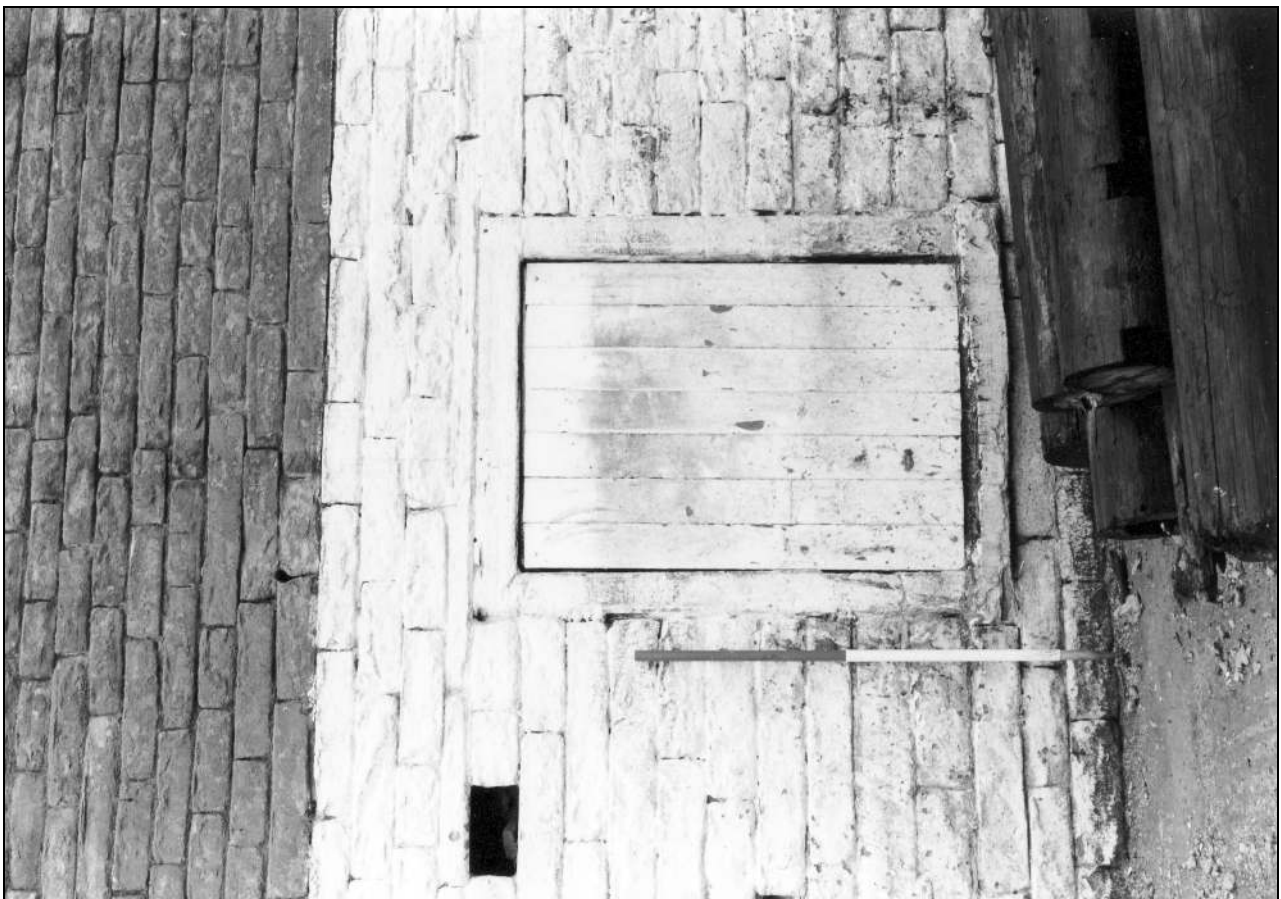
Photo 16: Detail of boarded window in south gable (film 2, frame 3)

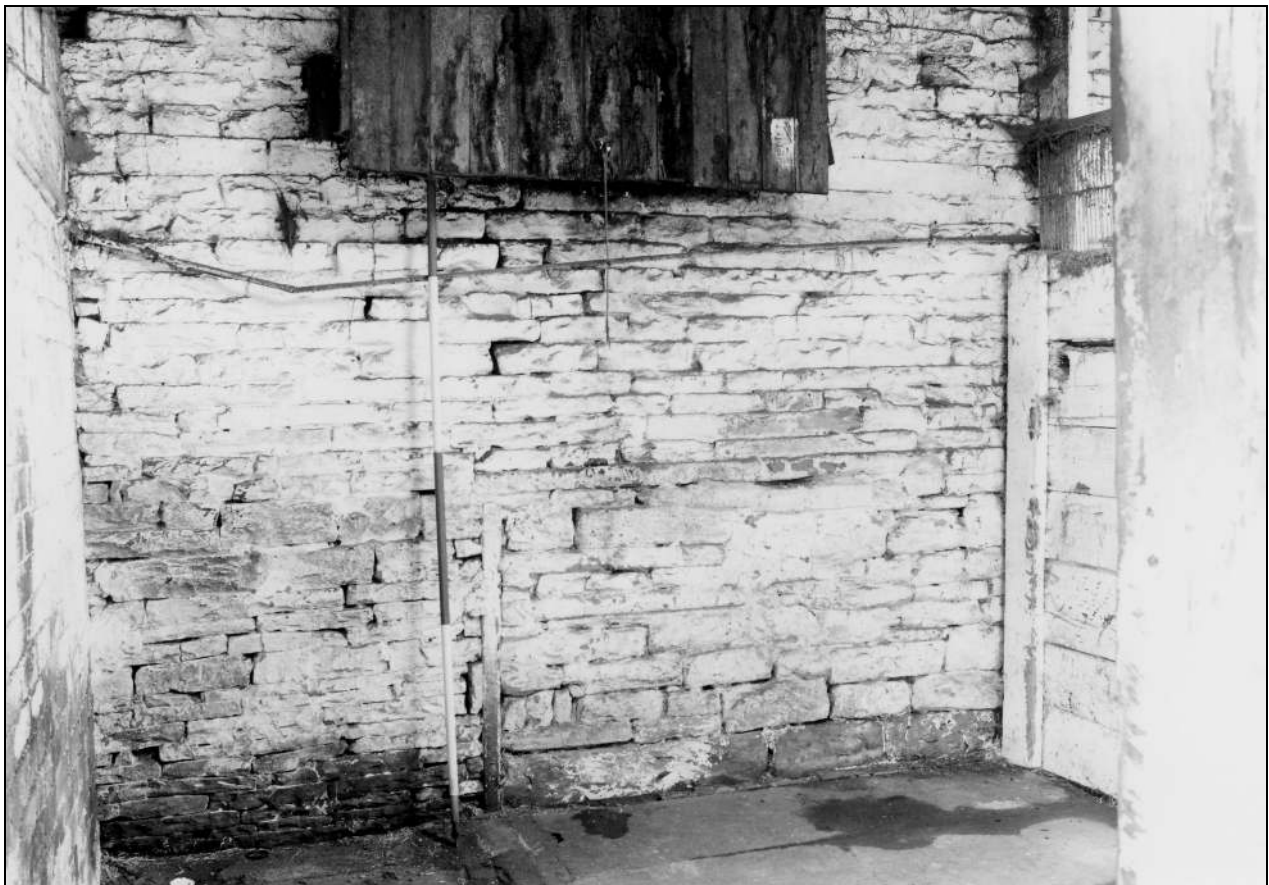
Photo 26: East wall of barn within later lean-to, showing blocked window at foot, from the east (film 2, frame 15)

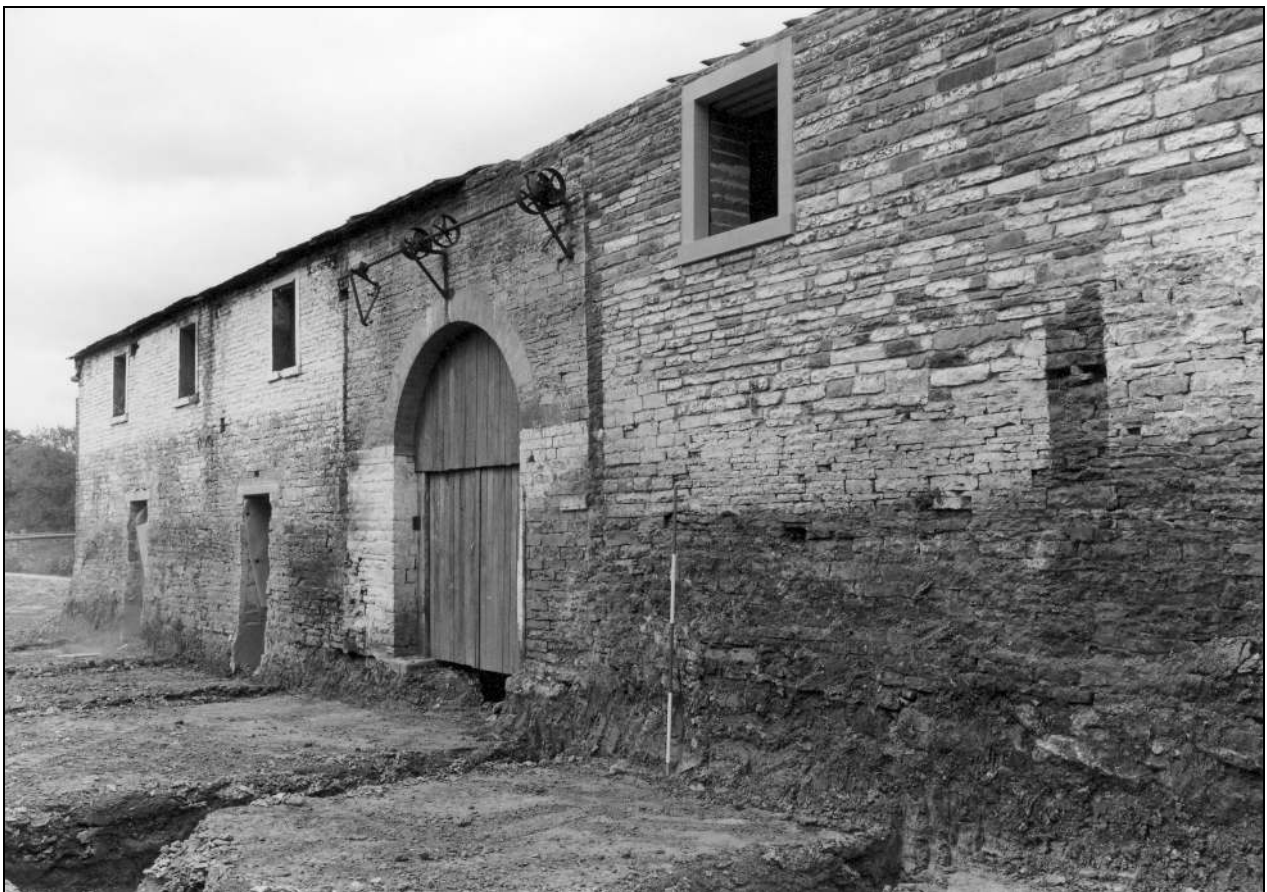
Photo 28: East elevation of barn, from the north-east, after demolition of lean-tos, 2014 (film 8, frame 6)

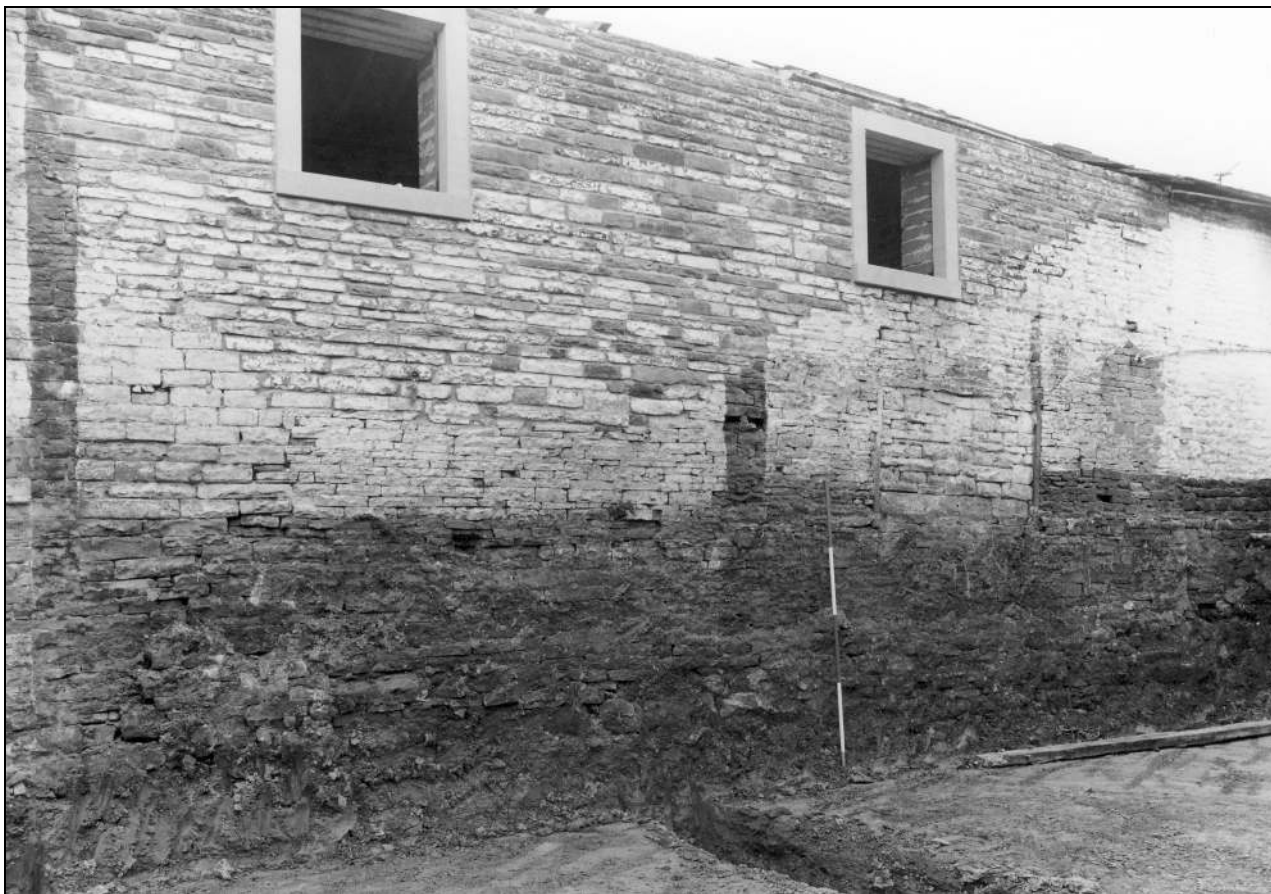
Photo 29: East elevation of barn, to north of arched doorway, after demolition of lean-tos, 2014 (film 8, frame 5)

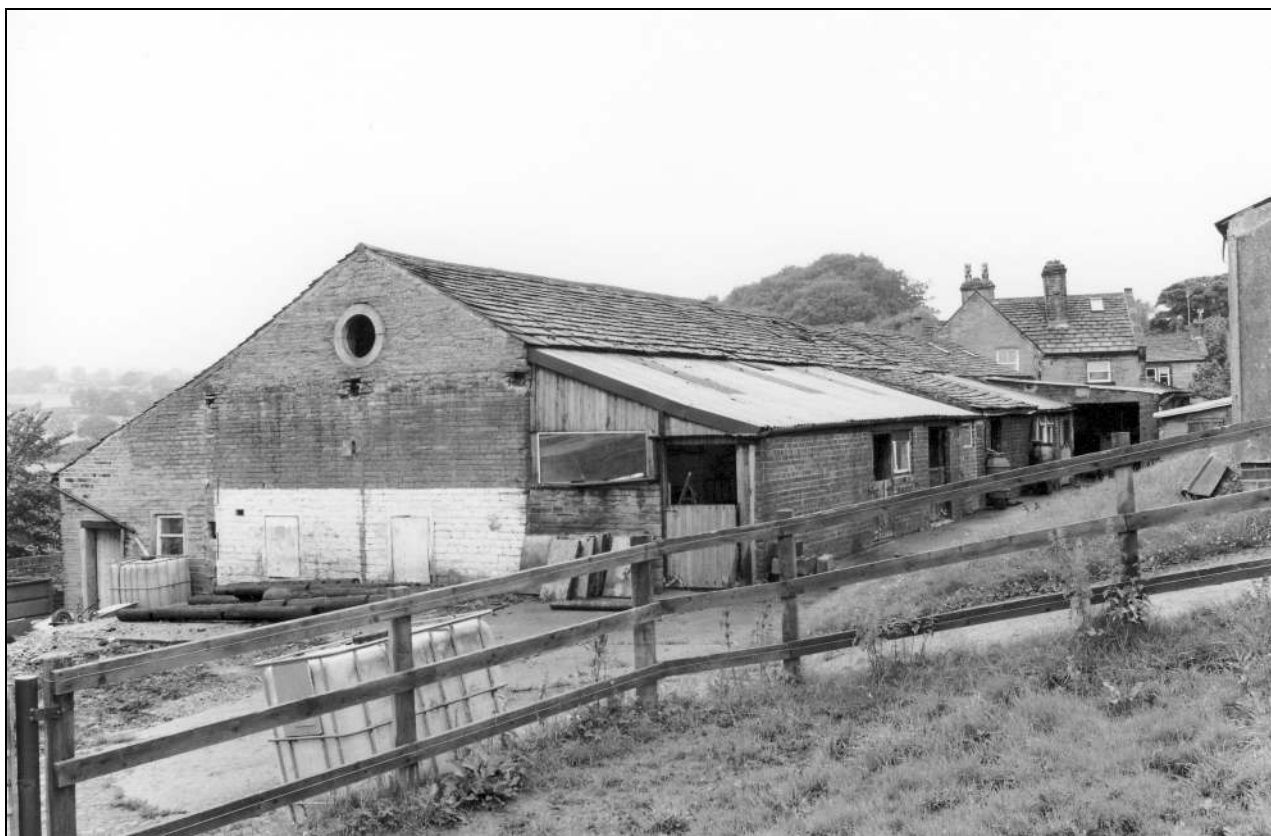
Photo 30: General view of the barn from the south-east, showing later lean-tos (film 1, frame 17)

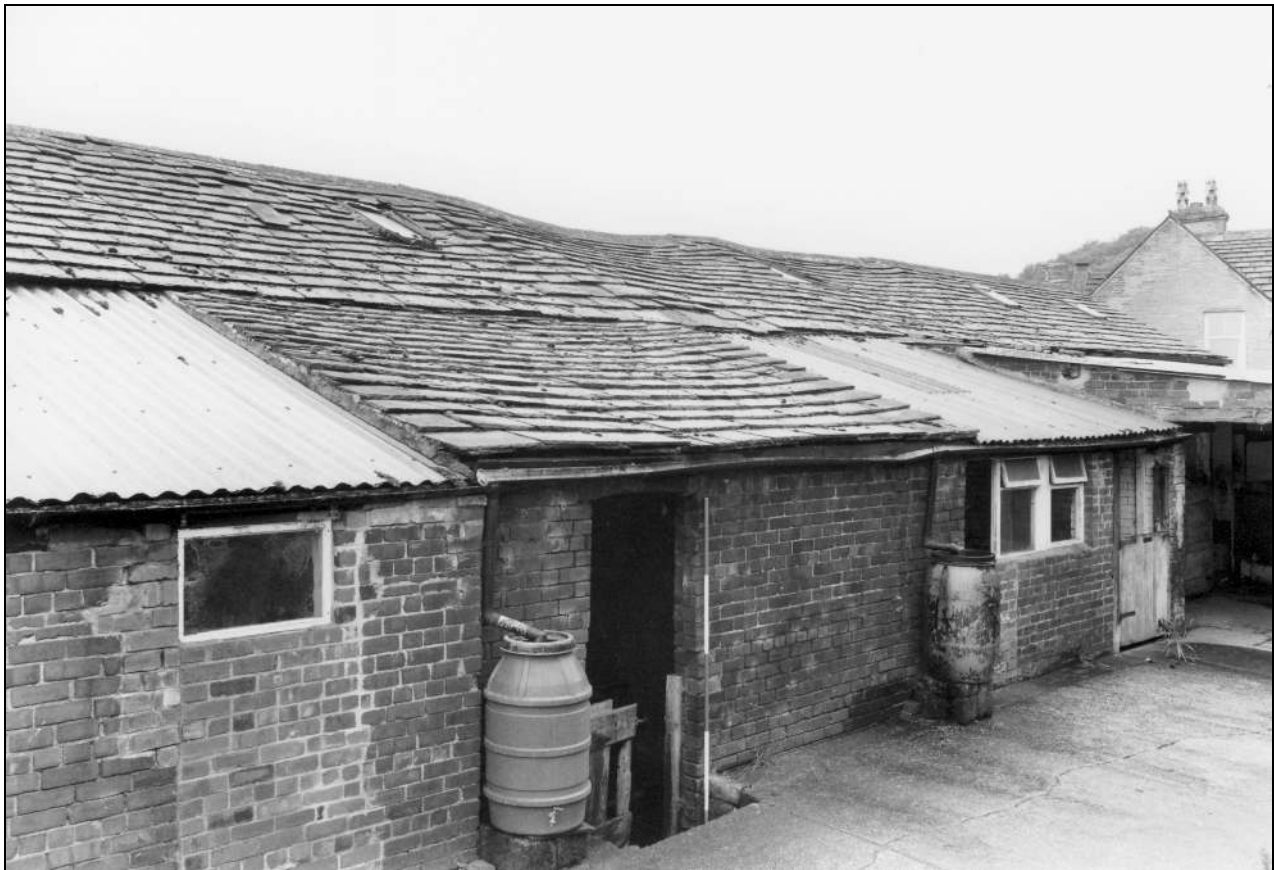
Photo 31: Early C20 brick lean-to against east cart entrance, from the south-east (film 1, frame 18)

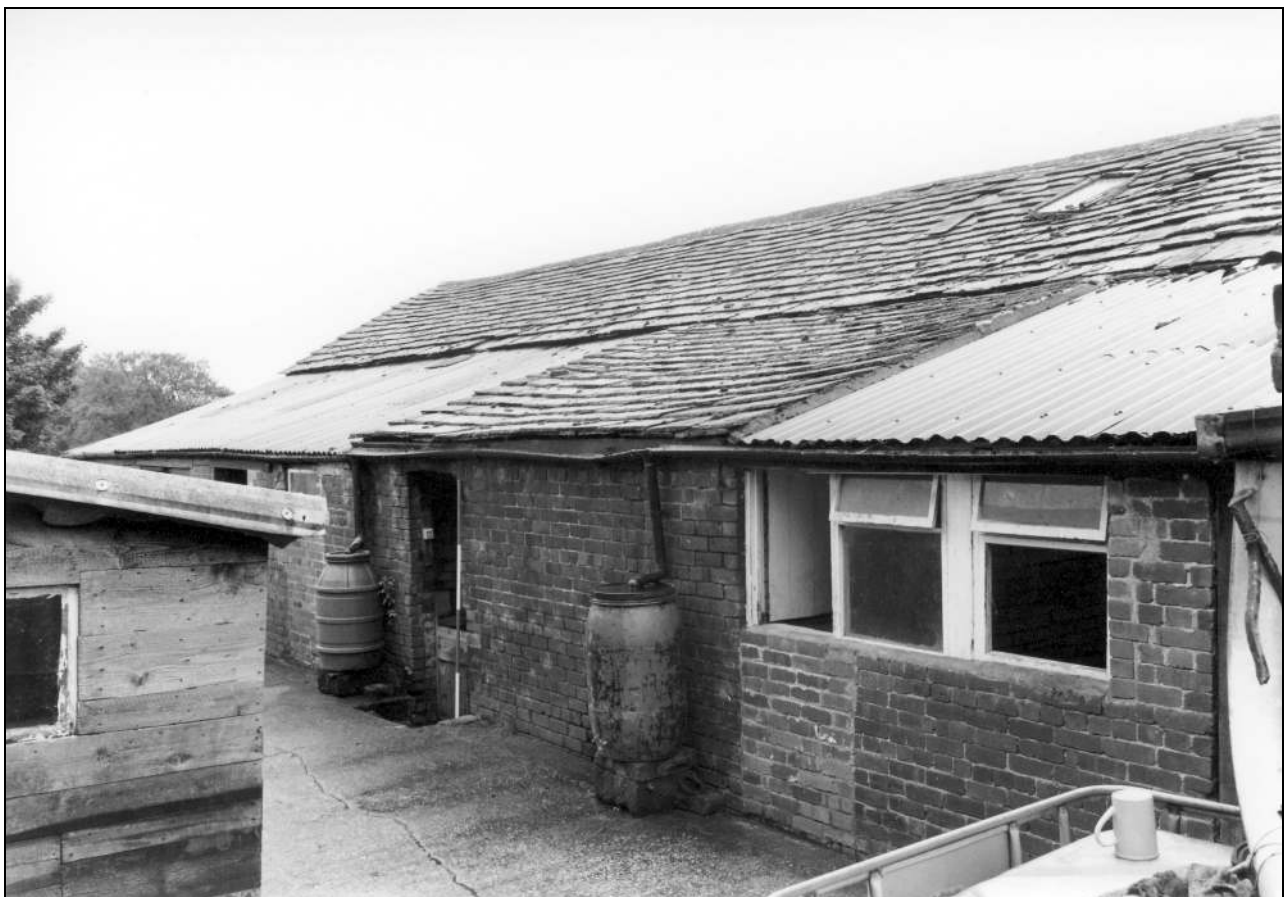
Photo 32: Early C20 brick lean-to against east cart entrance, from the north-east (film 2, frame 1)

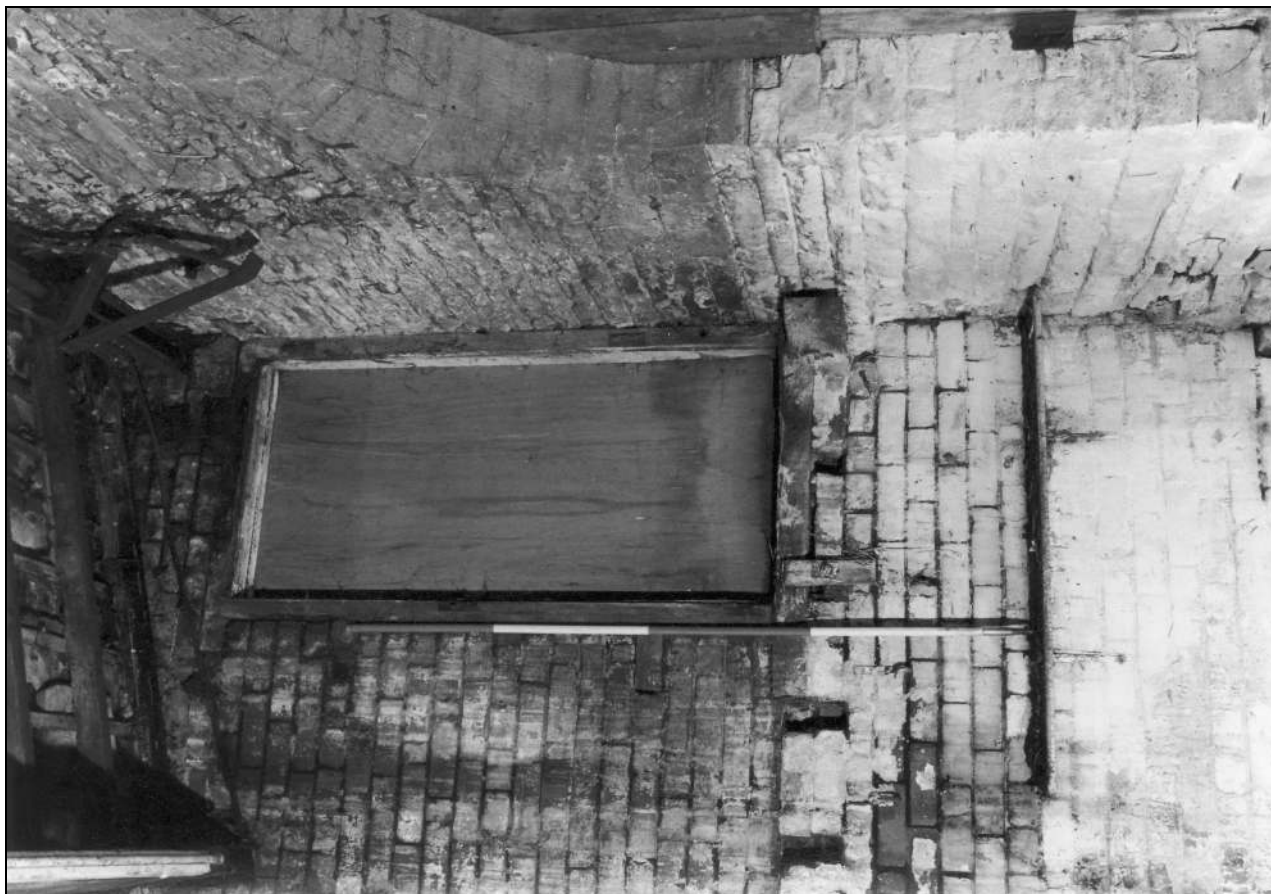
Photo 33: Interior of early C20 brick lean-to against east cart entrance, from the north (film 3, frame 5)

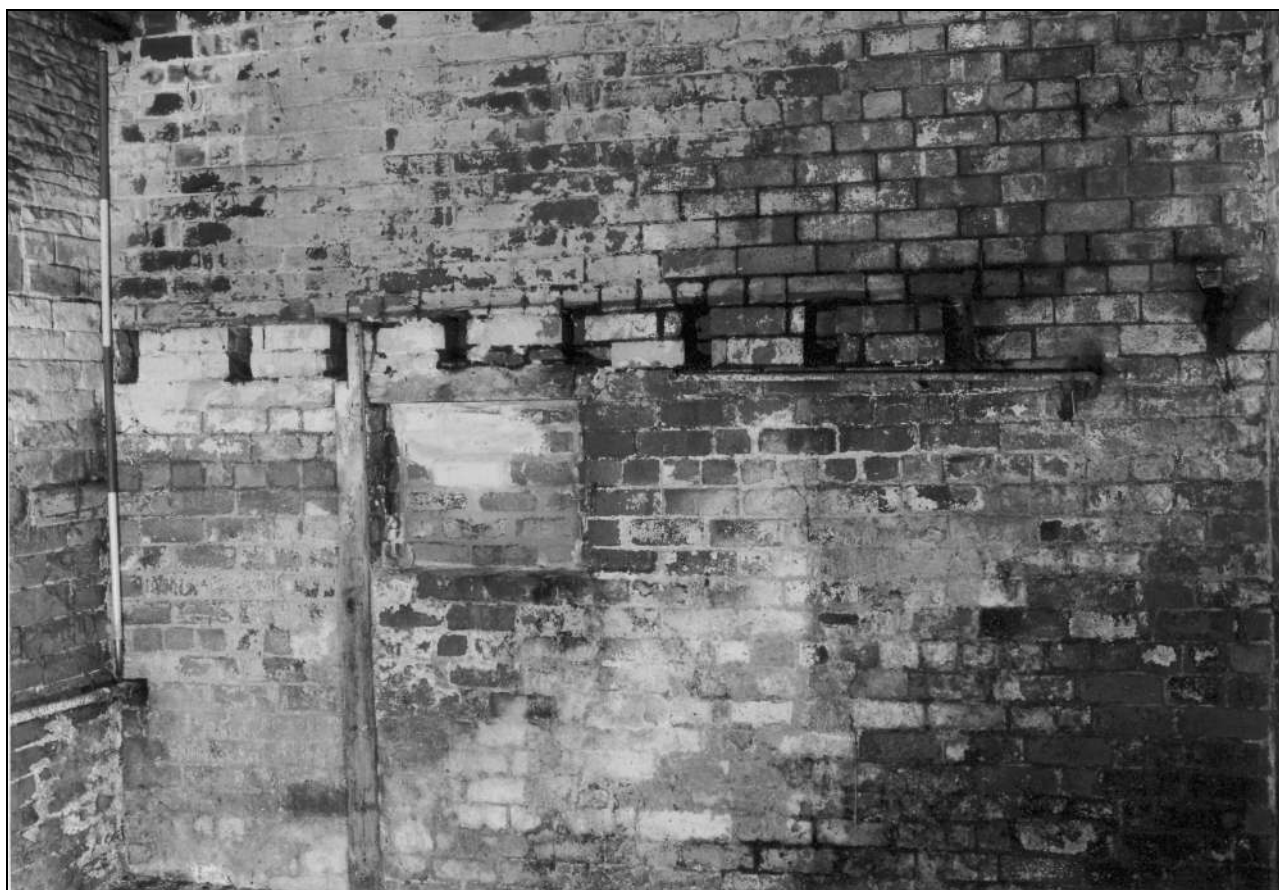
Photo 34: Interior of early C20 brick lean-to against east cart entrance, from the south (film 3, frame 2)

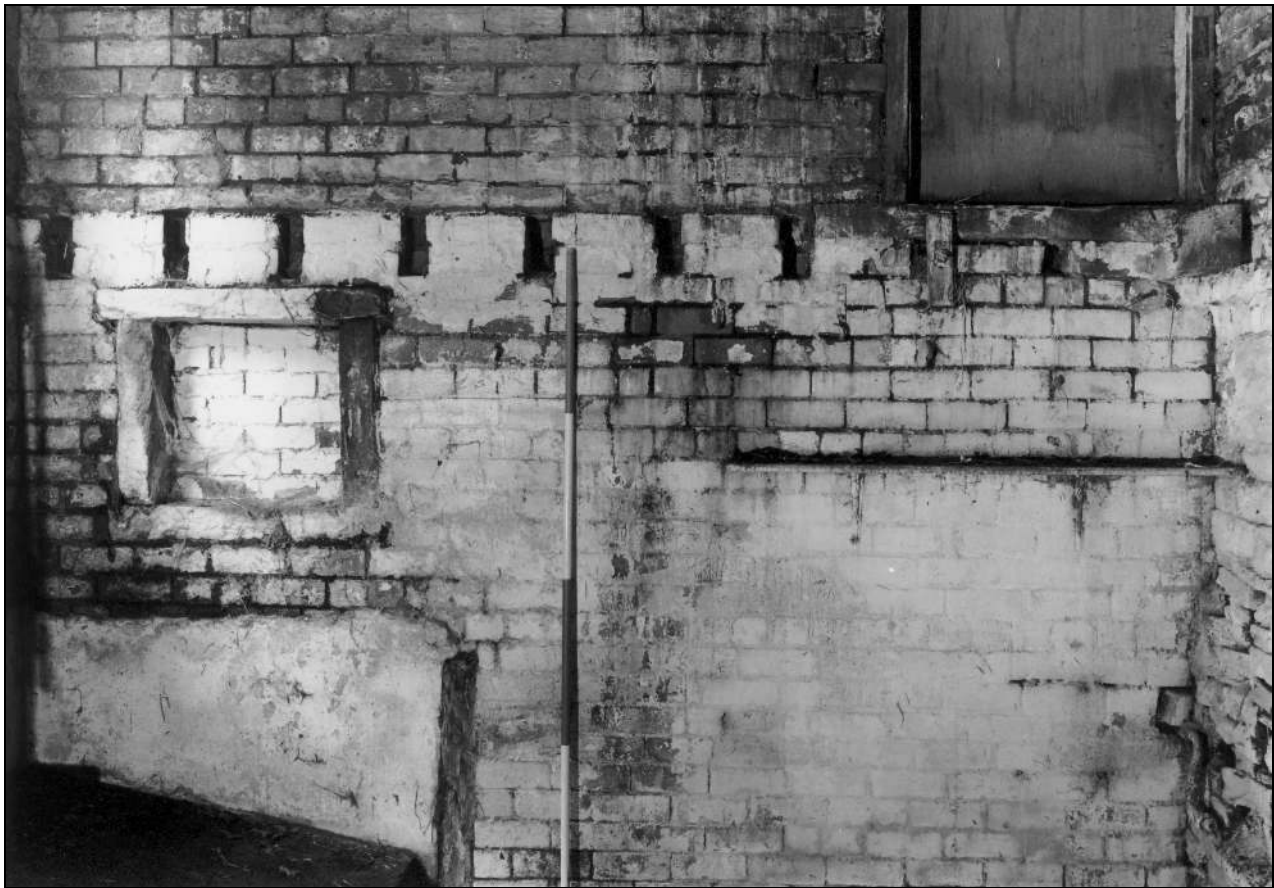
Photo 35: Interior of early C20 brick lean-to against east cart entrance, from the north (film 3, frame 4)

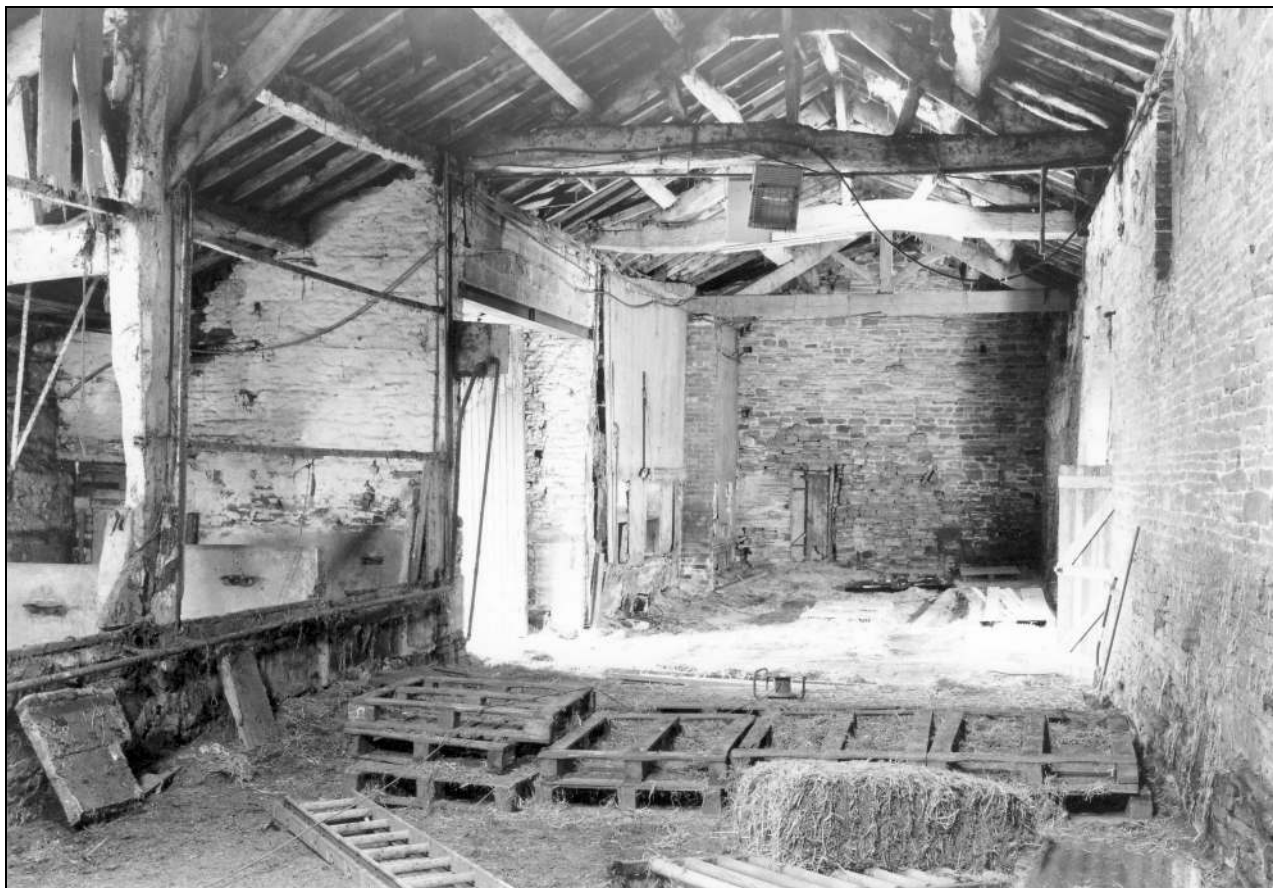
Photo 39: Barn interior, from the south-east (film 3, frame 10)

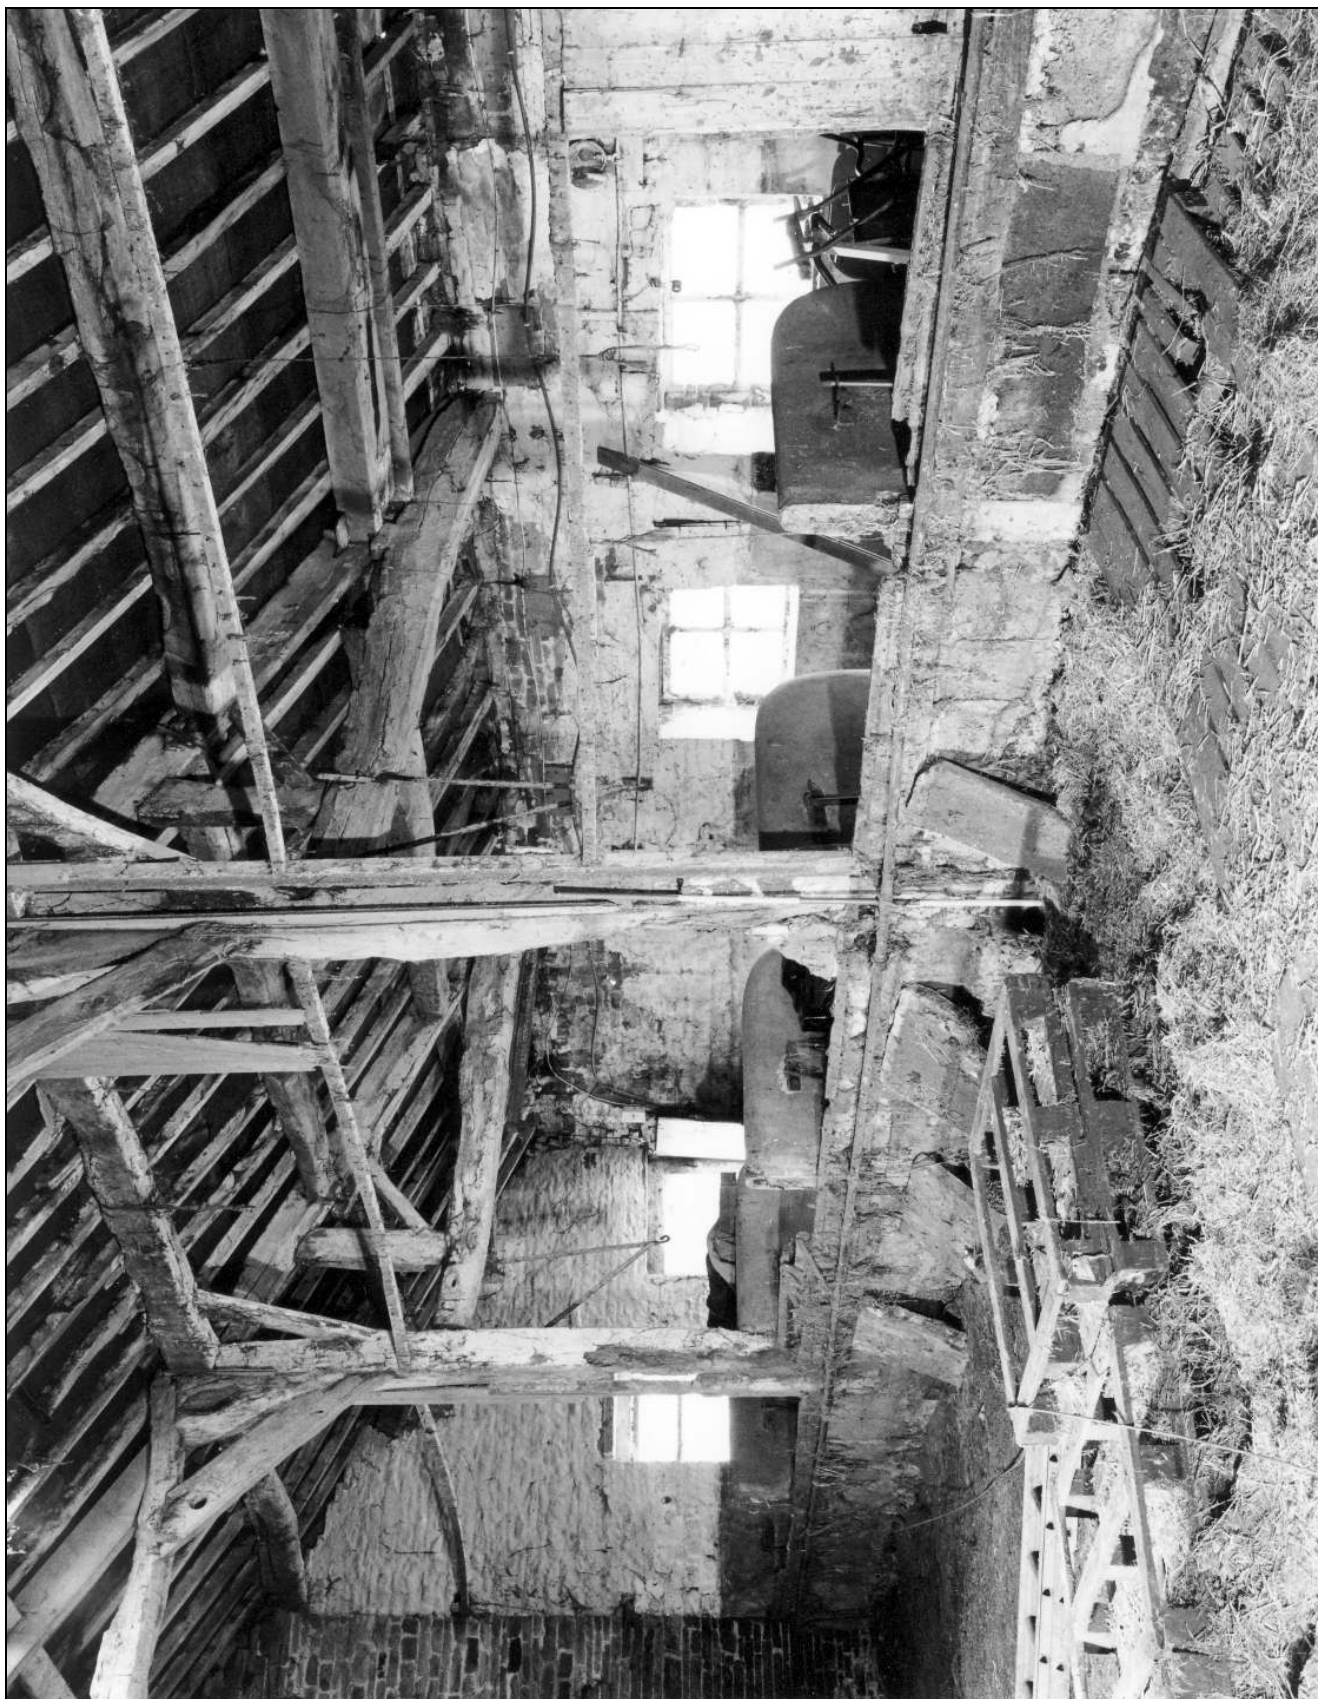
Photo 41: The south part of the aisle, from the north-east (film 3, frame 14)

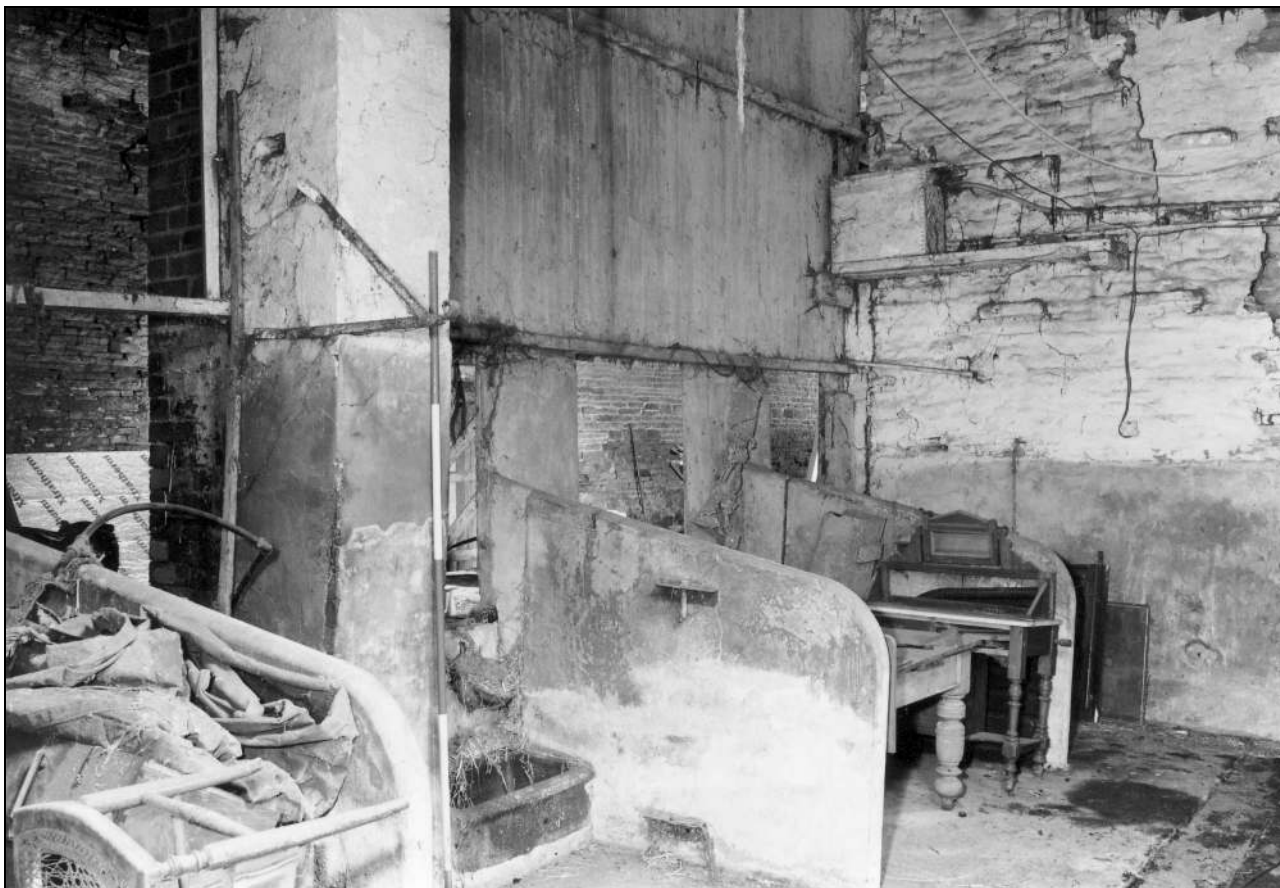
Photo 42: The north part of the aisle, from the north-west (film 7, frame 6)

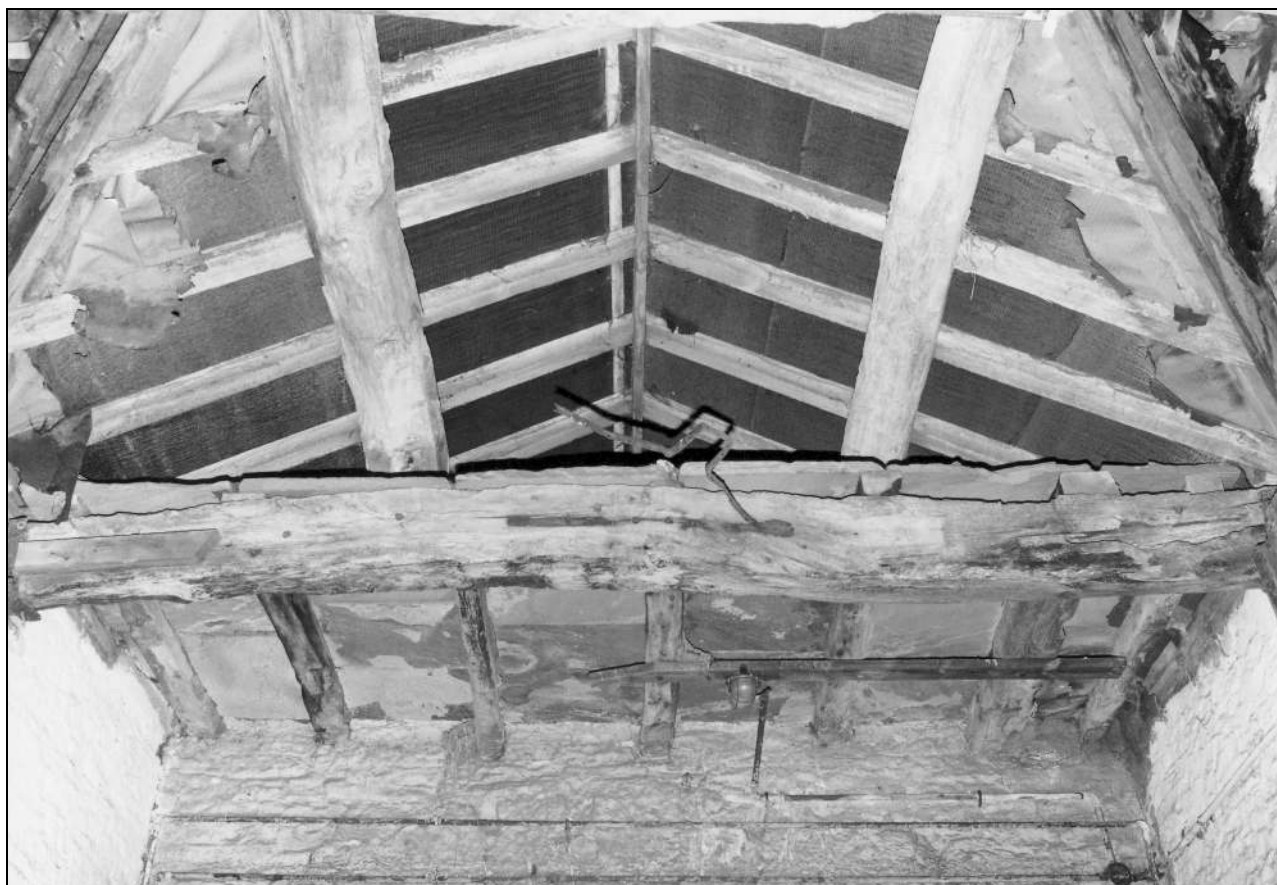
Photo 43: Flagged loft within gabled entry, from the east (film 2, frame 16)

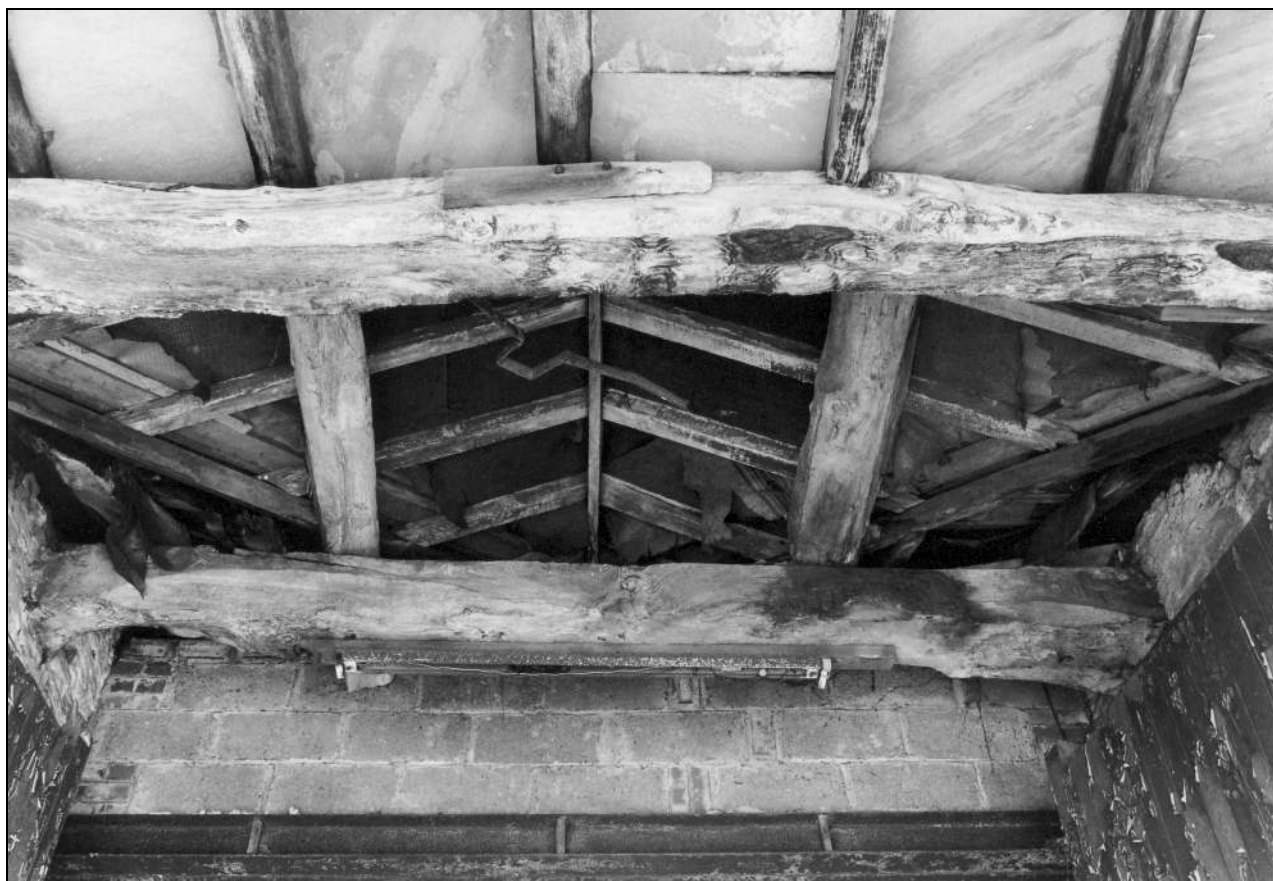
Photo 44: Beams over west entry, from the west (film 2, frame 18)
