Barn at Lower Rookes Farm  
Rookes Lane, Norwood Green, West Yorkshire:  
Historic Building Record

July 2014  
NGR: SE 14081 26343  
Historic township: Hipperholme with Brighouse

### Historic Building Record

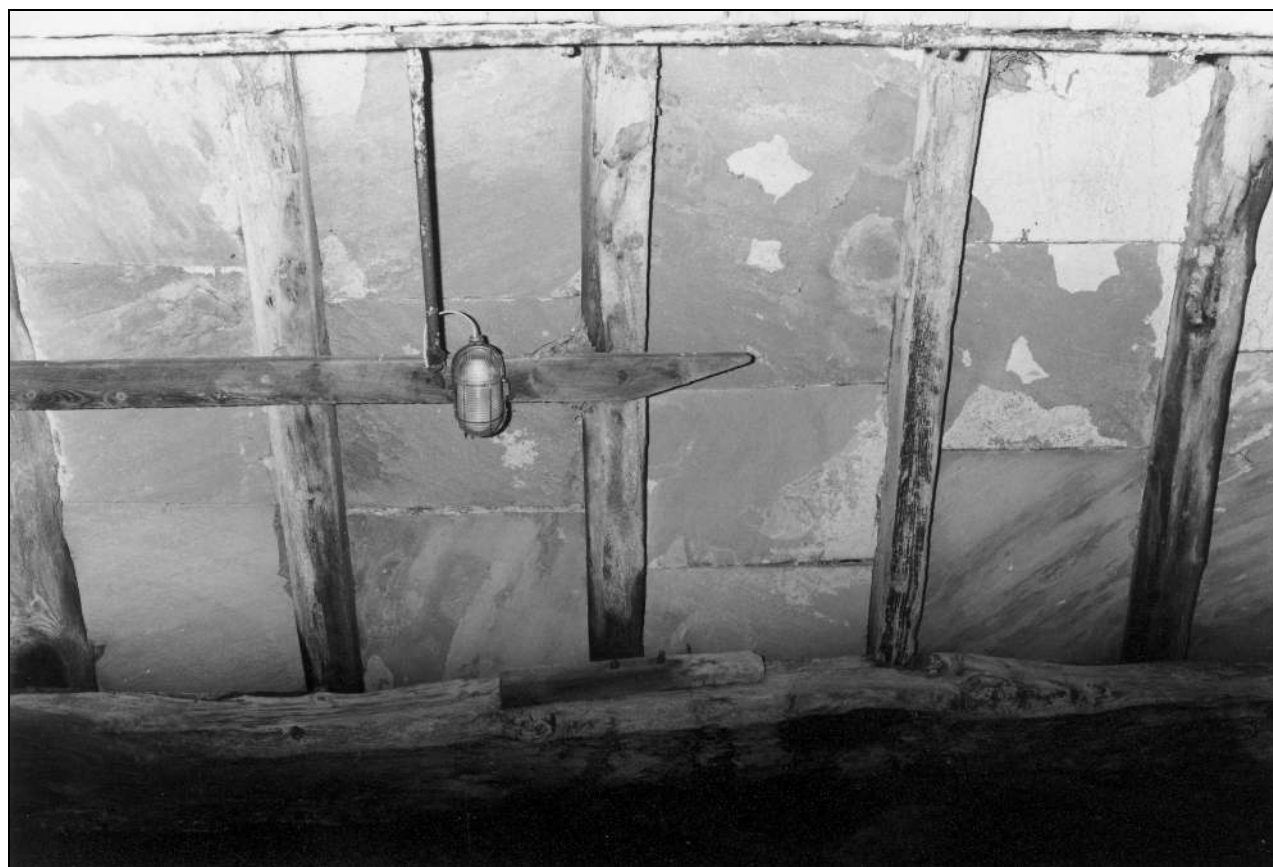
Photo 45: Underside of flagged loft within gabled entry, from the west (film 2, frame 17)

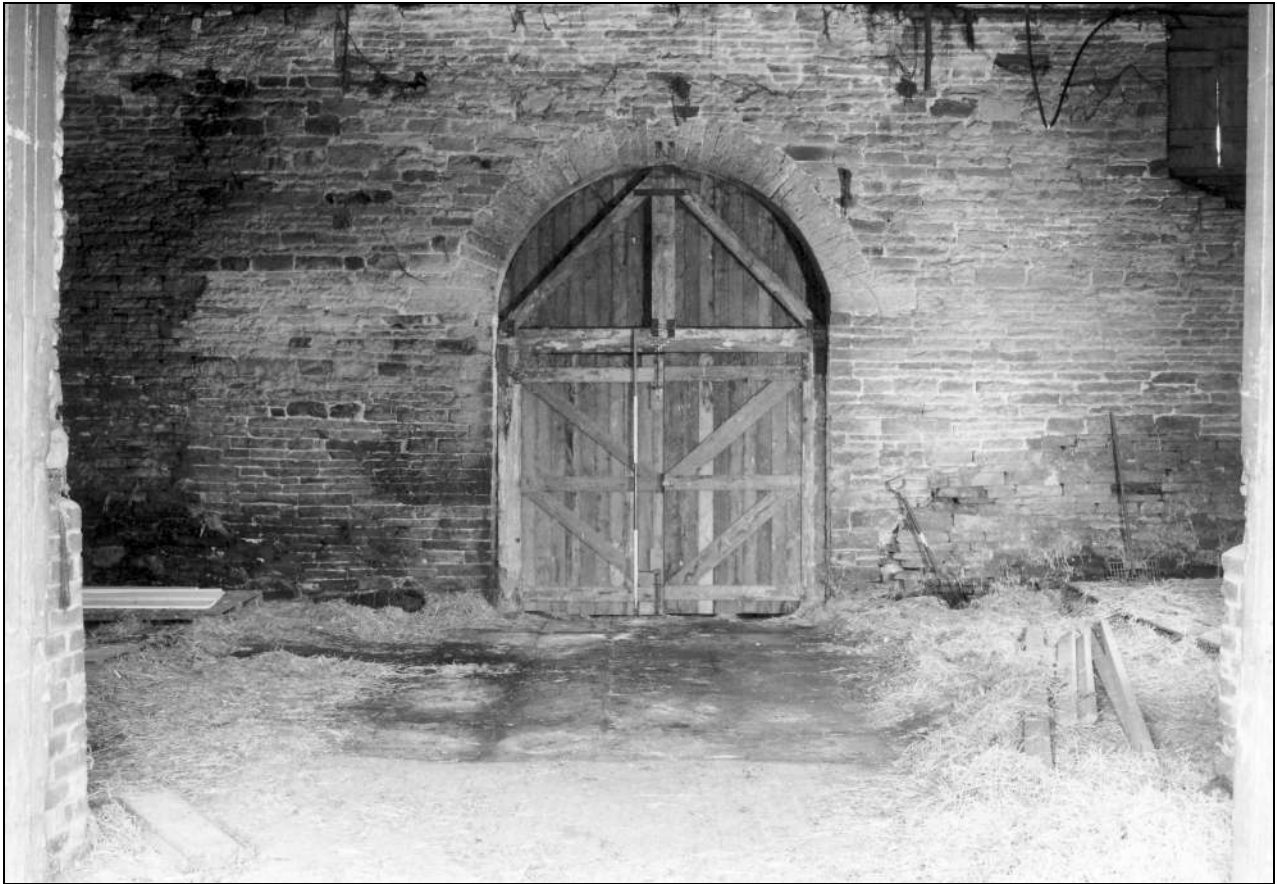
Photo 46: Threshing bay in barn, from the west (film 3, frame 7)

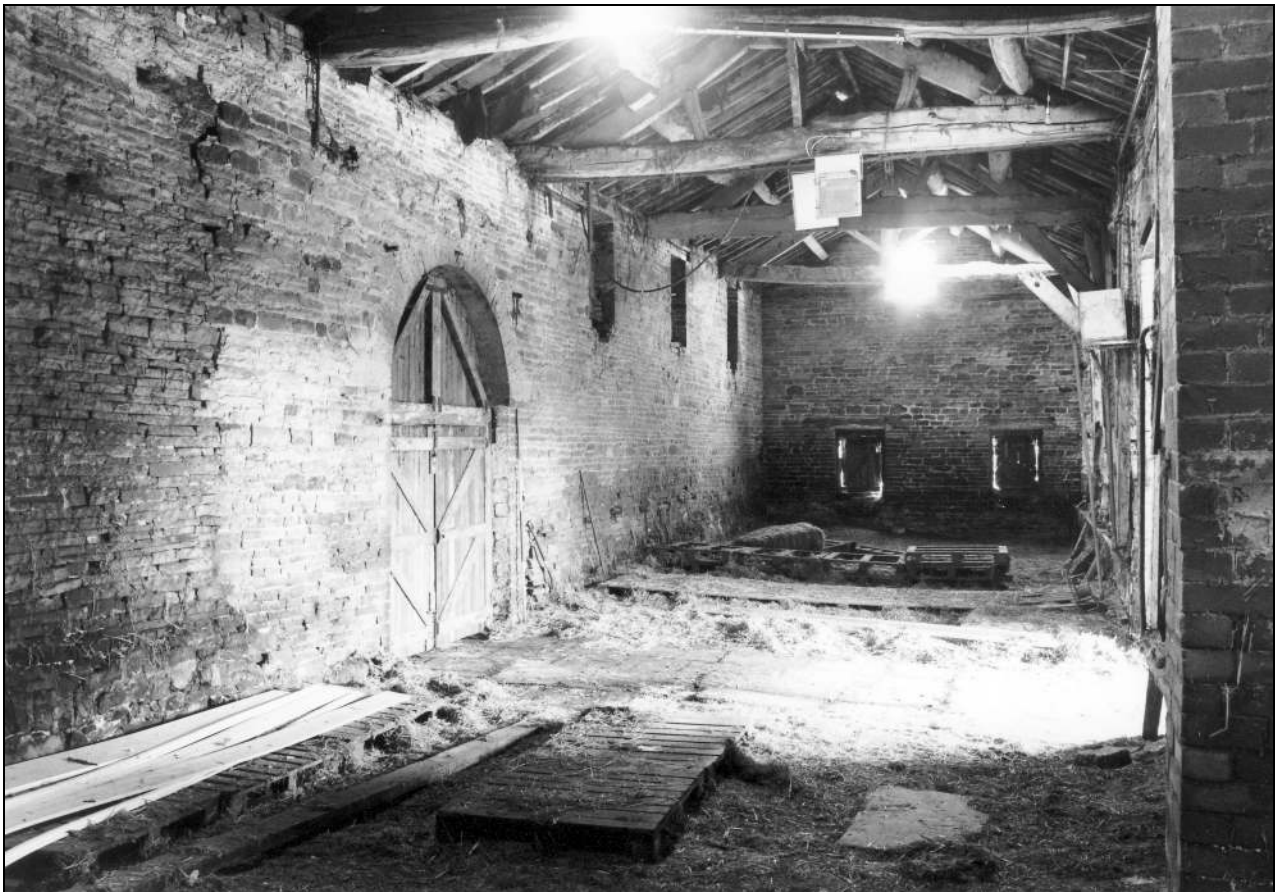
Photo 47: Barn interior, from the north-west (film 5, frame 4)

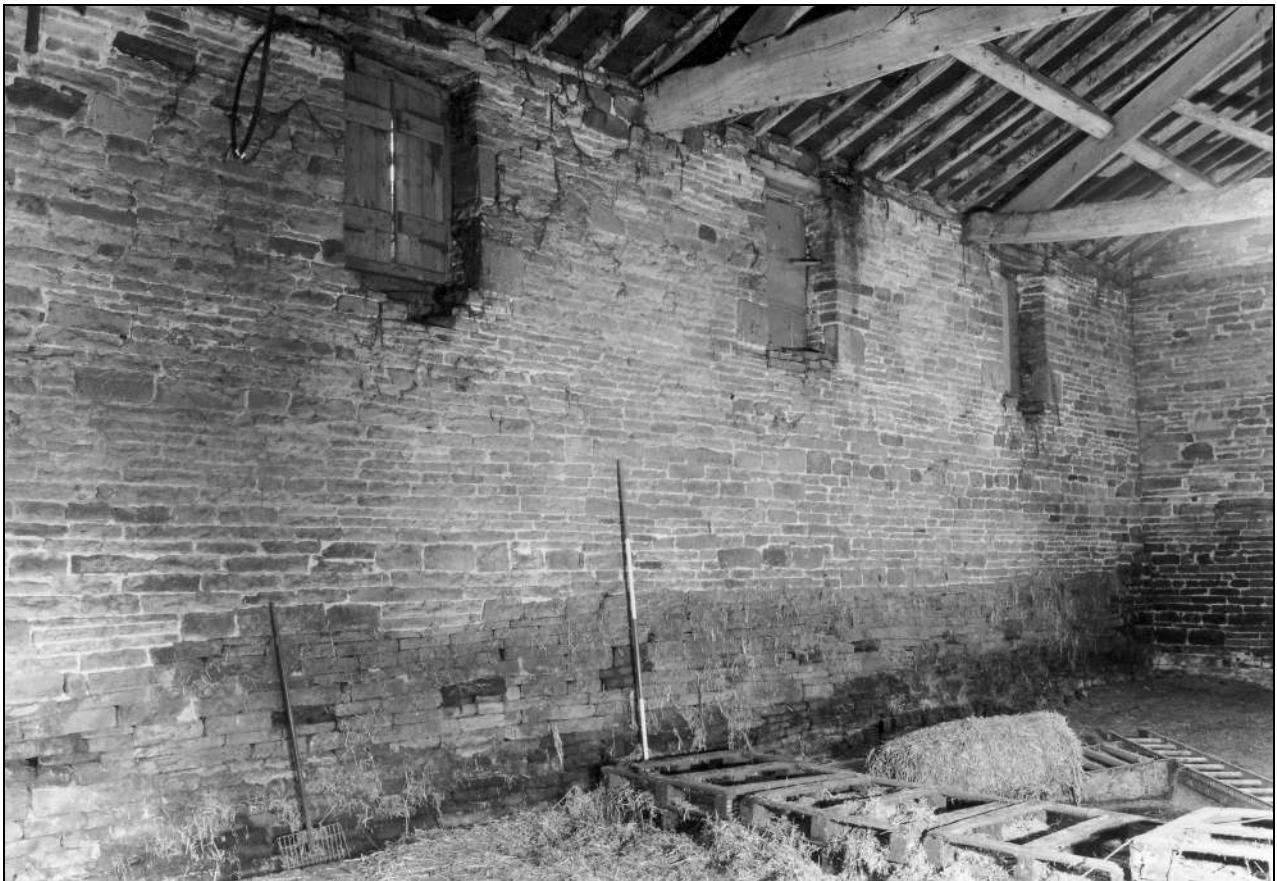
Photo 48: South end of east wall, inside barn, showing original stonework at foot with later openings above (film 3, frame 12)

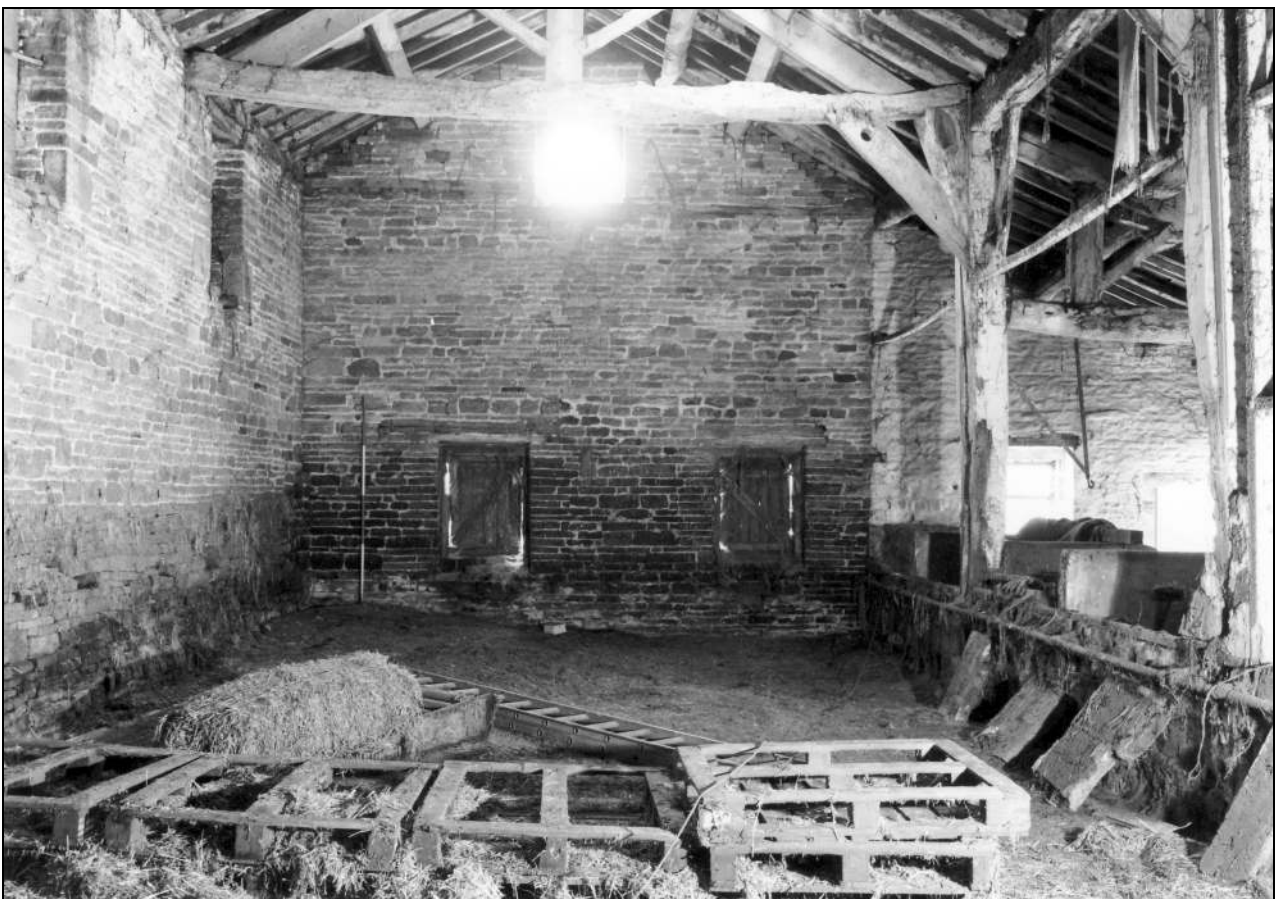
Photo 49: Barn interior: south end (film 3, frame 13)

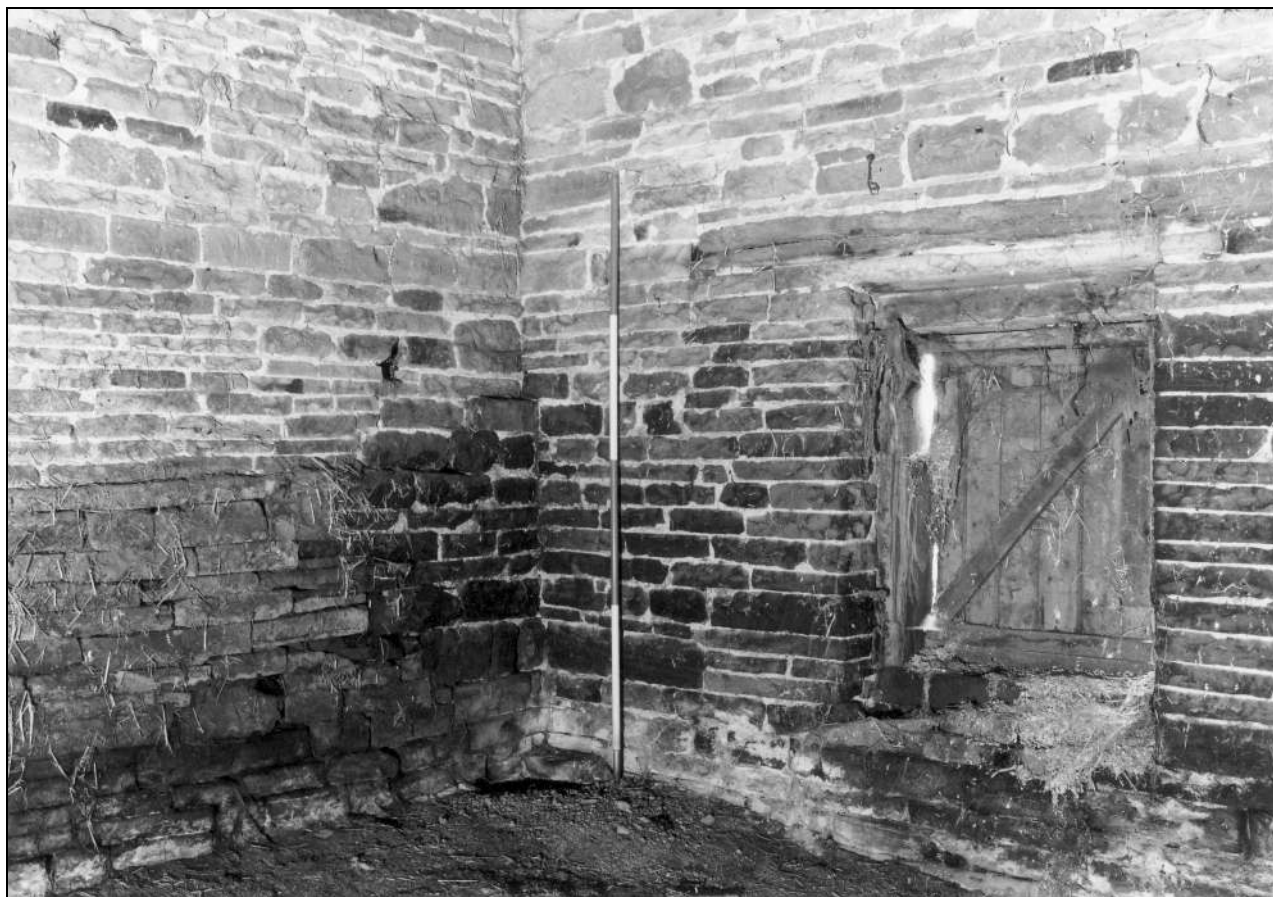
Photo 50: South-east corner inside barn, showing original stonework at left with rebuilt walls above and to right (film 3, frame 16)

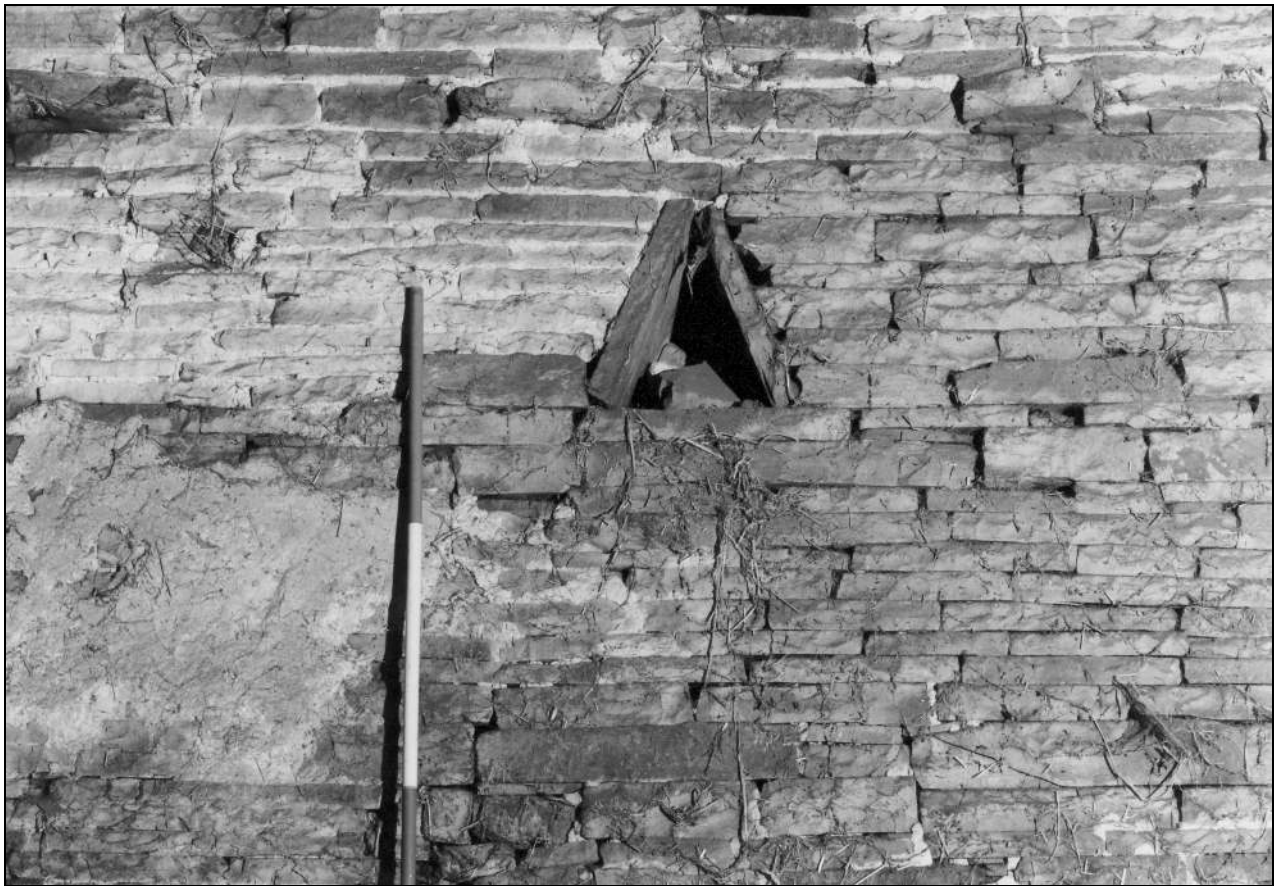
Photo 52: Blocked triangular breather in inside face of east wall (film 5, frame 3)

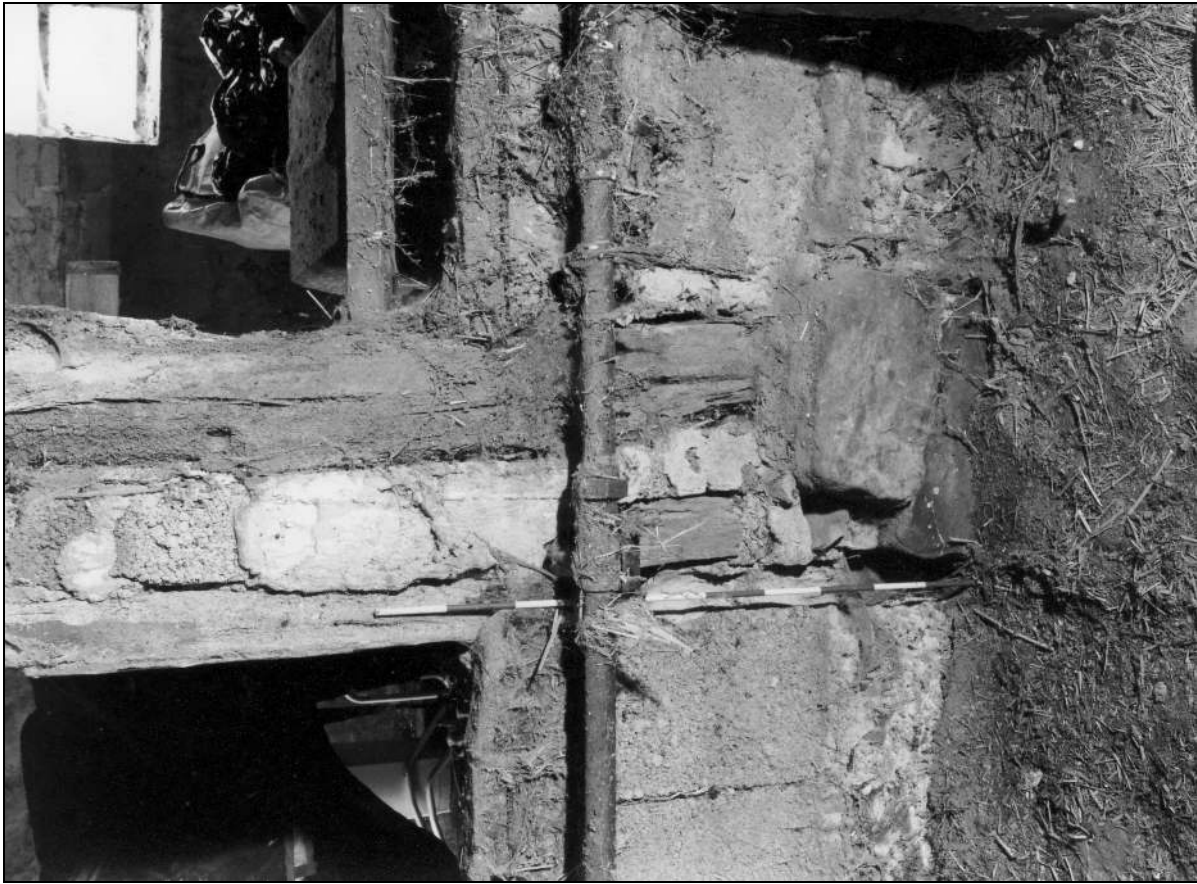
Photo 57: Truss 1: foot of arcade post and pad-stone, from the east (film 3, frame 17)

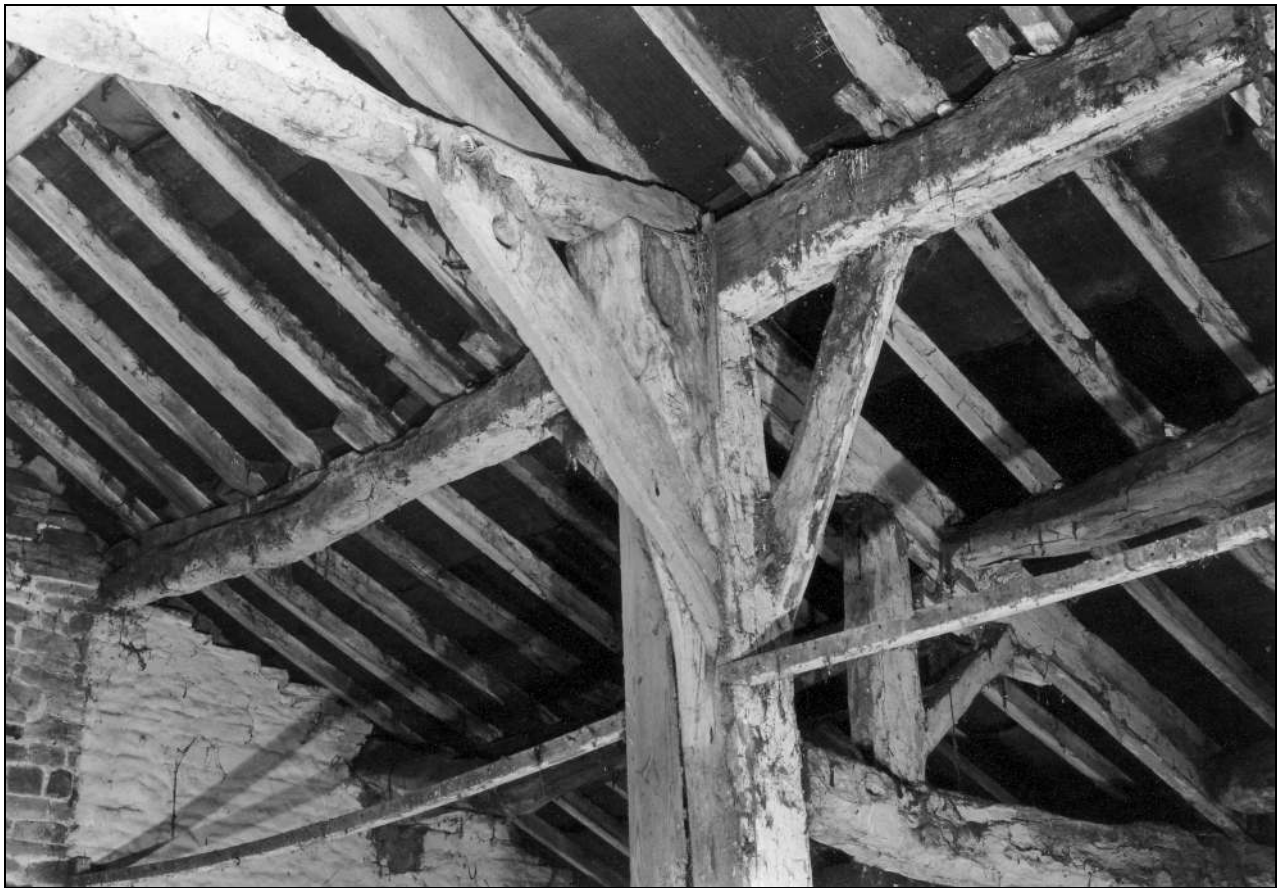
Photo 58: Truss 1: head of arcade post with original arcade plate and braces, with modern arch brace, from the north-east (film 4, frame 3)

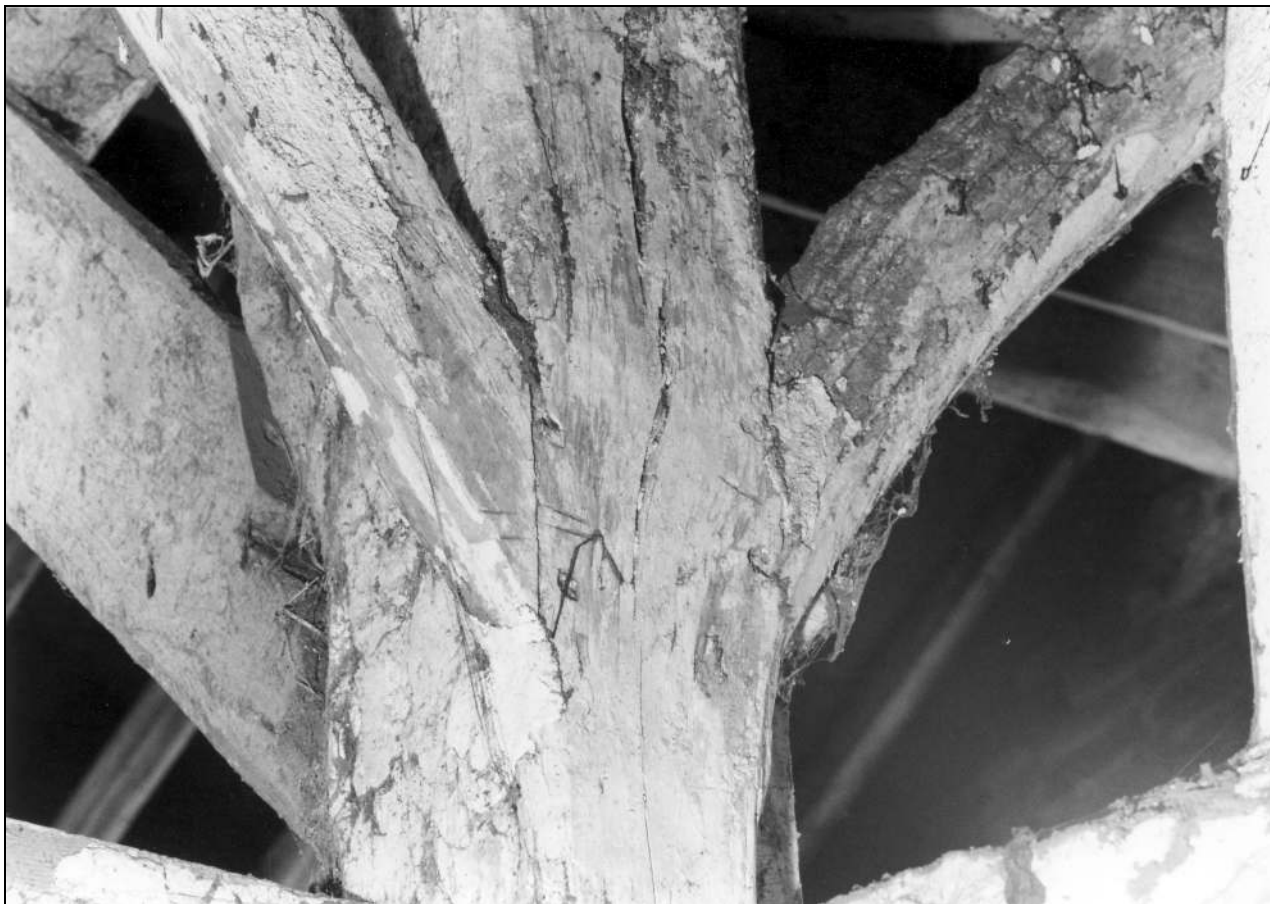
Photo 60: Truss 1: joint numbering "I" and "II" on arcade post and braces, from the north-west (film 6, frame 12)

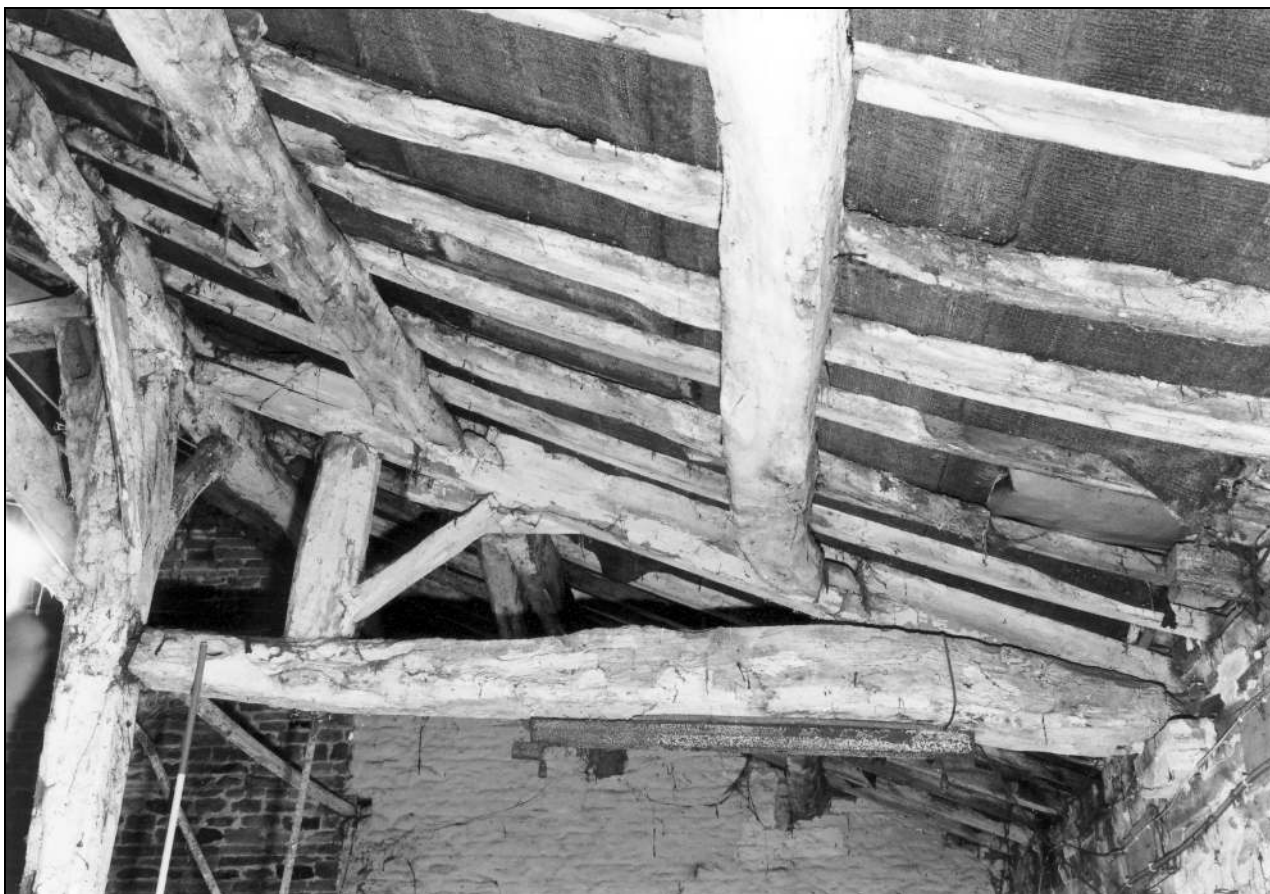
Photo 61: Truss 1: framing over aisle, from the north (film 6, frame 9)

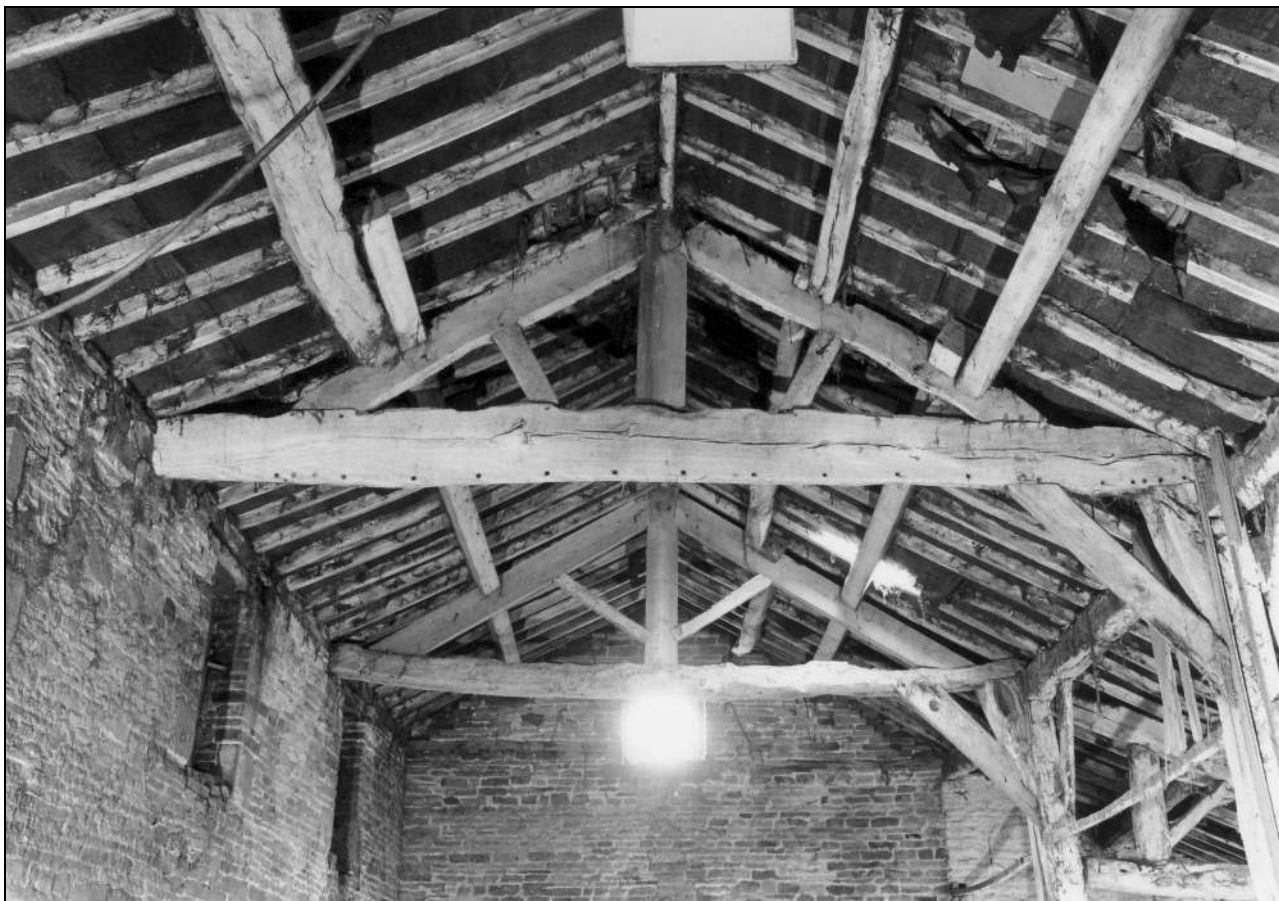
Photo 62: Truss 2, from the north (film 4, frame 6)

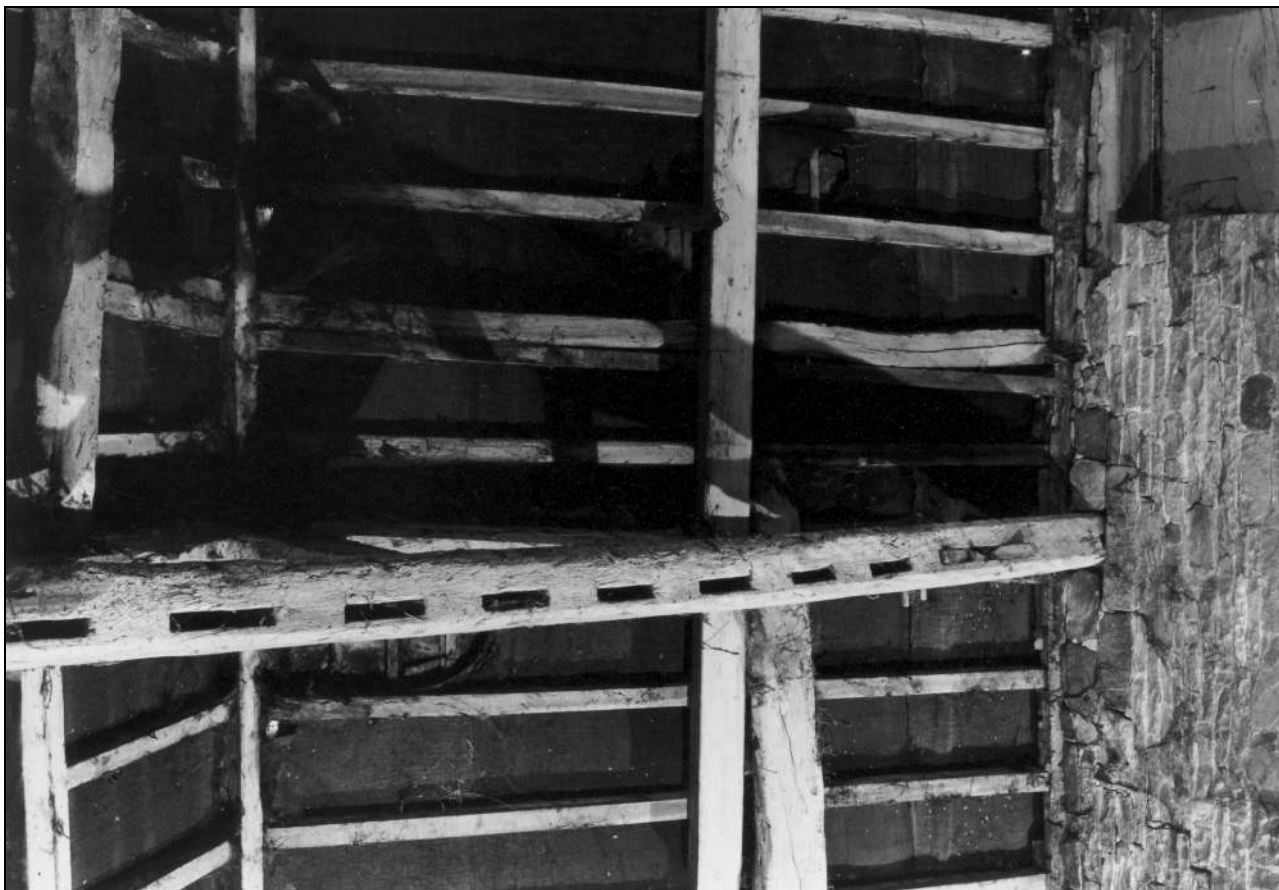
Photo 63: Truss 2: underside of tie beam, from the west (film 4, frame 8)

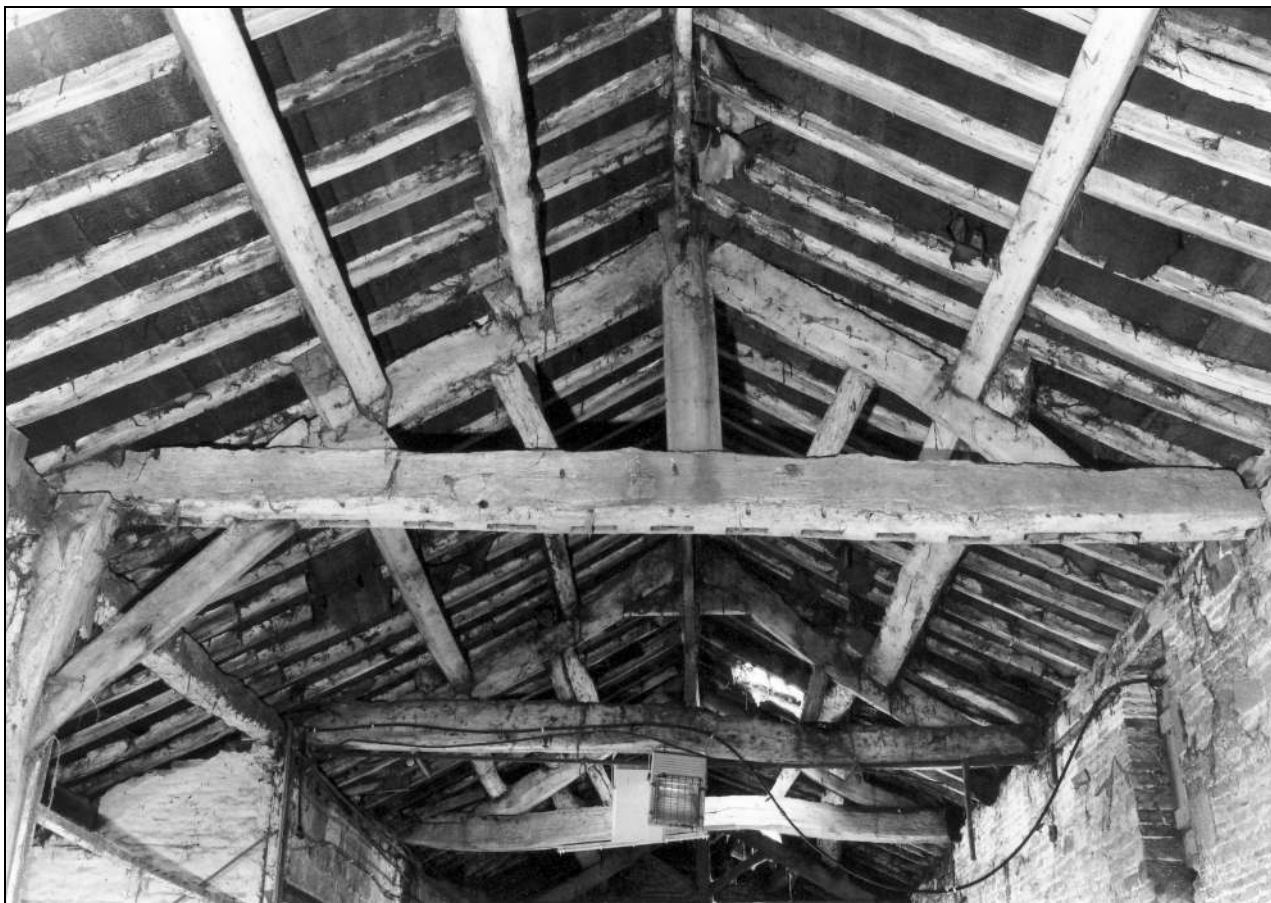
Photo 64: Truss 2, from the south (film 6, frame 5)

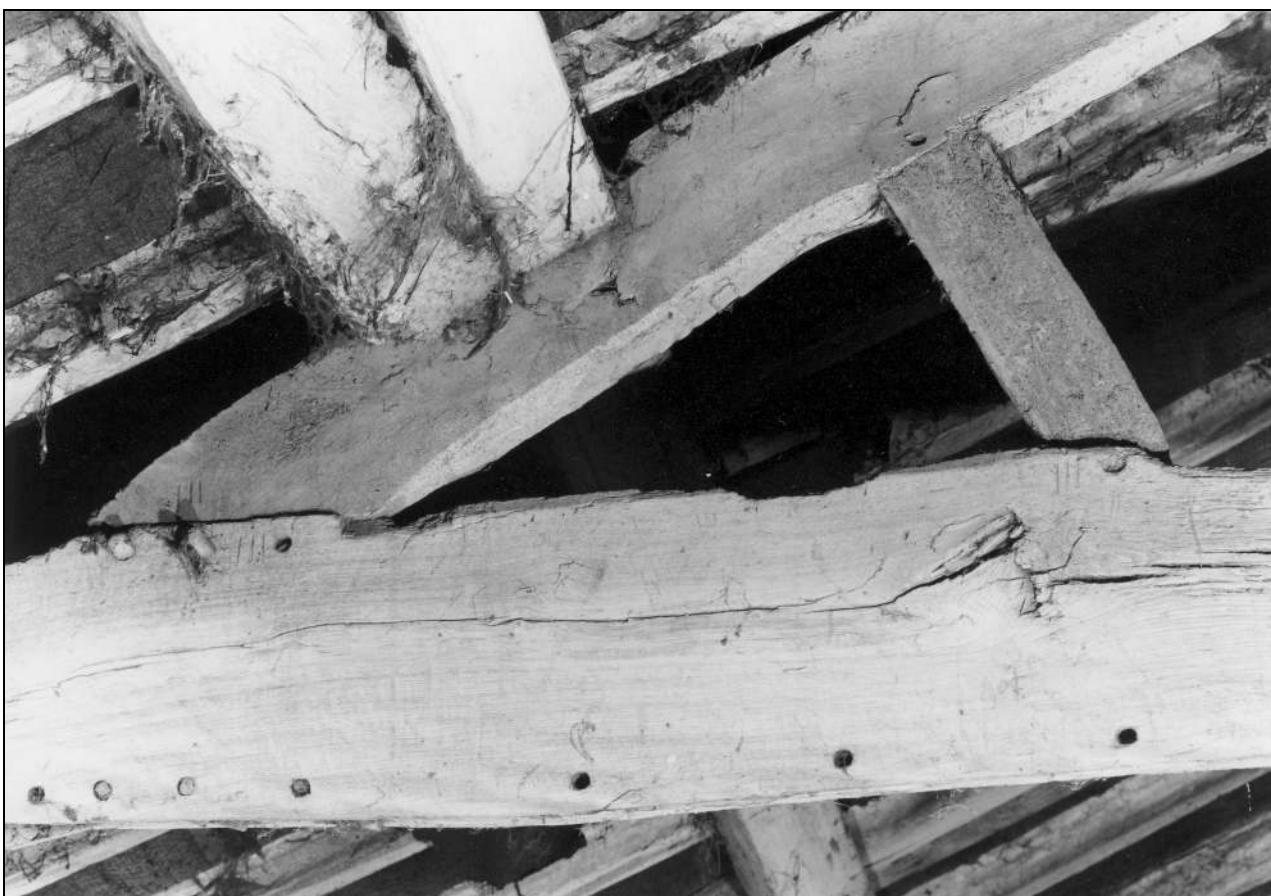
Photo 65: Truss 2: east end of tie beam, from the north, showing joint numbering "III" (film 4, frame 15)

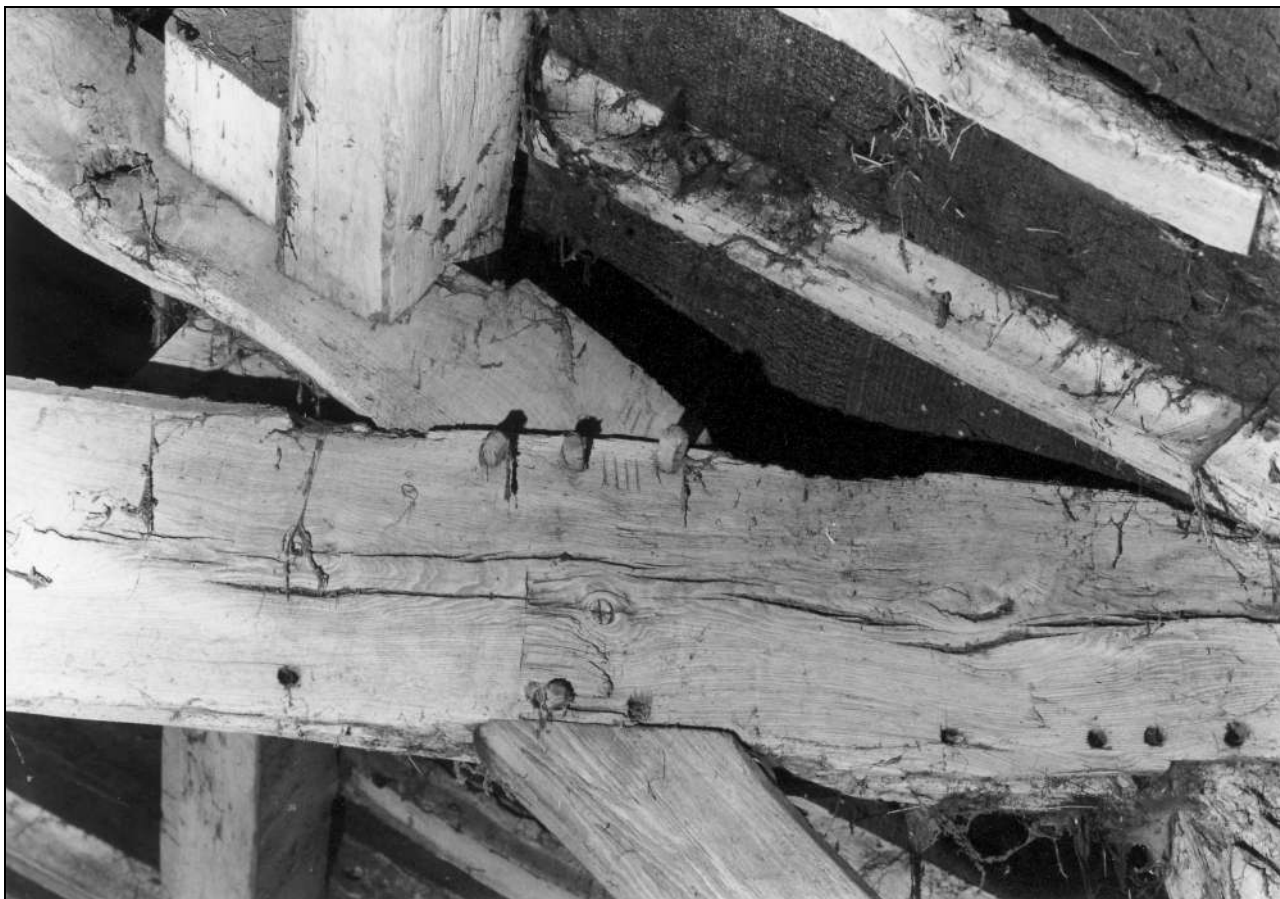
Photo 66: Truss 2: west end of tie beam, from the north, showing joint numbering "IIII" (film 4, frame 14)

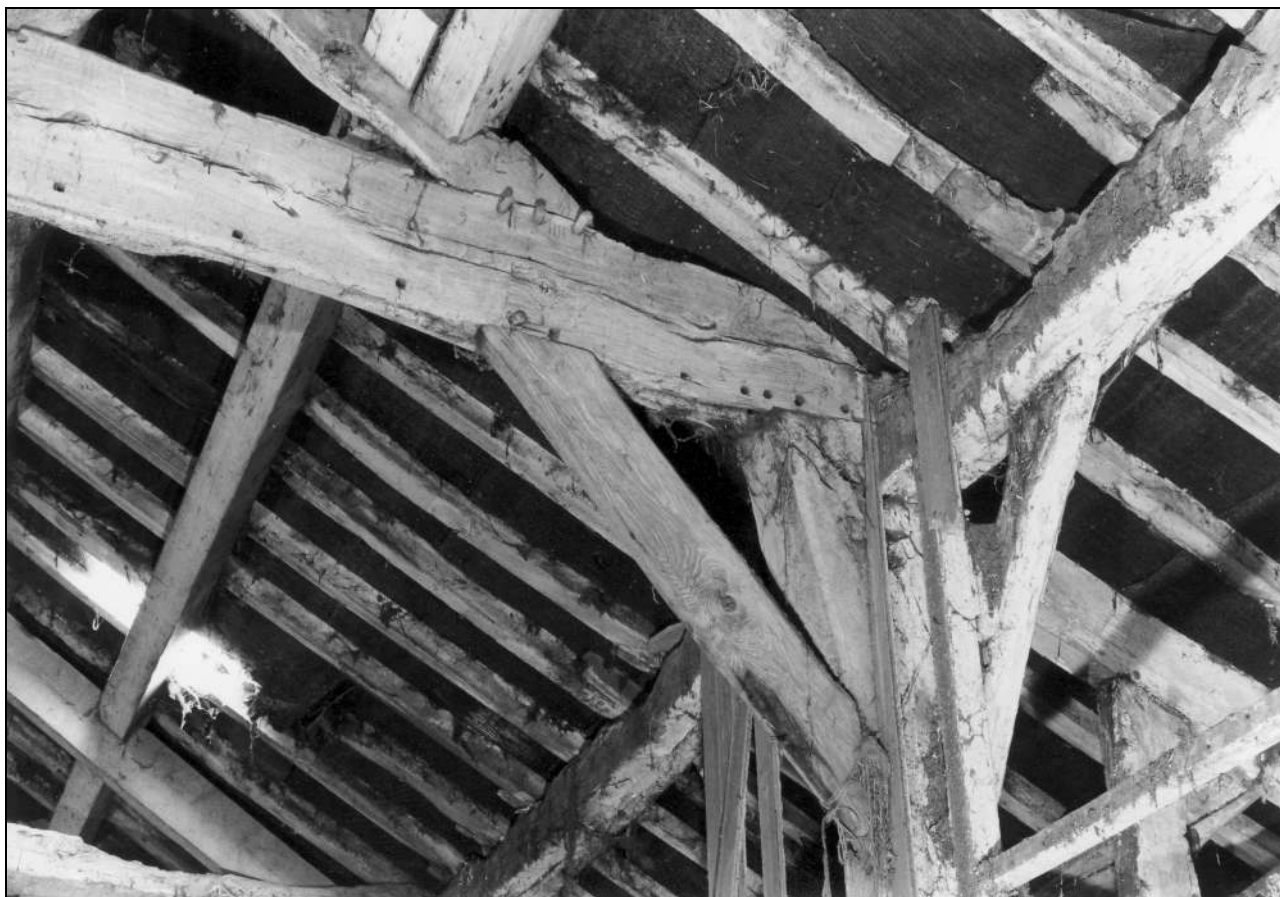
Photo 67: Truss 2: head of arcade post, from the north (film 4, frame 9)

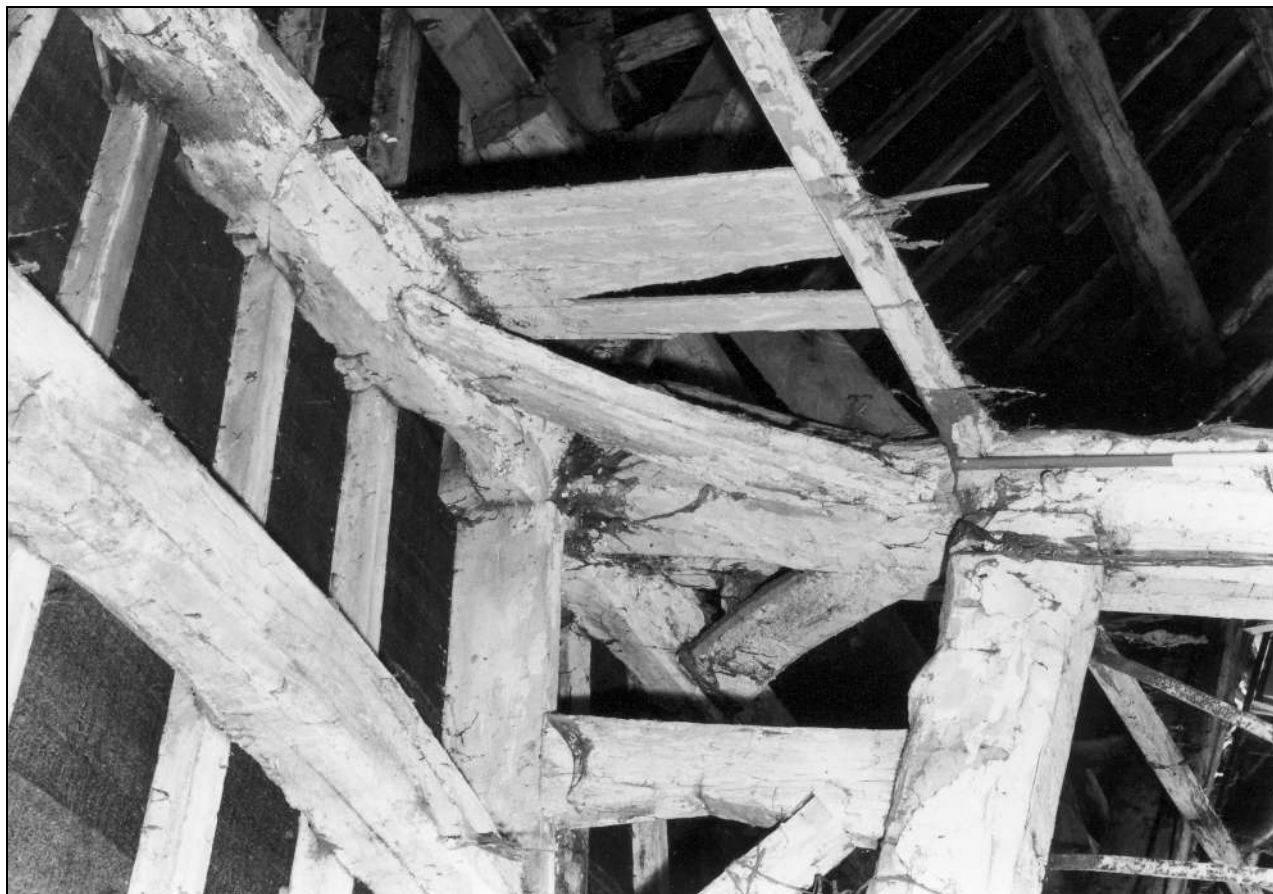
Photo 68: Truss 2: head of arcade post, from the south-west (film 6, frame 11)

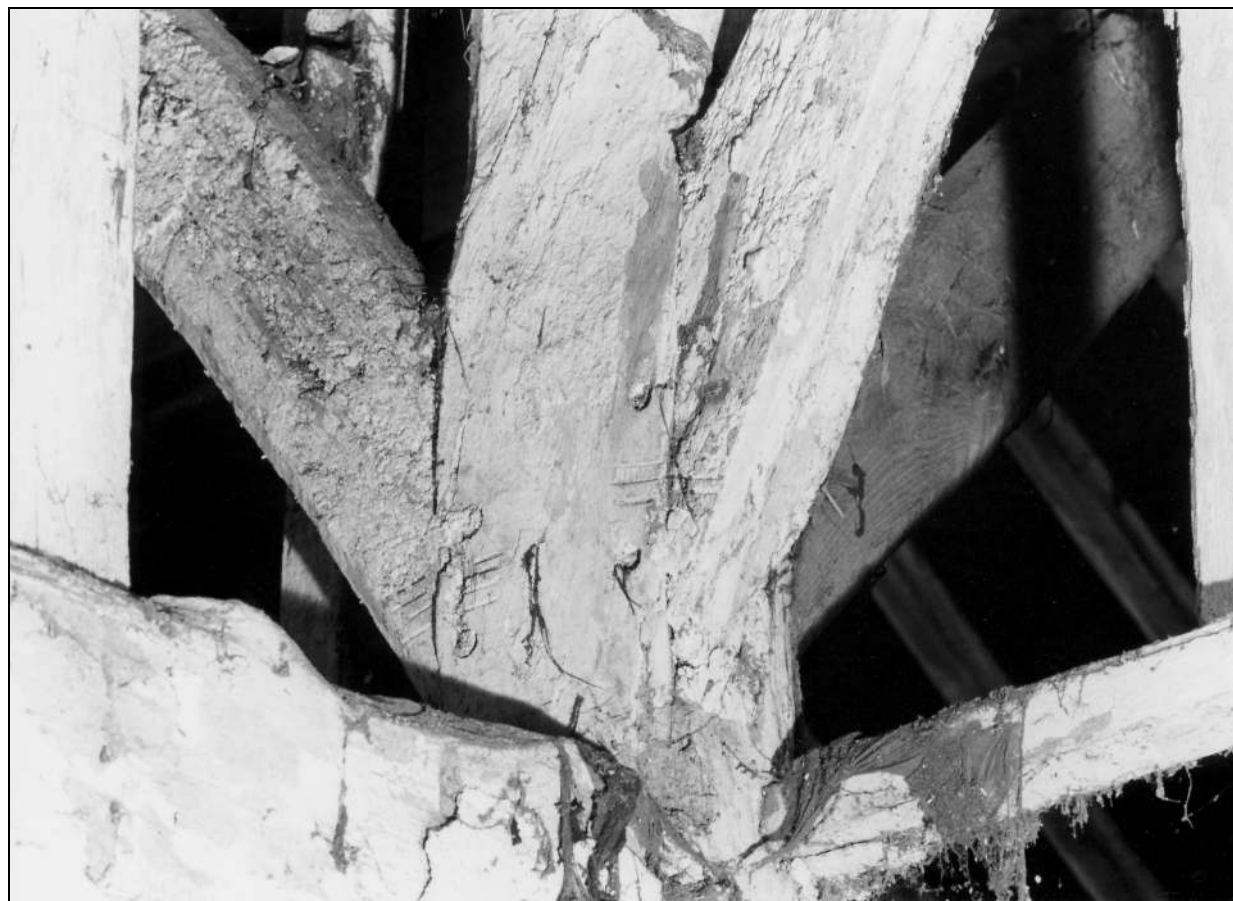
Photo 69: Truss 2: joint numbering "III" and "IIII" on arcade post and braces, from the south-west (film 6, frame 13)

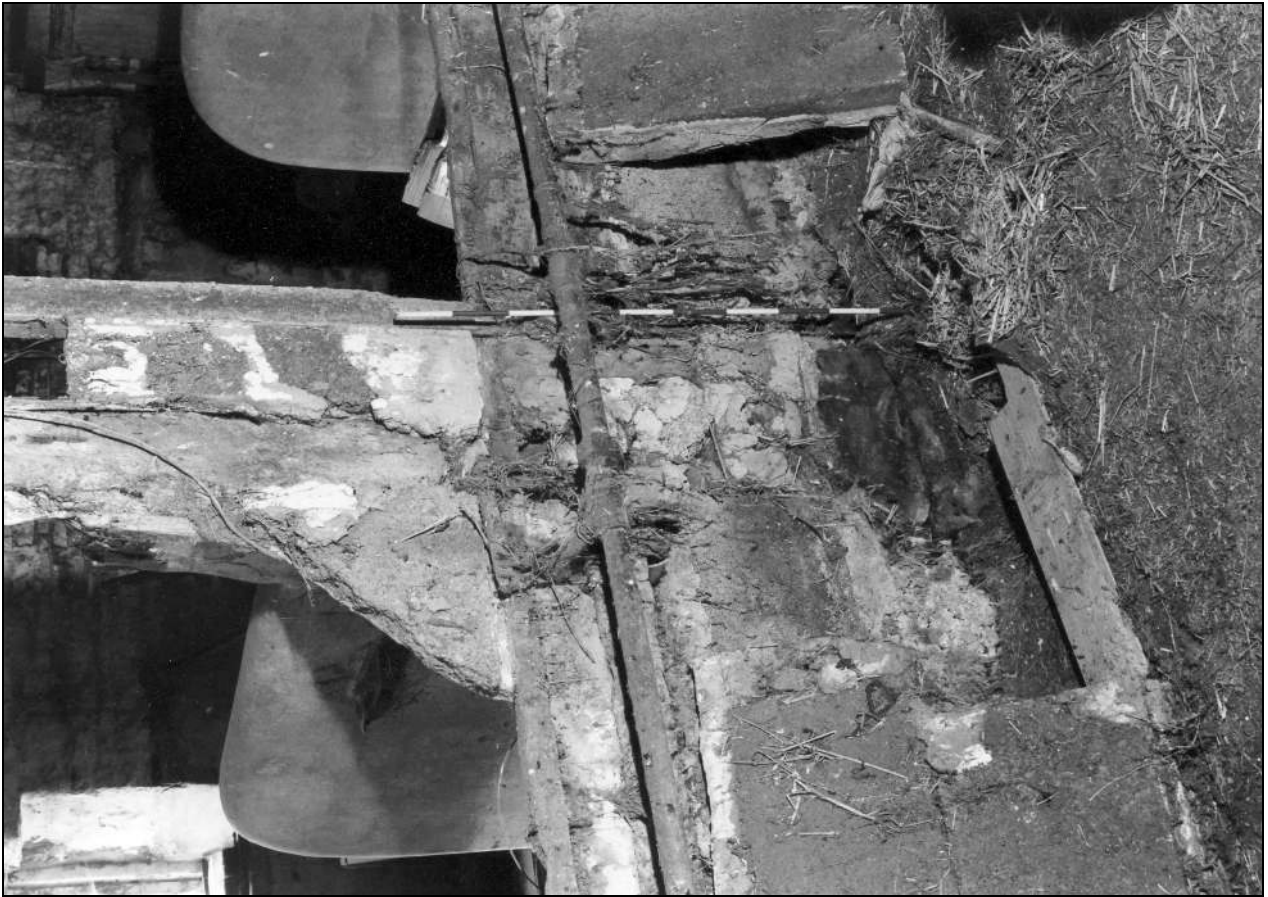
Photo 71: Truss 2: foot of arcade post and pad-stone, from the south-east (film 4, frame 4)
