CART SHED AND BARN, WHARRAM PERCY FARM,  
WHARRAM PERCY, NORTH YORKSHIRE

ARCHITECTURAL AND  
WILDLIFE SURVEY

Report no: 2009/354.R01  
Version: Final  
Date: March 2010  
Authors: Shaun Richardson & Ed Dennison

The Birdsall Estates Company Ltd  
Estate Office  
Birdsall  
Malton  
North Yorkshire YO17 9NU

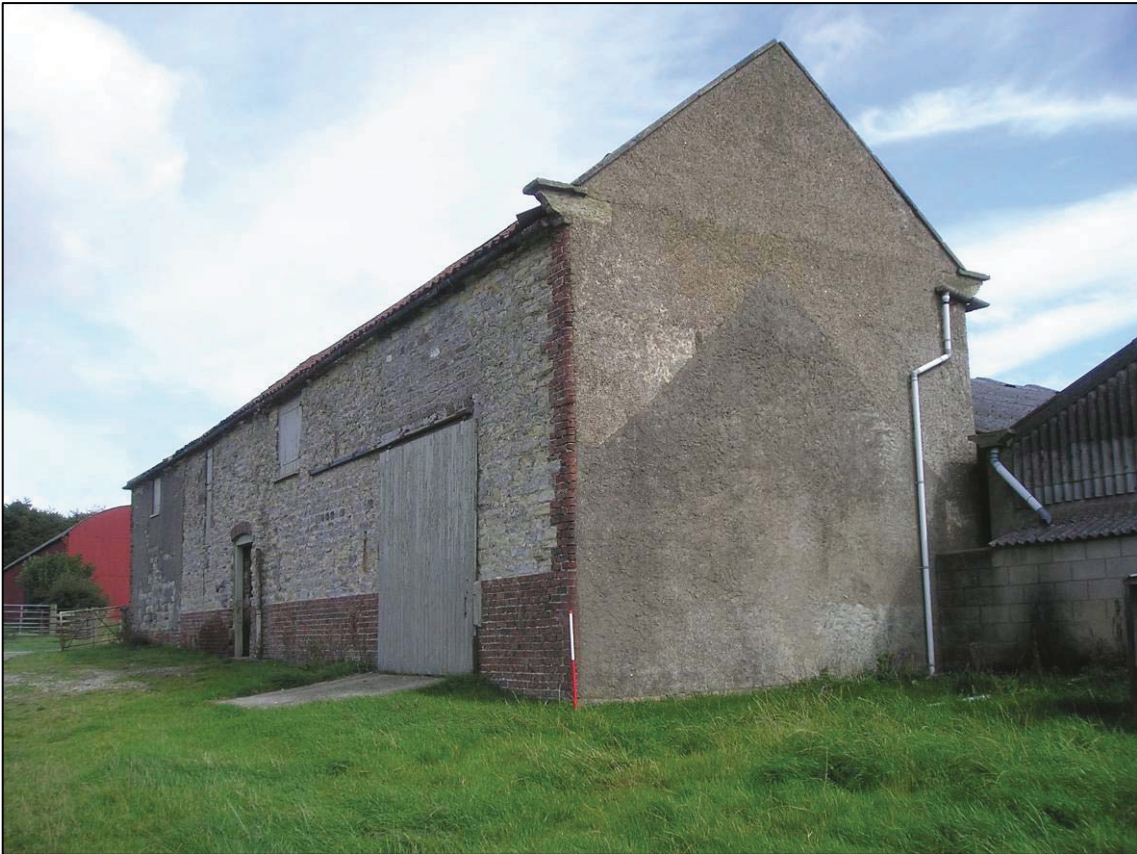
Plate 8: South gable and west elevation of barn, looking NE (photo 3/13).

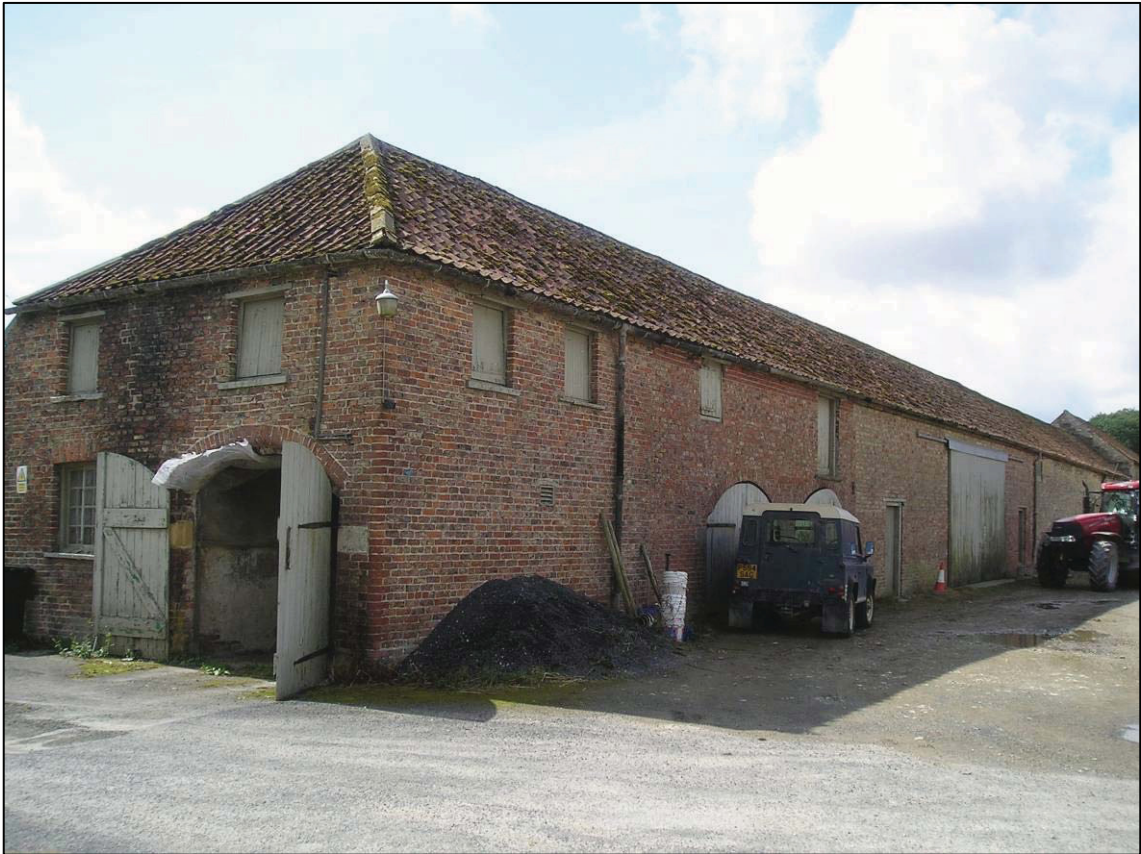
Plate 11: East part of north range, looking SW (photo 3/98).
