REPAIRS AND ALTERATIONS TO THE  
PRIEST'S HOUSE AND CHAPEL,  
BARDEN TOWER, BARDEN, NORTH YORKSHIRE

ARCHITECTURAL AND ARCHAEOLOGICAL  
OBSERVATION, INVESTIGATION AND RECORDING

Report no: 2015/510.R01  
Version: Final  
Date: December 2016  
Author: Ed Dennison & Shaun Richardson

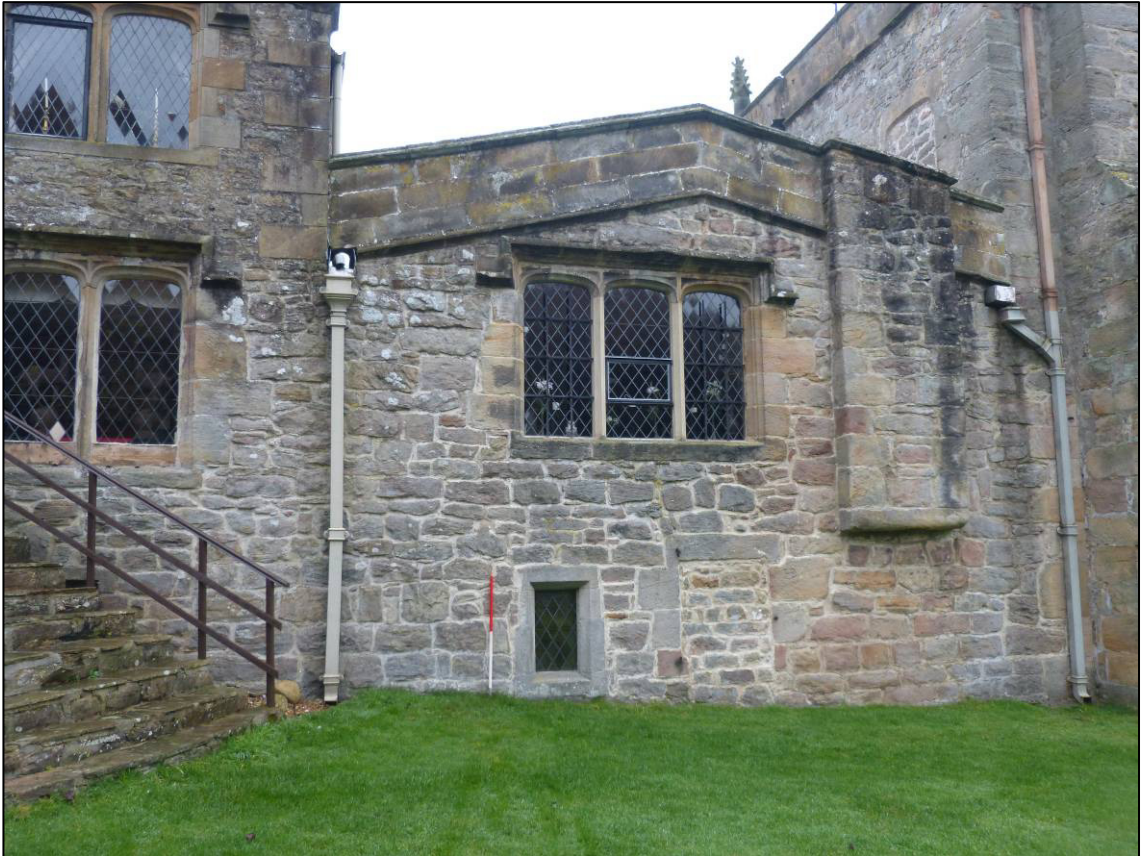
- 3.15 The west gable of the chapel has a small, chamfered, flat-headed window to the lower ground floor, with a blocked flat-headed doorway to the south [1/131, 1/132] (see plate 6). The doorway has a quoined surround; on the upper quoin to the south side, there are the carved initials 'I B' and to the lintel 'T + S' [1/160] (see plate 5 and figure 4). It is possible that these, and other initials carved around the exterior of the lower ground floor, may relate to the Simpson family, who occupied Barden Tower during the later 17th and early 18th centuries (Bedford-Payne 2016, 187). Above, to the ground floor, there is a three-light mullioned window, very similar to those in the west gable of the domestic block [1/133]. To the south of the window, there is a projecting chimney breast, rising from a corbelled base, which runs to the top of the sandstone parapet. It was suggested in 1989 that this chimney breast may have been added on at a later date (YVBSG 1989, 2). Large quoins to the south of the chimney breast again suggest that the tower is not of the same build as the chapel. However, these do not rise any higher than the base of the ashlar parapet, and so the recessed section of the tower's west side above must also have been built over later. The chapel is surmounted by the same angled ashlar parapet with mouldings as the domestic block.

Plate 6: Chapel, west elevation, looking NE (photo 1/131).

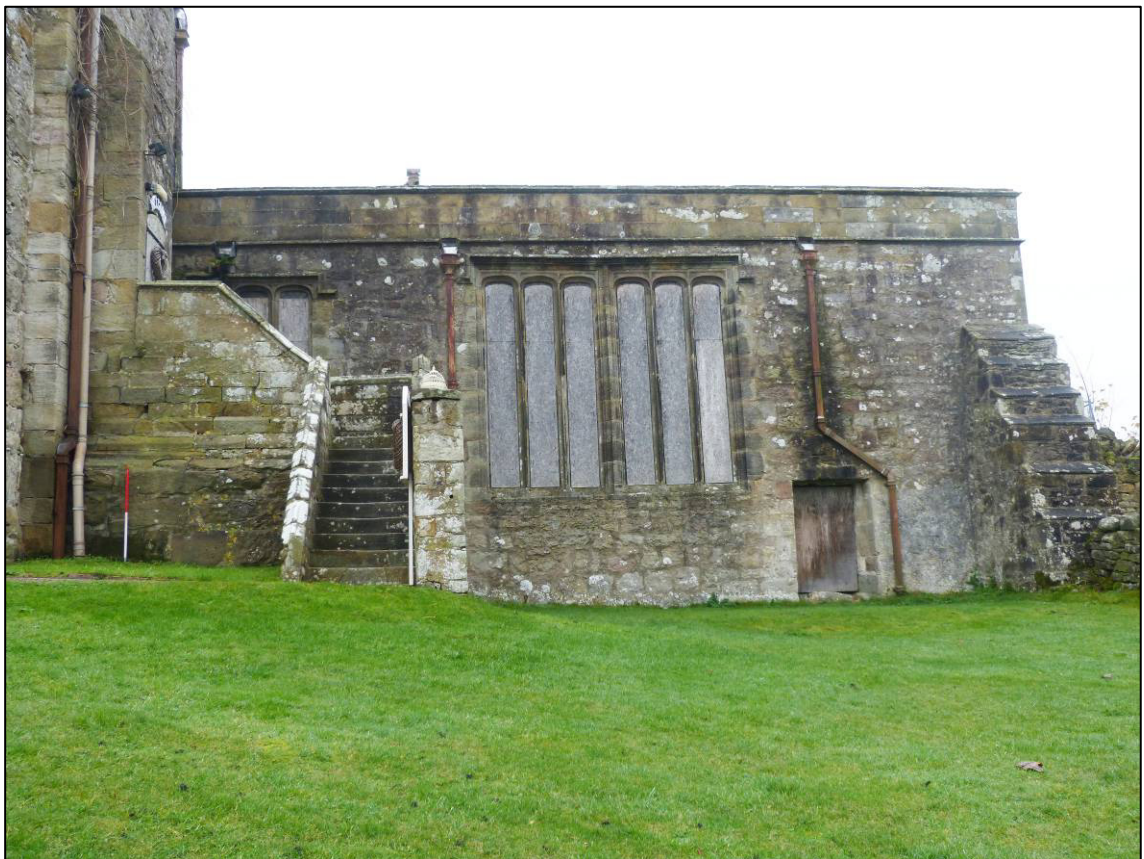
- 3.21 The west end of the south elevation of the chapel has a tall, three-light moulded chamfered mullioned window with elliptical headed lights and a hoodmould; the mullions have cavetto sections, whilst the hoodmould is dropped and returned at either end, but is without stops [1/154] (see plate 11). Each light is glazed with fixed diamond-paned leaded glass [1/167; 2/368]. To the east, at a lower level, there appears to be a small flat-headed blocked window [1/174], although it is not clearly visible internally. The main window lies in the centre of the elevation, and is of similar form to the three-light window described above, but is of six-lights, separated by a central king mullion [1/169, 1/171, 1/173; 2/365, 2/366]. The glazing is of diamond-paned leaded glass; to the centre of each set of three lights, the middle pane swings vertically inwards (YVBSG 1989, 2). To the east of this window, there is a flat-headed doorway, with a plain quoined surround [1/178] (see plate 39). This was previously suggested to be a later insertion (YVBSG 1989, 2) and the 1954 Listed Building description describes it as a 'small four-centred arched doorway', so it does appear to have been substantially altered during the second half of the 20th century. At the east end of the elevation, there is a very large stepped angle buttress, again, like that to the tower, a later addition to the chapel [1/180]. The south elevation of the chapel is surmounted by the same horizontal ashlar parapet as described elsewhere on the building [2/347].

Plate 11: Chapel, south elevation, looking NW (photo 1/154).

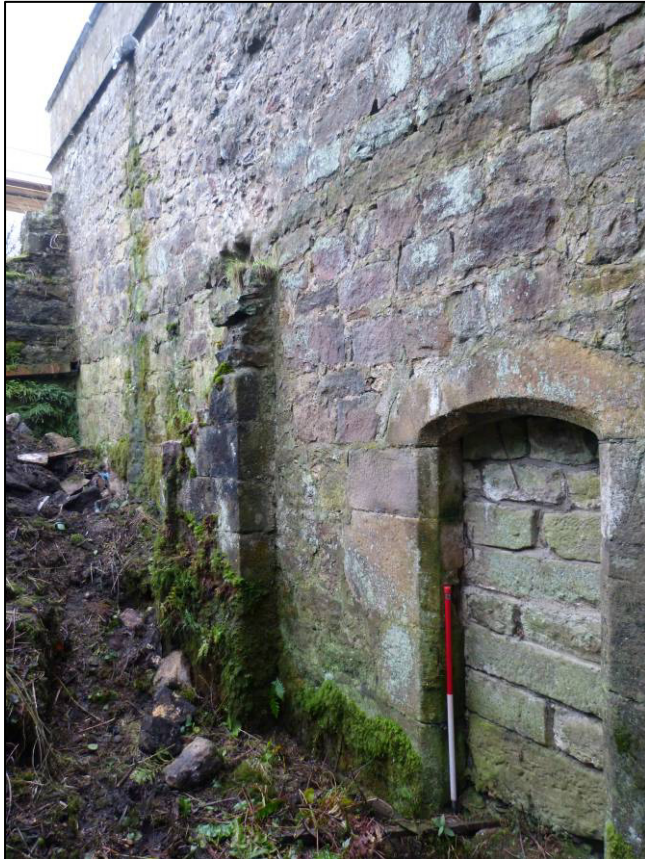
- 4.9 The lower ground floor of the structure could be accessed through the blocked doorway in the north elevation of the chapel [3/401, 3/402] (see plate 14). Some 1.40m to the east of this doorway, a shallow projection from the face of the elevation [3/403] proved, on clearance and excavation, to be one side of a splayed doorway, rebated to the west face and chamfered to the east. This doorway was of similar form to those internal doorways seen within the ground floor of the domestic block and tower, and indeed was set in a north-south aligned wall of similar width (0.90m) [3/404, 3/407, 3/408, 3/410, 3/412-3/414, 3/417] (see plate 29). Again, this wall appears to have been noted in 1994 (see figure 7). The line of the retaining wall, apparently tied into this north-south wall, could be followed as a low structure to the east for at least another 2.15m (see figure 9). At the east end of the chapel's north elevation, a structure that had been decayed above

Plate 14: Chapel, lower ground floor, north elevation, looking NE (photo 3/401).

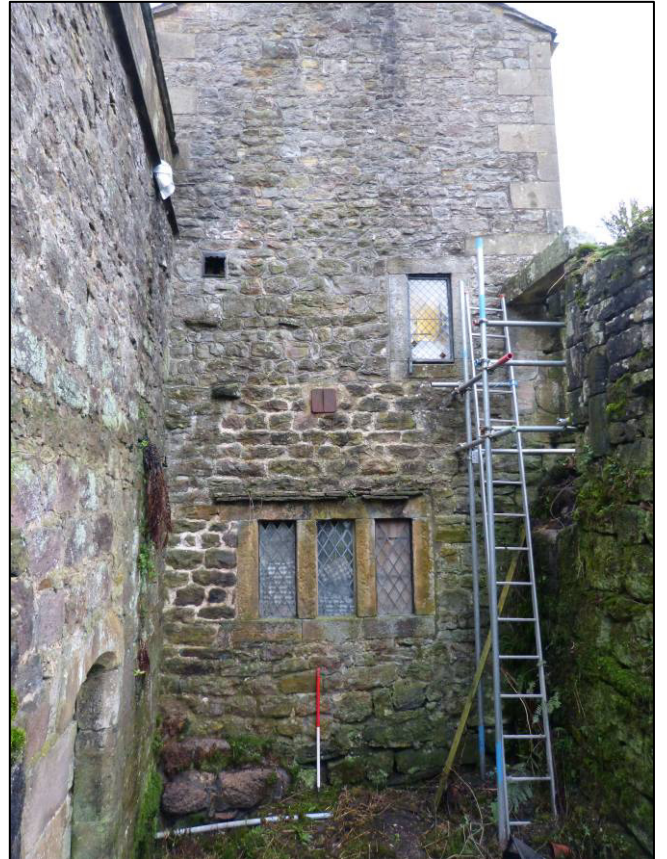
Plate 15: Domestic block, east gable from within sunken area, looking SW (photo 3/395).

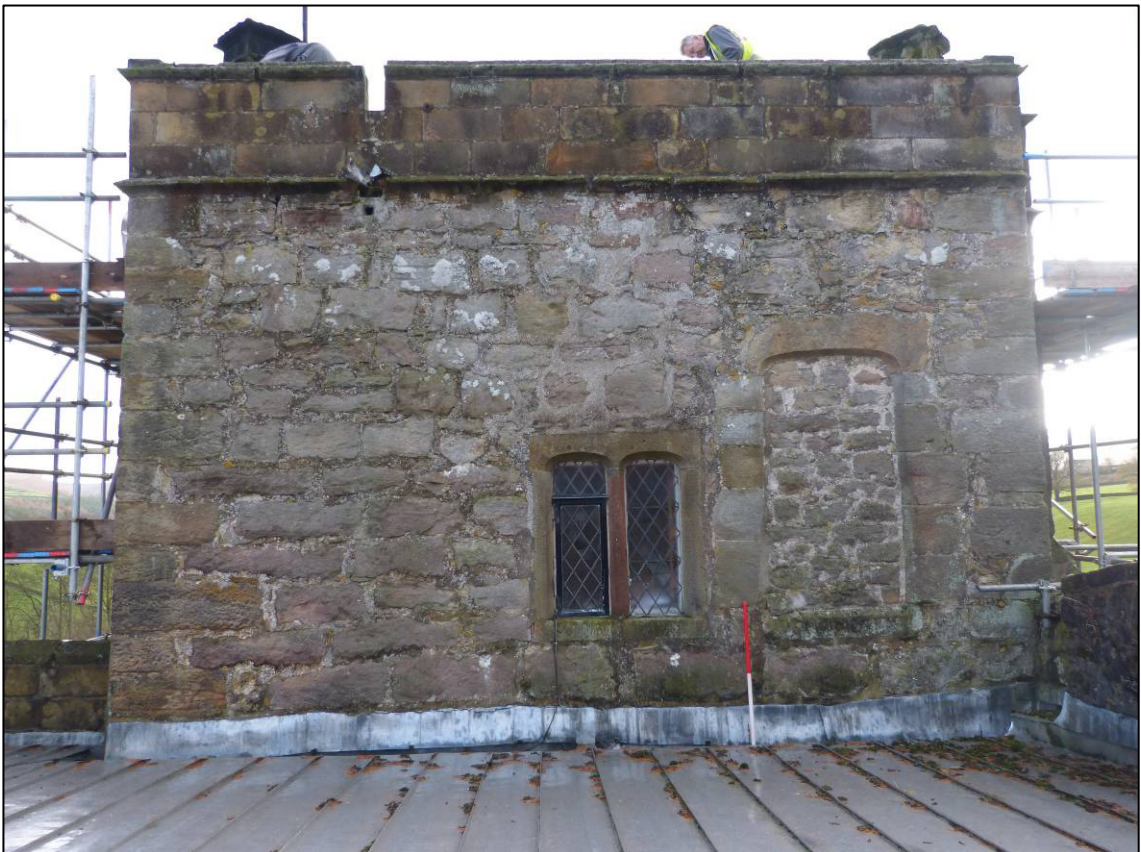
Plate 25: Tower, 1st floor, north elevation, looking SE (photo 2/349).

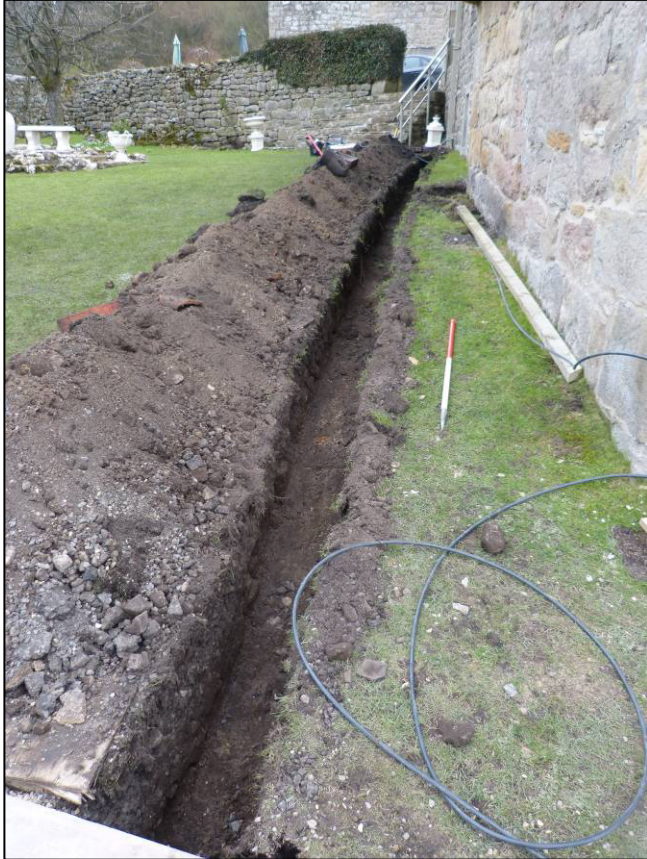
- 4.16 The trench ran south-south-east for a distance of 18.40m [5/908, 5/909, 5/912, 5/915] (see plate 31), with a short spur from another replaced downpipe exposing another chamfered plinth to the base of the chapel's west gable, this time projecting 0.20m from the wall face above [5/910]. A piece of *ex situ* moulded masonry recovered from the topsoil (001) was probably once part of the chimney rising from the truncated chimney breast in the west gable of the chapel [5/913, 5/914] (see plate 33). The trench maintained a constant width and depth for the whole of the 18.40m, and the same two deposits were exposed.

Plate 31: Drainage trench T1, looking NW  
(photo 5/908).

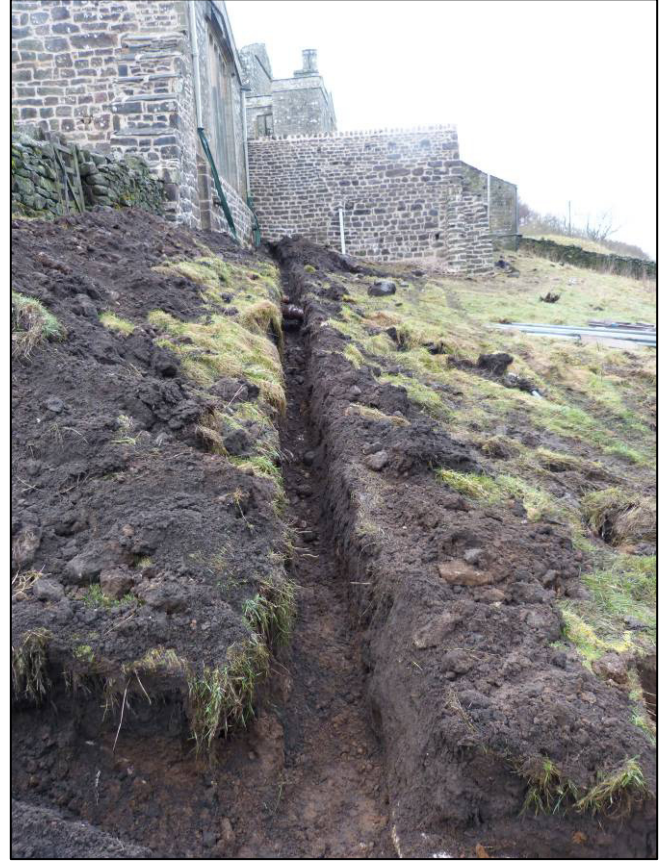
- 4.24 This 0.40m wide trench was dug from an existing downpipe located in the north-east corner of the chapel, for a distance of 24.00m in a south-east direction to join up with Trench 2 just before the soakaway pit [6/935-6/937] (see plate 35). The deposits encountered in this trench were the same as those seen to the west of the drystone wall i.e. turf and topsoil (001) typically 0.20m deep overlying a compacted dark orange-brown gritty silt sand (006) which extended beyond the base of the trench.

Plate 35: Drainage trench T5, looking NW (photo 6/937).

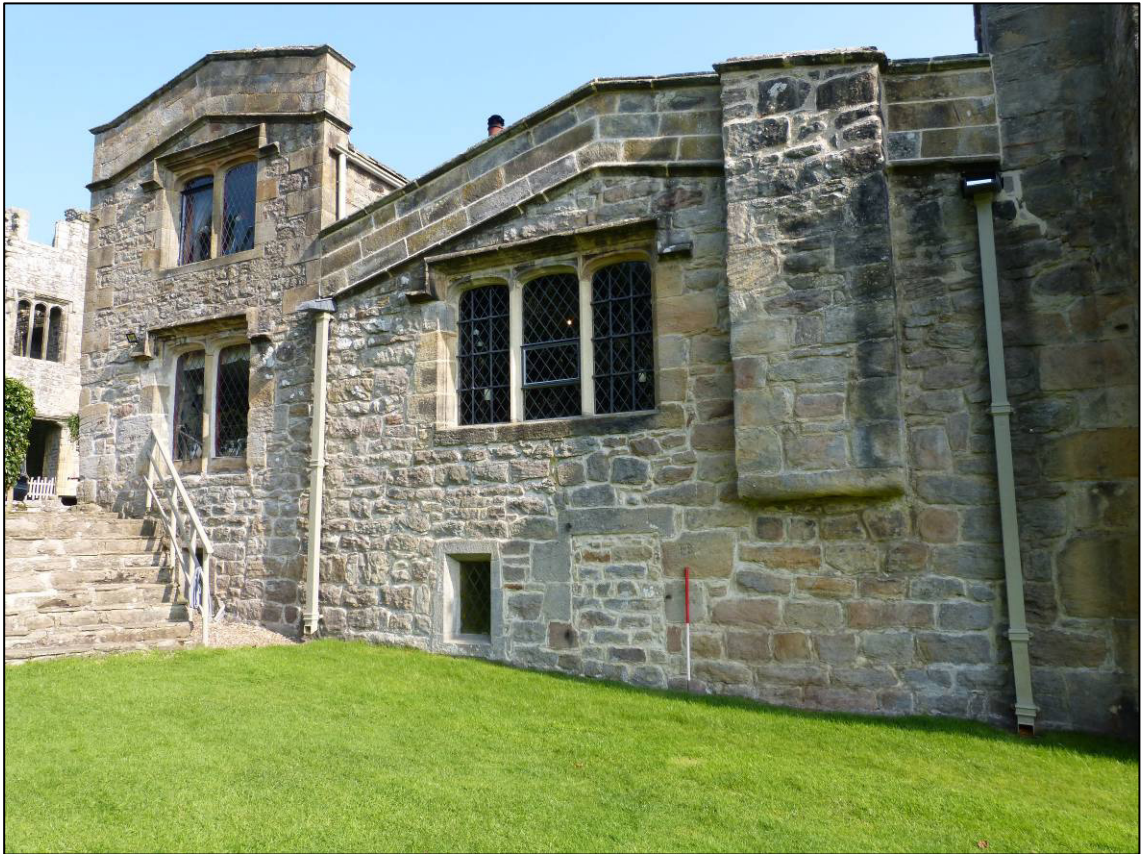
Plate 37: Chapel and domestic block, west gables, works complete, looking N (photo 7/574).

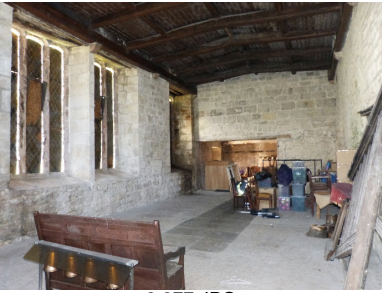
2-376.JPG

Plate 22: Chapel interior, altar step, looking E (photo 2/376).

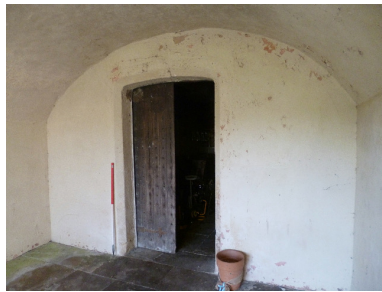
2-648.JPG

Plate 18: Tower, lower ground floor entrance chamber interior, looking NW (photo 2/648).
