FLAMBOROUGH CASTLE, TOWER STREET,  
FLAMBOROUGH, EAST YORKSHIRE

ARCHAEOLOGICAL SURVEY  
AND MONITORING OF 2017-18 REPAIRS

Report no: 2017/538.R01  
Version: Final  
Date: December 2018  
Author: Ed Dennison & Shaun Richardson

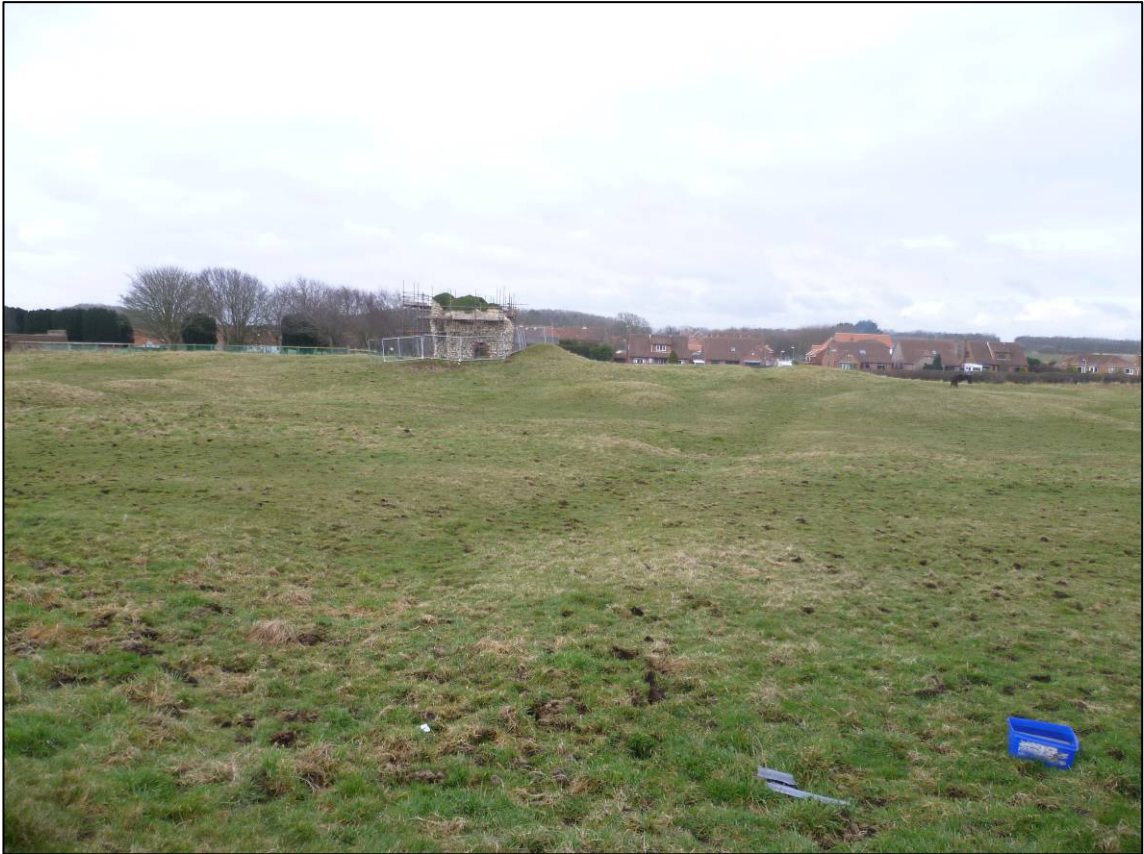
Plate 1: General view of castle (Site 6G), across earthworks, looking W (photo 5/884).

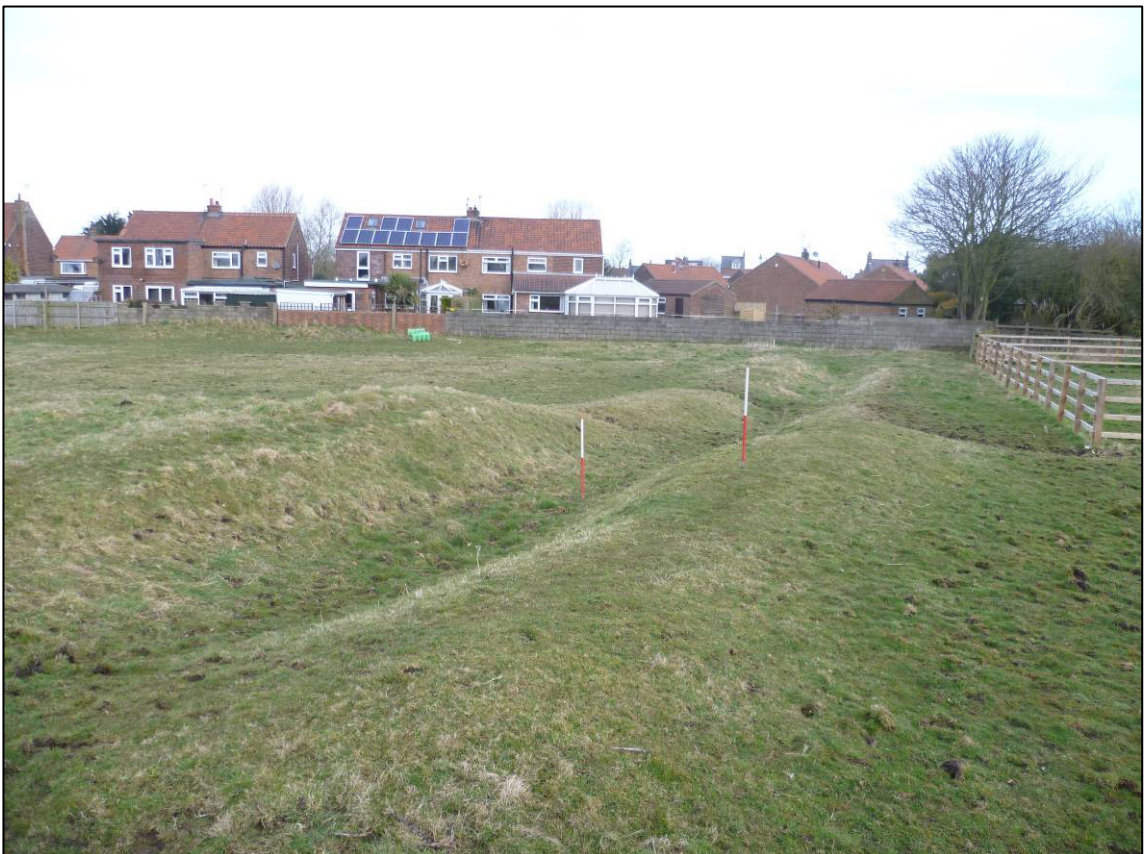
- 3.6 The earthwork is formed by a well-defined and prominent linear depression, set on a shallow north-east/south-west alignment [1/795, 1/796; 5/847] (see plate 2). It measures c.36.0m in length and has an average width of 3.5m across the top but only c.1.5m across the base. The steeply scarped sides of the depression have a maximum depth of c.1.0m at the south end, but generally average 0.6m or less. The depression is flanked by flat-topped banks, which have a chalk rubble content. They are again more prominent towards the south end, perhaps because the linear depression is either cut through an earlier earthwork (**Site 3B**) or possibly because this end of the earthwork represents a feature, such as a former building, towards which the linear depression ran. Although the depression fades some 5.0m short of the northern boundary of the survey area, the banks can be traced as far as the boundary. The depression cannot be traced quite to the north side of the castle platform (**Site 6**), although there is a slight break in the bank defining the north side in line with the depression.

Plate 2: Sunken watercourse or leat (Site 1), looking N (photo 5/847).

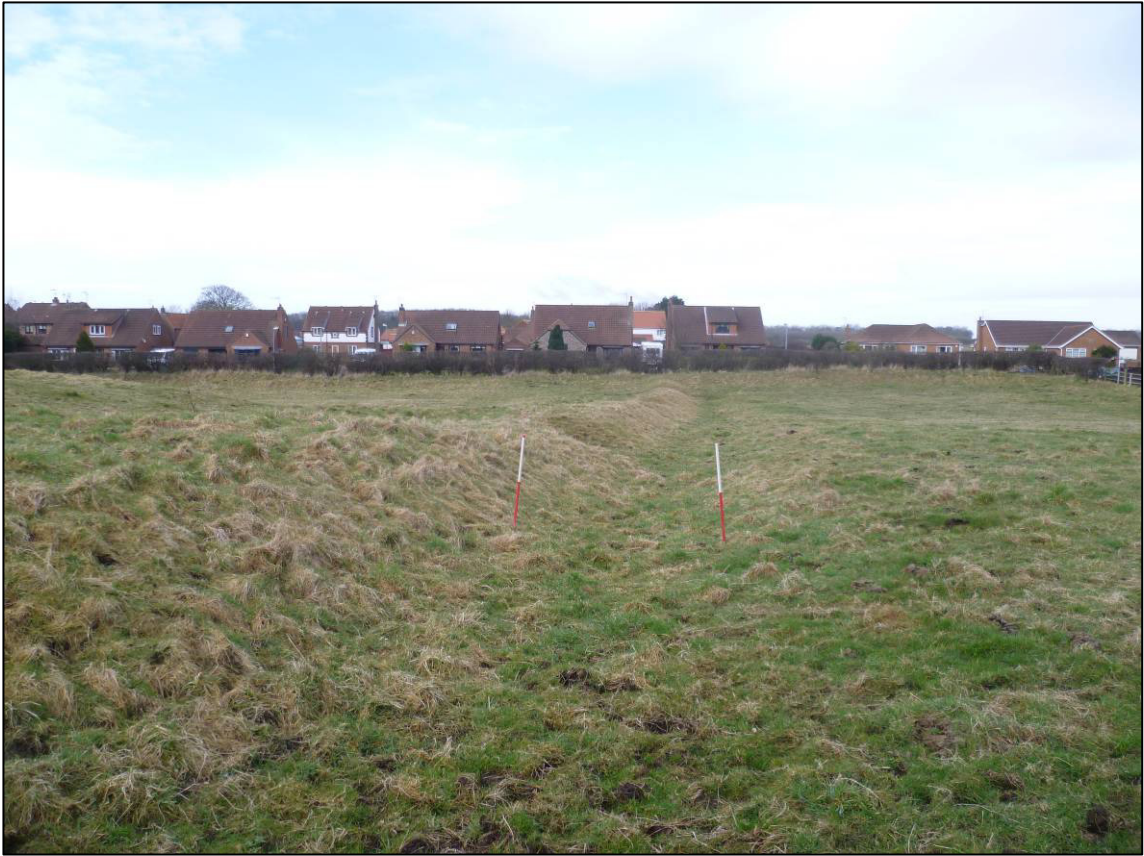
Plate 3: Bank (Site 2) with ditch on N side, looking E (photo 5/850).

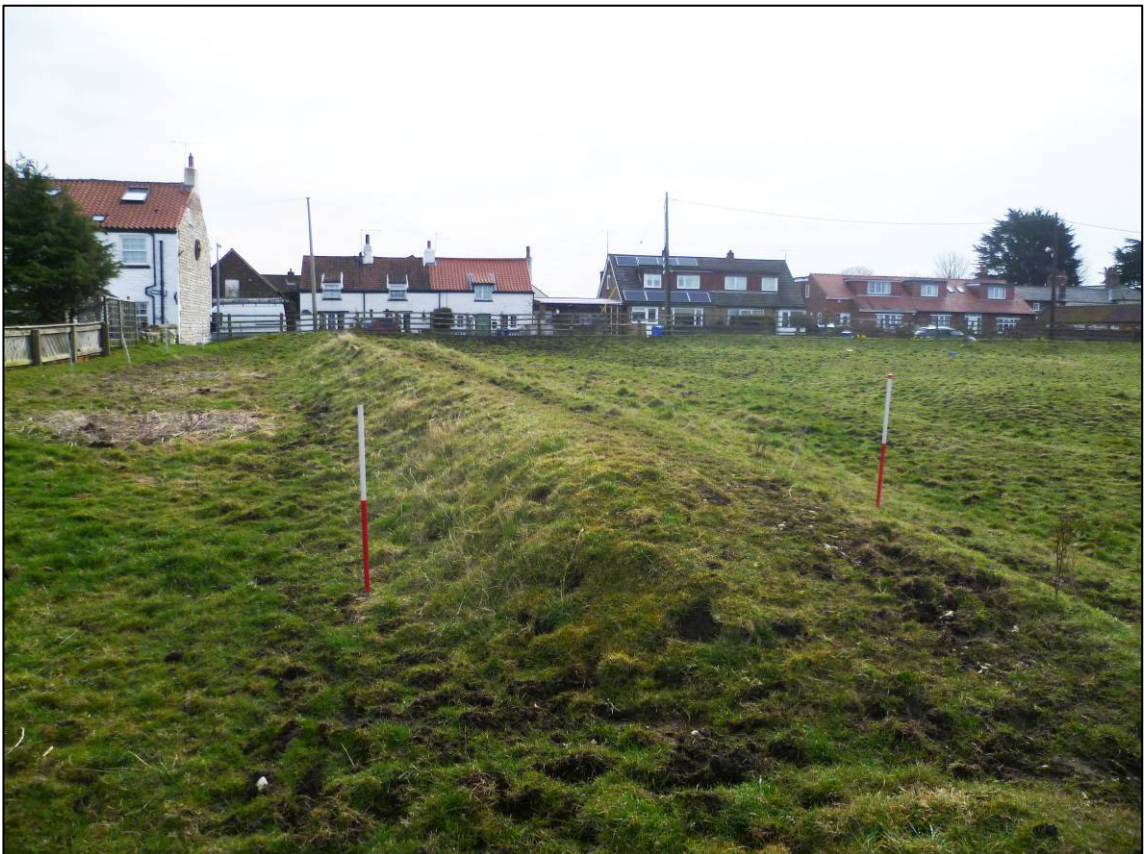
Plate 6: Bank (Site 4), looking E (photo 5/840).

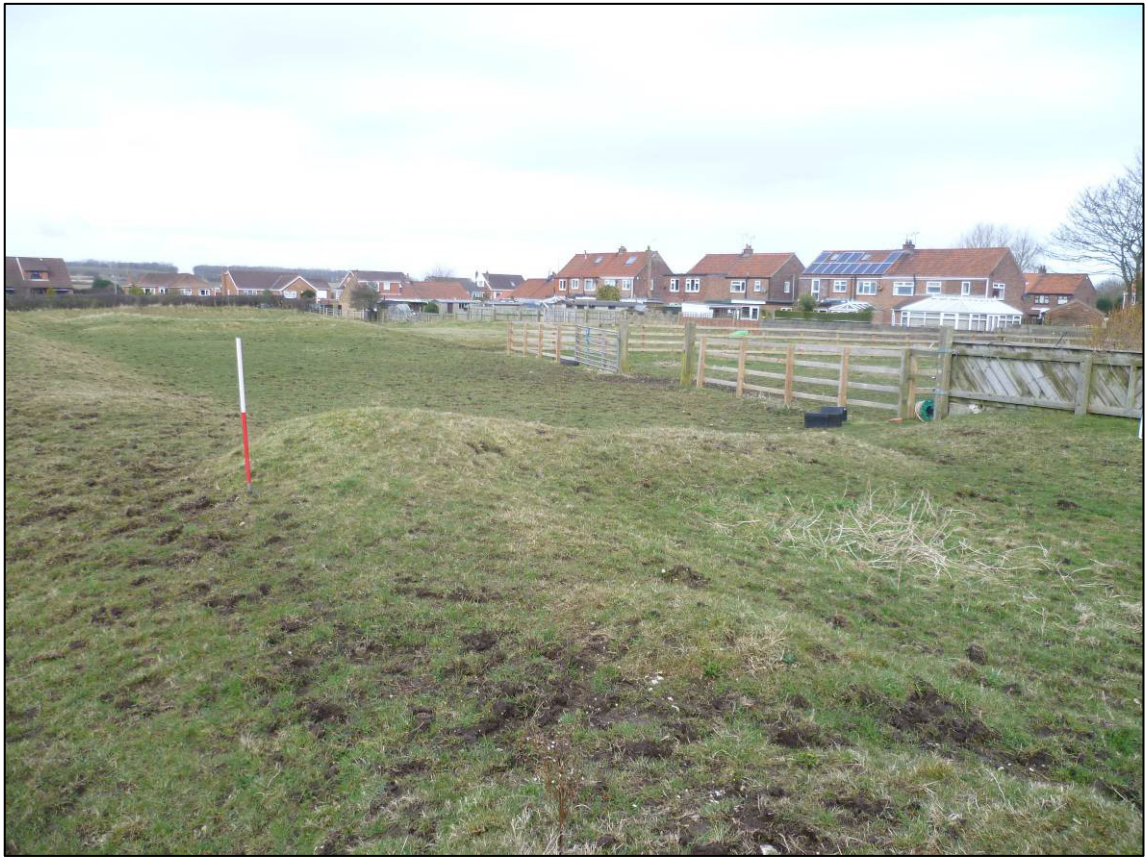
Plate 7: Bank (Site 4), right-angled section, looking NW (photo 5/842).

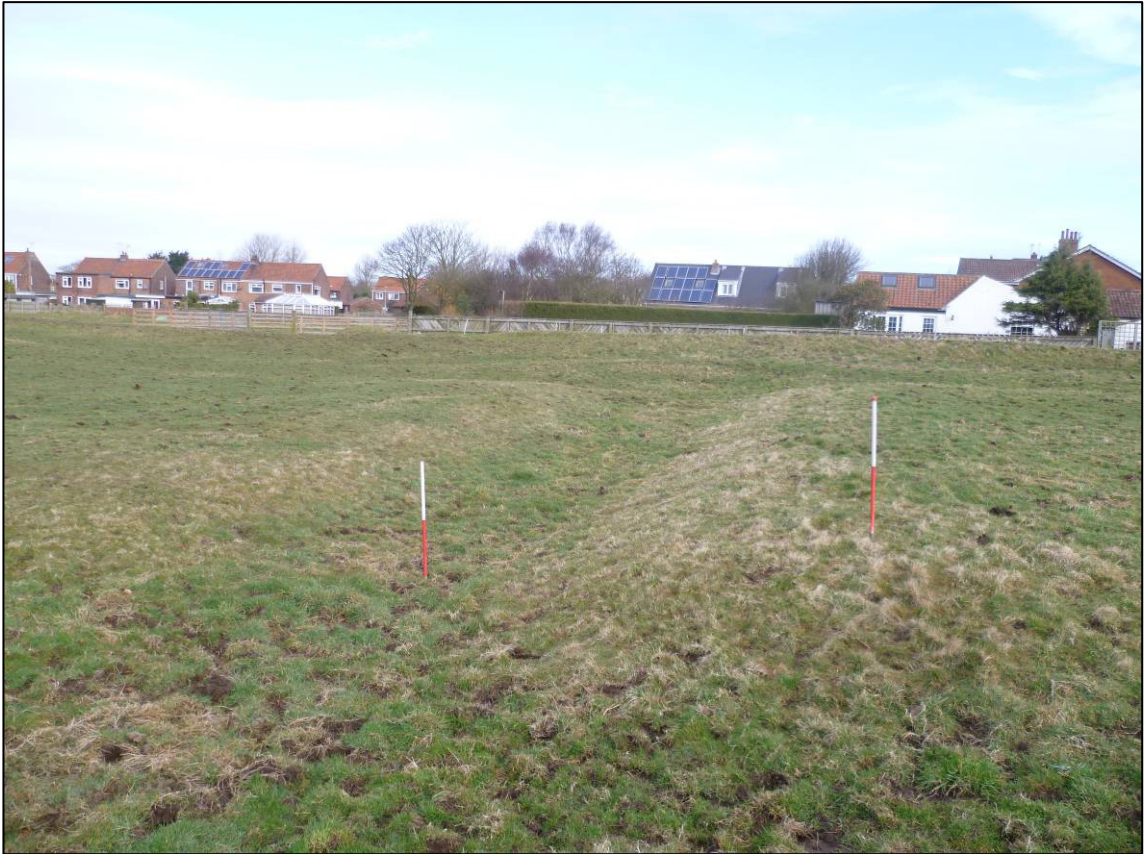
Plate 9: Central north-south ditch (Site 5B) in garden area, looking N (photo 5/838).

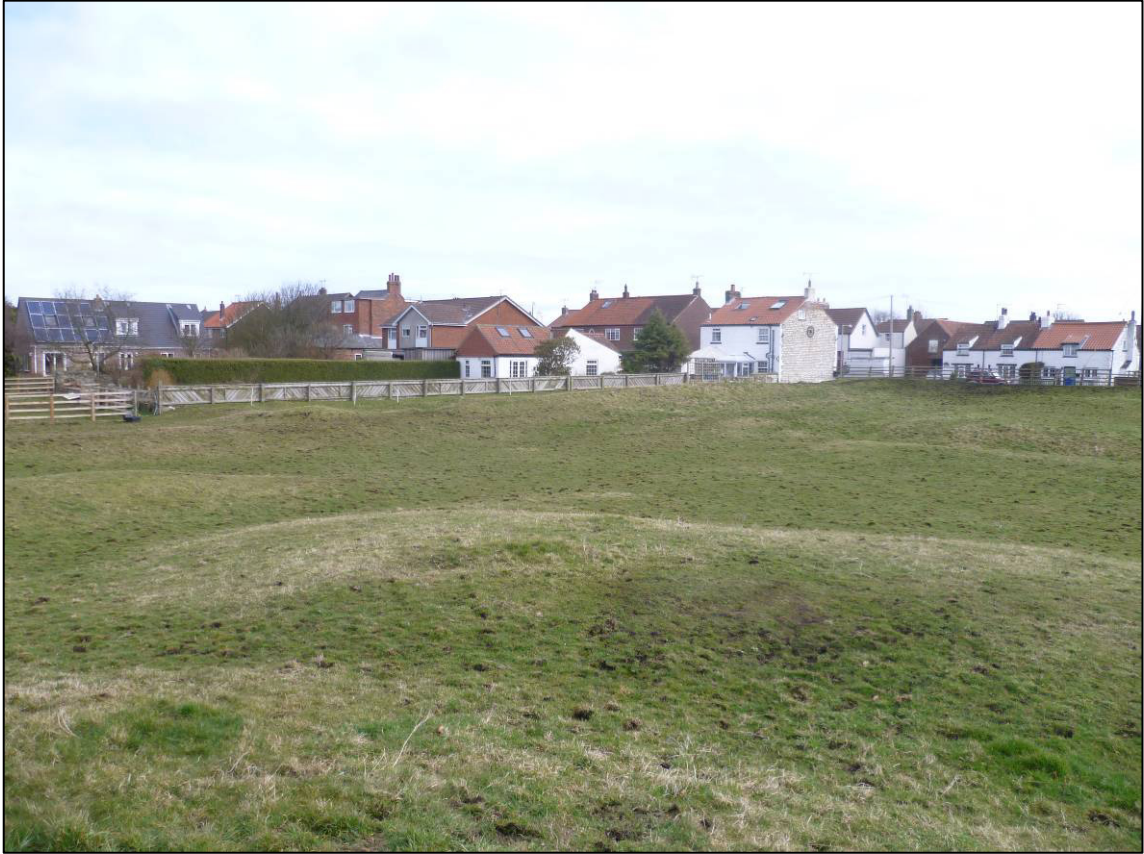
Plate 11: Mound (Site 5D) in gardens area, looking NE (photo 5/861).

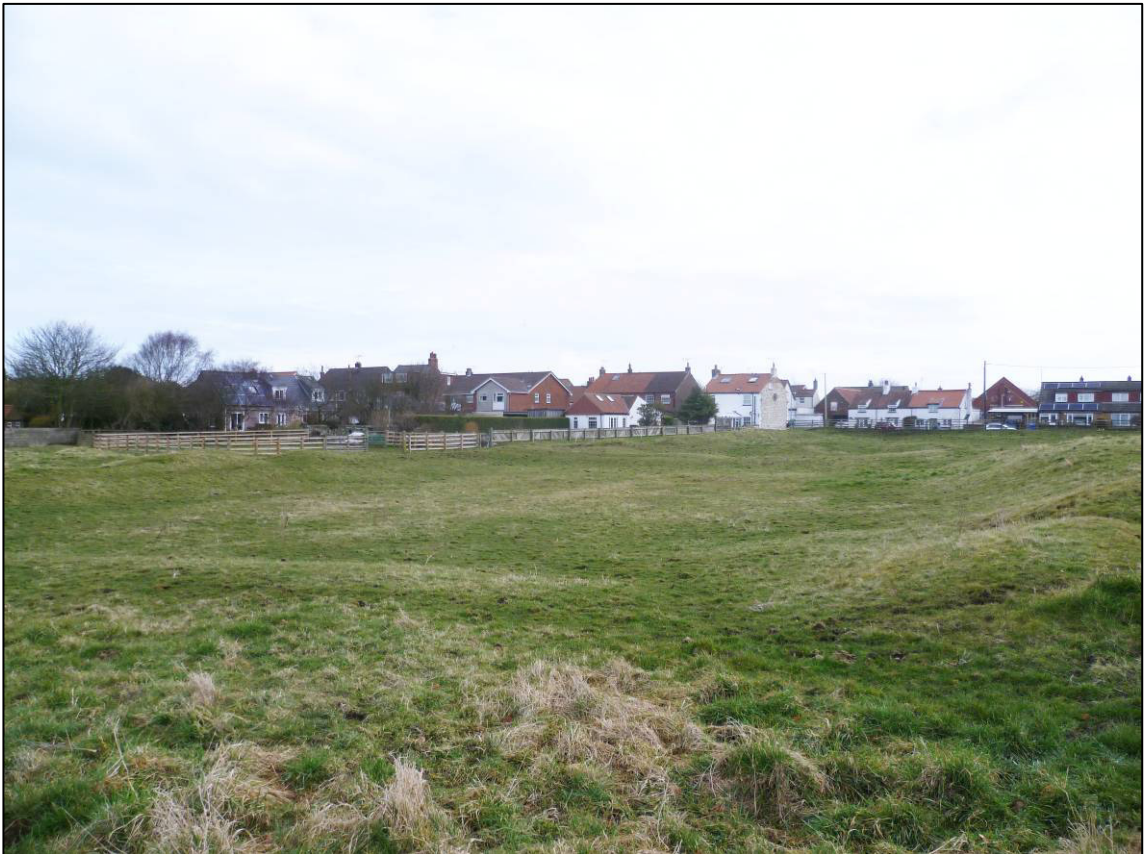
earthworks **6E** and **6F** actually form one long single building [1/809; 4/645; 5/819] (see plate 16).

Plate 16: Building platforms (Sites 6E & 6F) and possible outer court (Site 6A) beyond, looking N (photo 5/819).

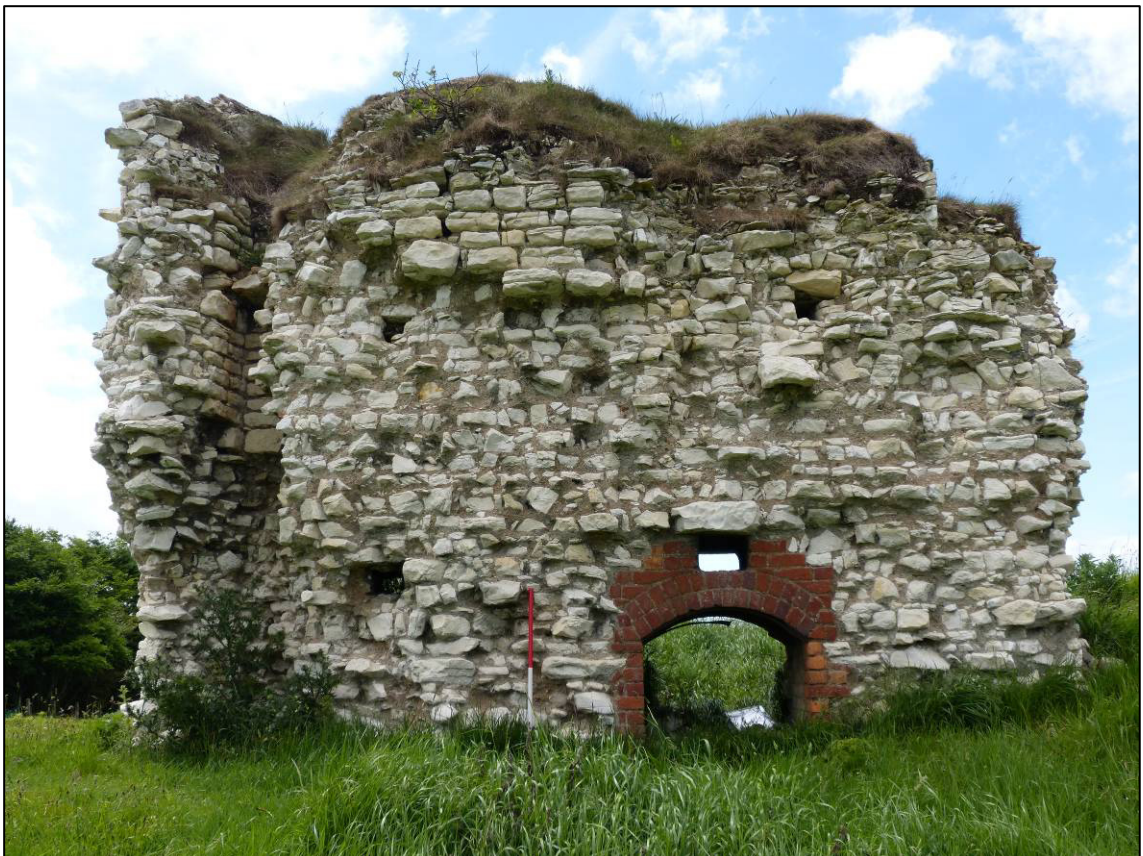
Plate 31: Castle (Site 6G), south external elevation, looking N (photo 1/804).

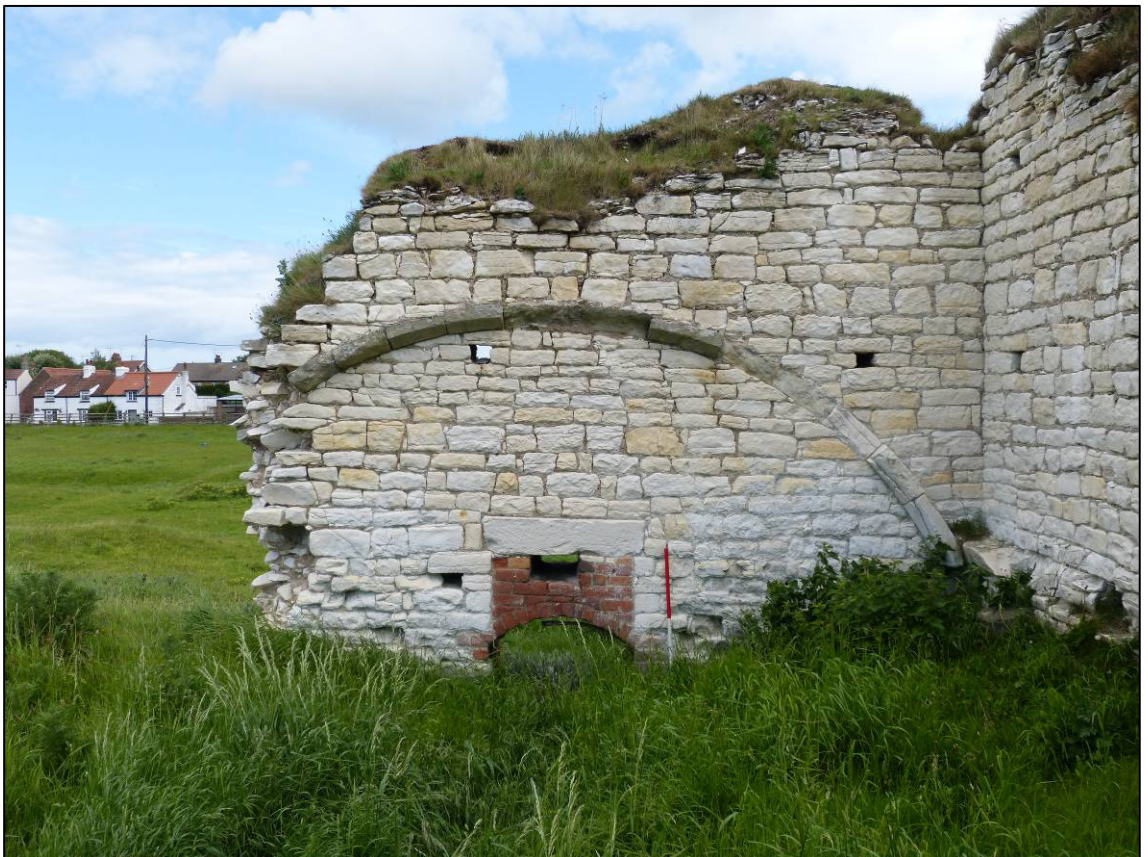
Plate 36: Castle (Site 6G), south internal wall top, window after clearance, looking SW (photo 3/270).

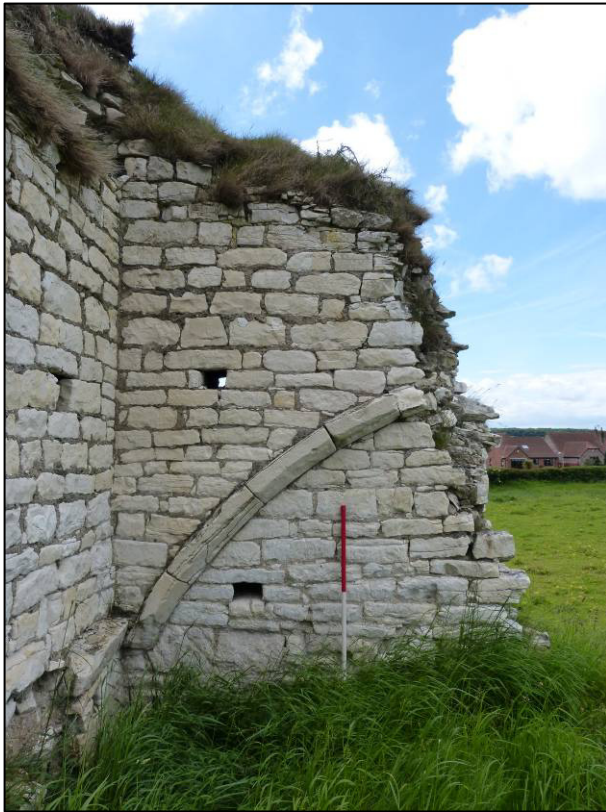
- 3.43 The internal east wall of the structure also retains part of a broad barrel vault, defined by a chamfered chalk string course (see figure 12F and plate 37); the wall face above and below the vault is set in the same plane, so that the string course projects from the wall. There are two lines of putlog holes to the wall, at the lower and middle levels, each comprising two holes, and the low doorway to the base below the vault. The opening at the base of the wall has a monolithic chalk lintel to this face, and was 1.04m wide before it was blocked with brick [1/800; 3/318; 4/796]. The bottom chamfer of the upper level doorway jamb at the north end of the wall is also visible [4/795].

Plate 37: Castle (Site 6G), east internal elevation, looking E (photo 1/800).
