The Ancillary Buildings Associated With High House, Purfleet, Essex

Historic Buildings Assessment

February 2009

Client: The Regeneration Practice

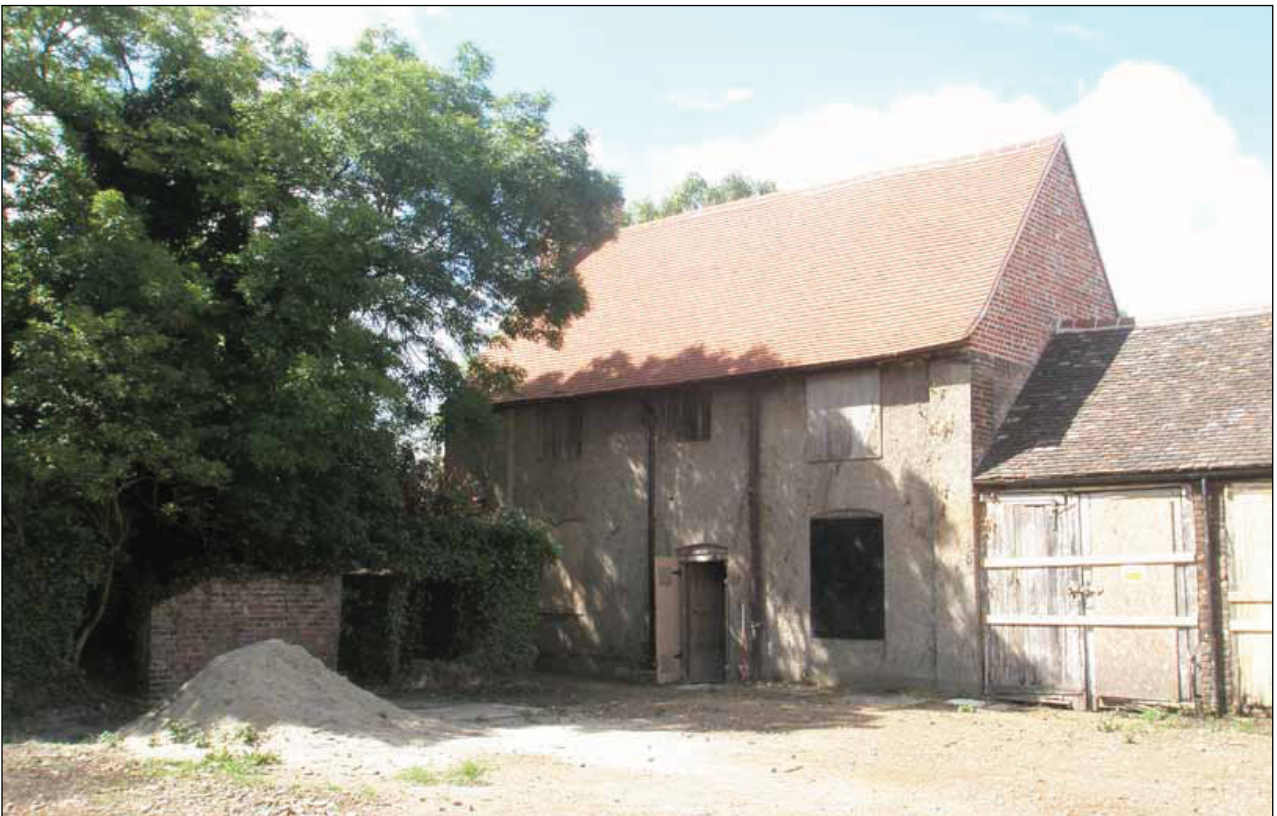
Plate 2: View from south east of main courtyard, showing all/parts of Buildings 2, 3 and 4

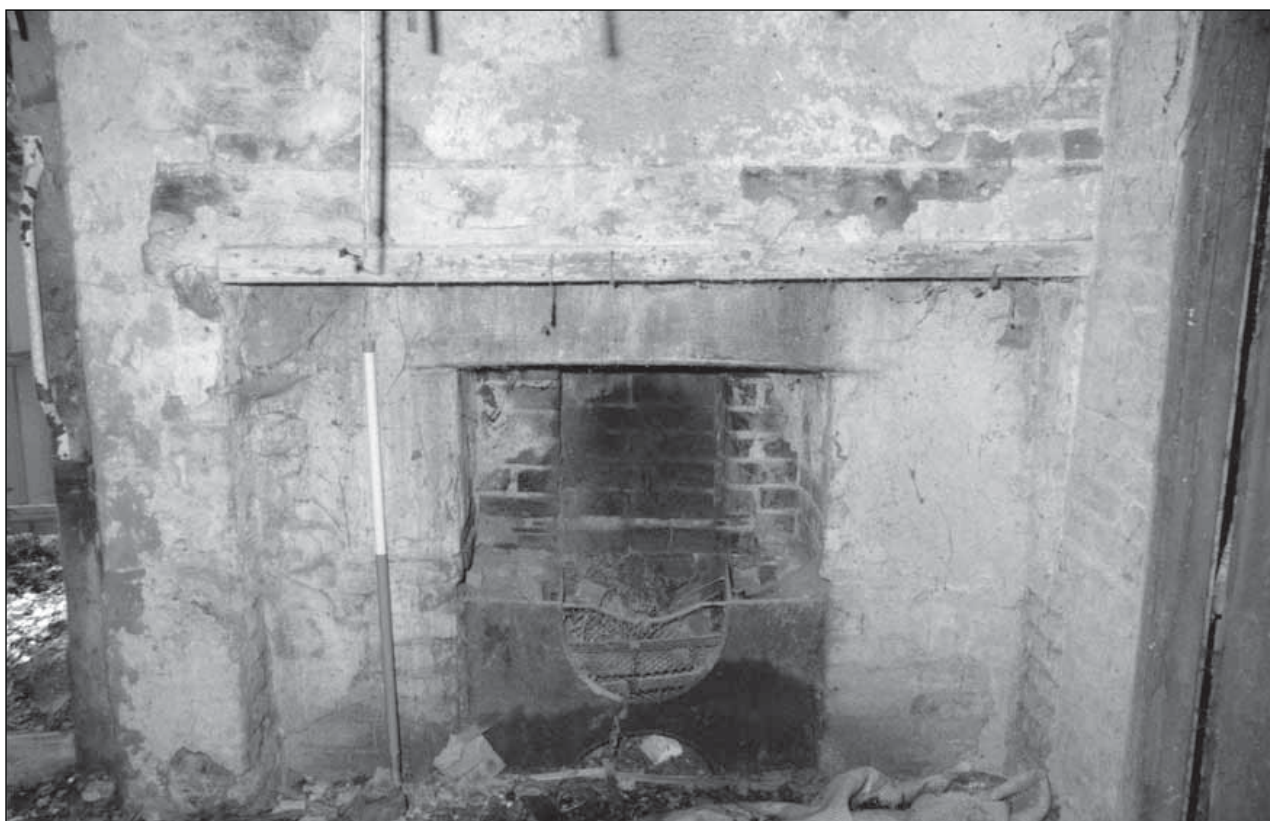
- 3.2.4 Room 2:2 has brick floor and a lathe and plaster ceiling, the walls have also been plastered although much of this has degraded. Green and white paint survives on the window, and some small traces of green paint survive on the walls. There is a stud wall with brick-nogging on the north side with a plain plank and batten door leading into Room 2:3.

Plate 3: Fireplace in Room 2:2

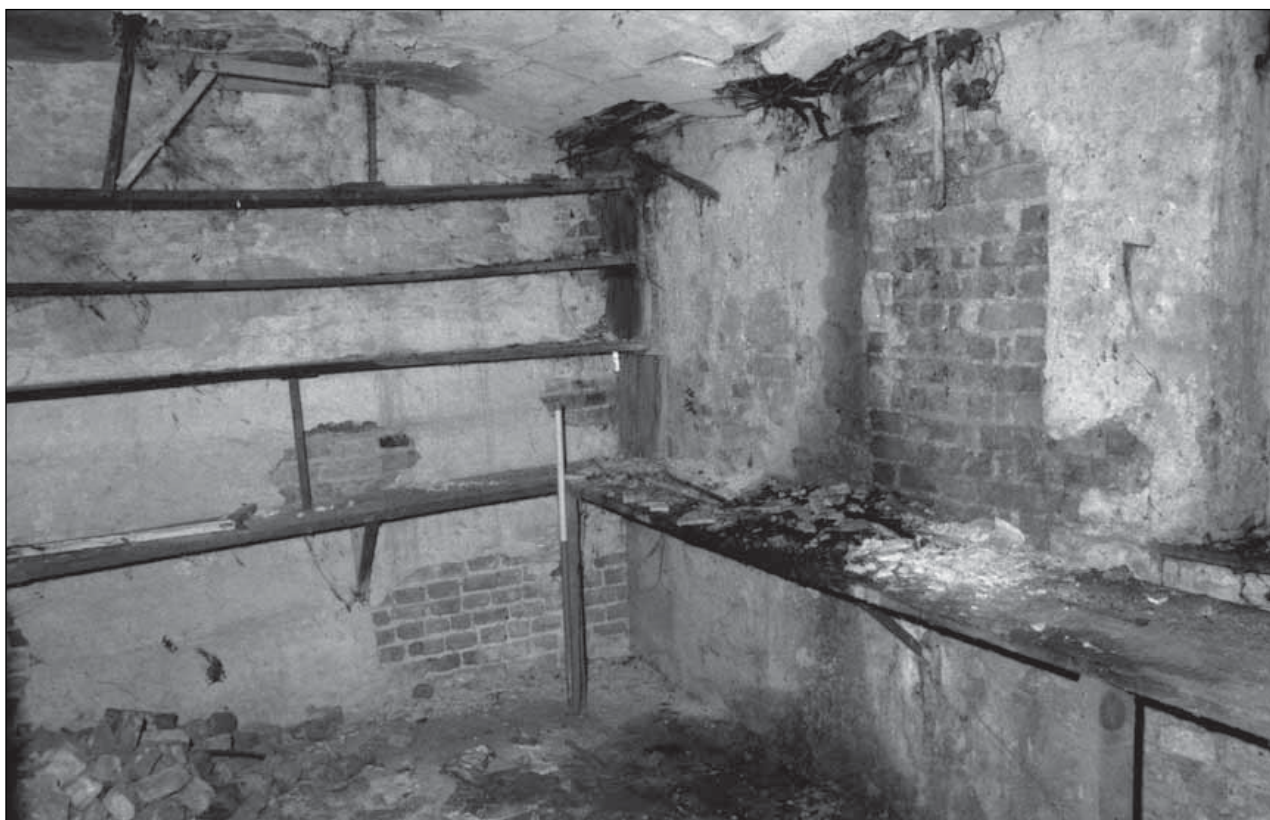
Plate 4: View from south west corner of Room 2:3

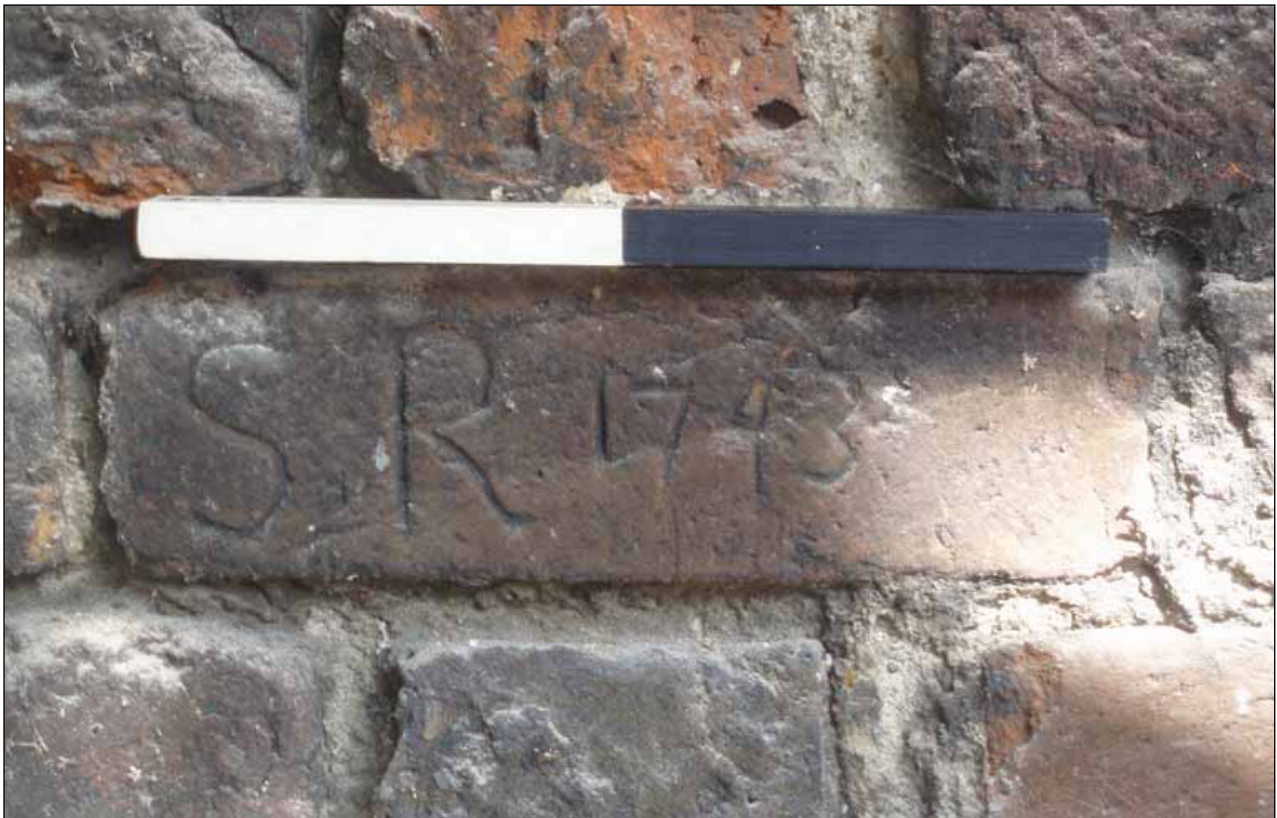
Plate 5: Dated brick in west gable of Building 3

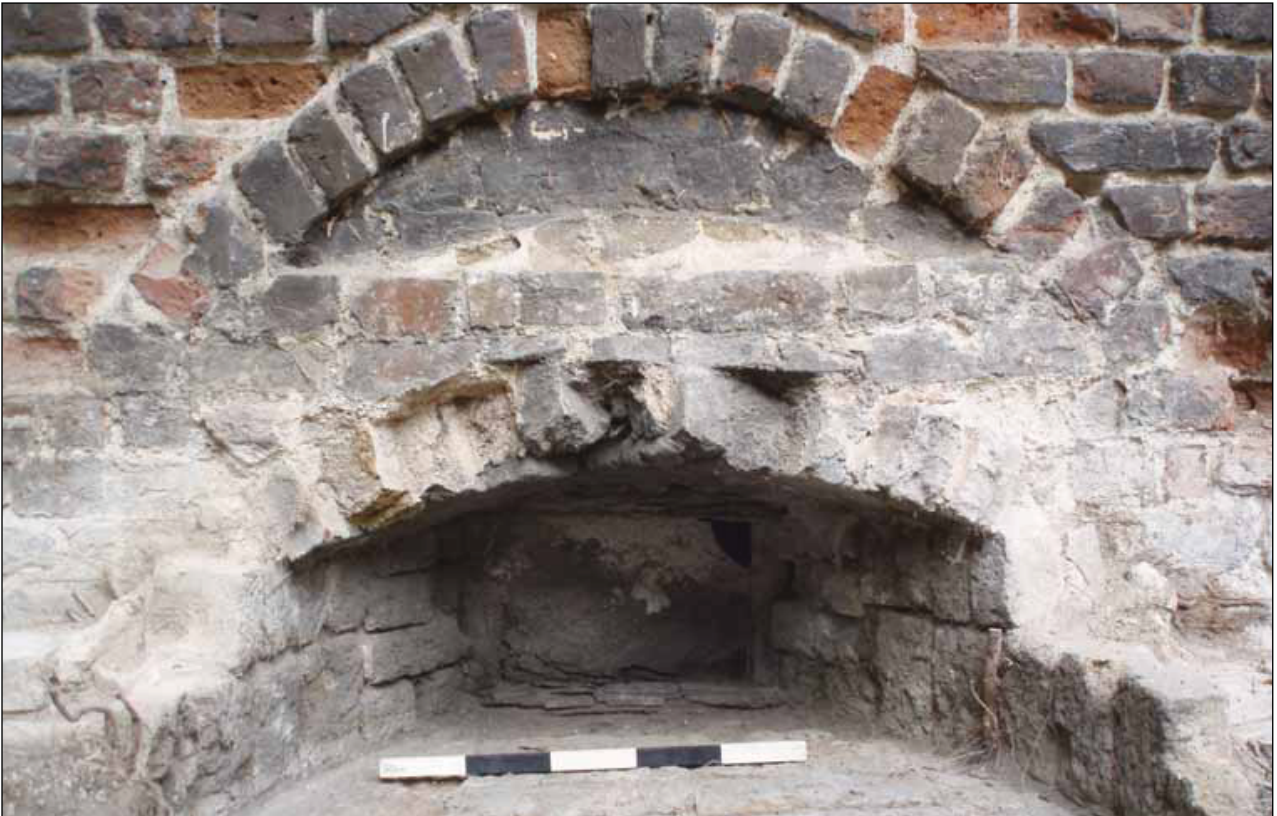
Plate 7: Door from bread oven into chimney flue, in west gable of Building 3

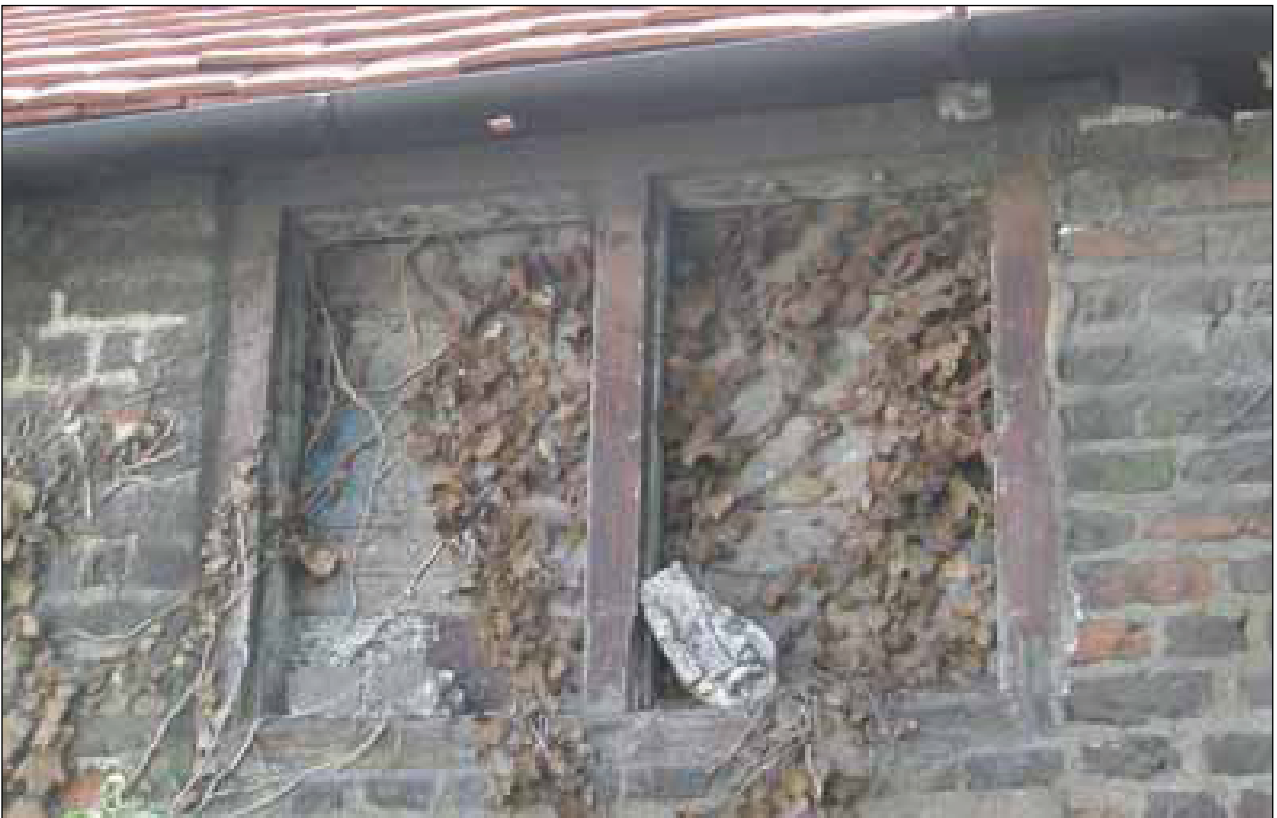
Plate 8: Central first floor window in north facing elevation of Building 3

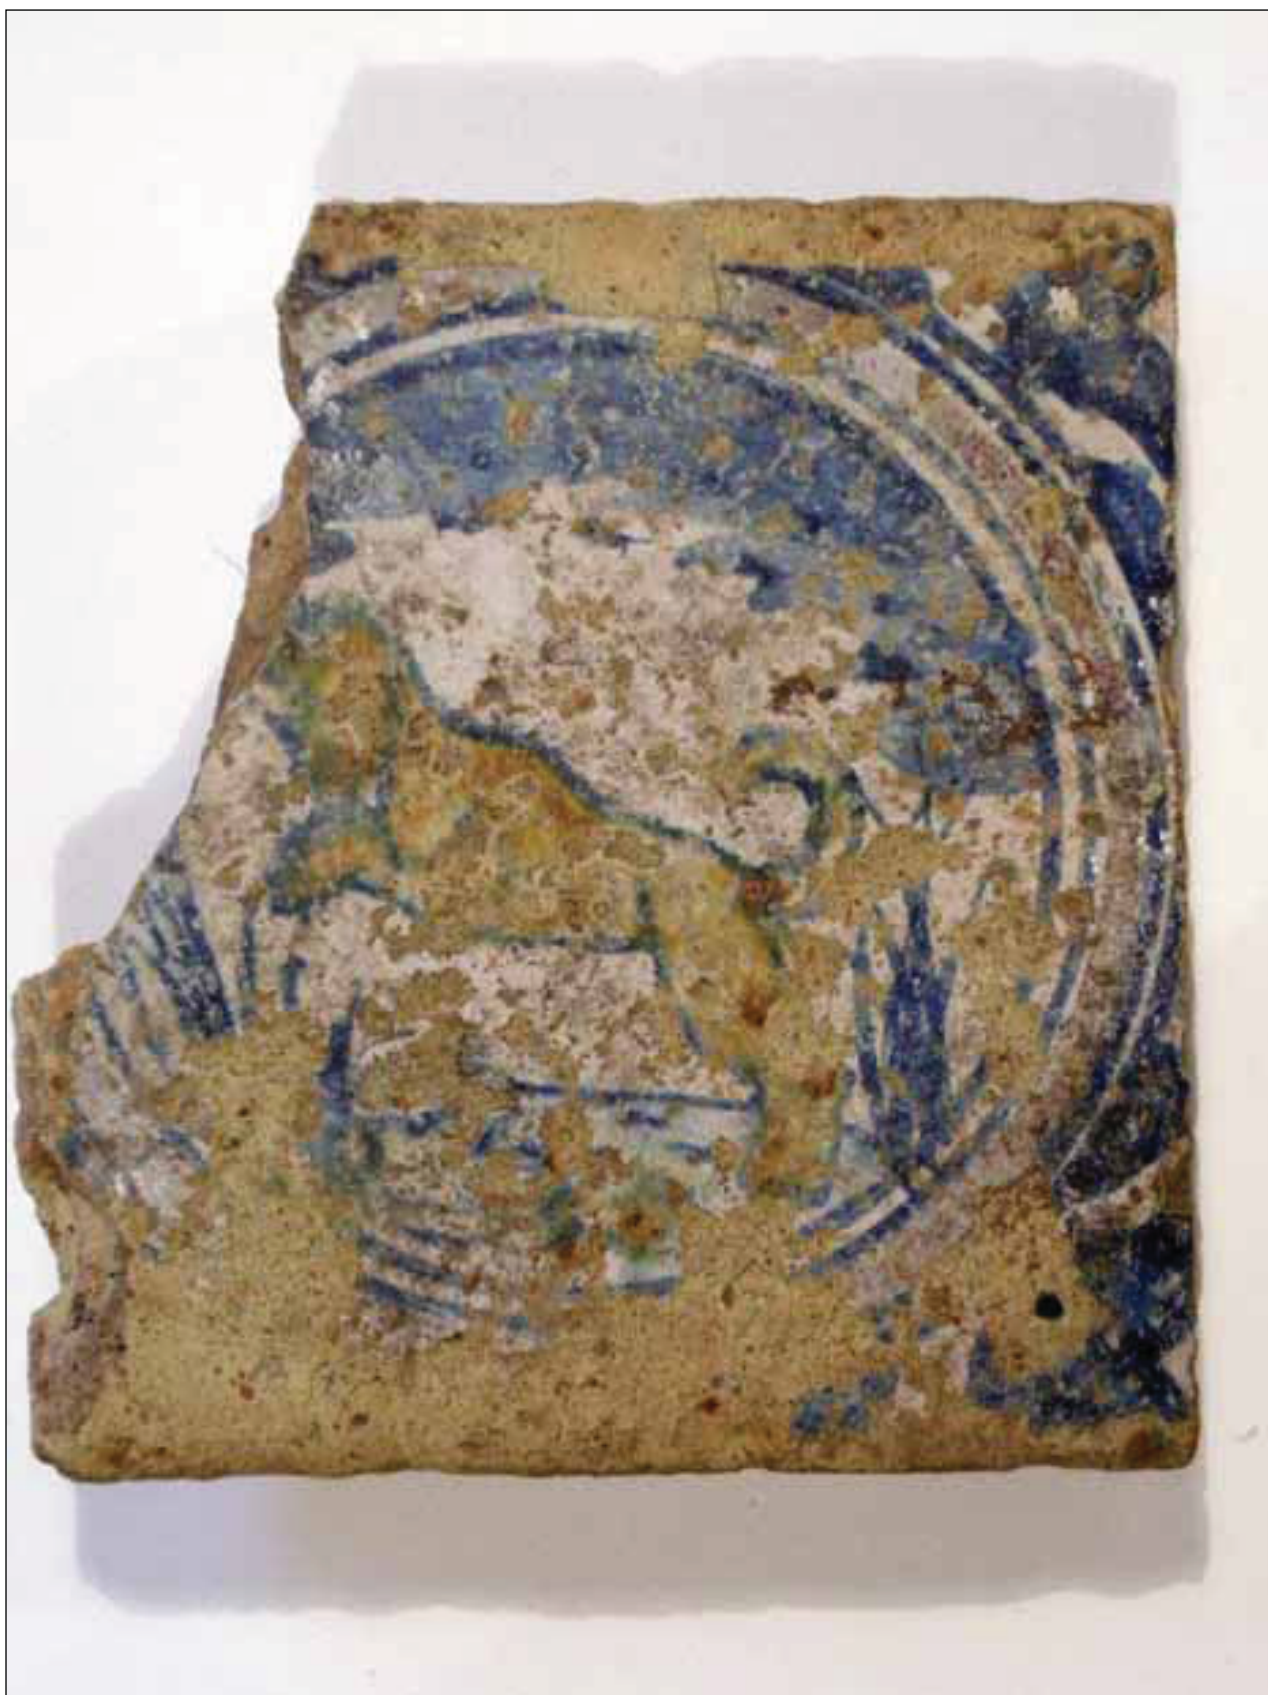
Plate 9: Tile found buried near out-building to the north west of Building 3

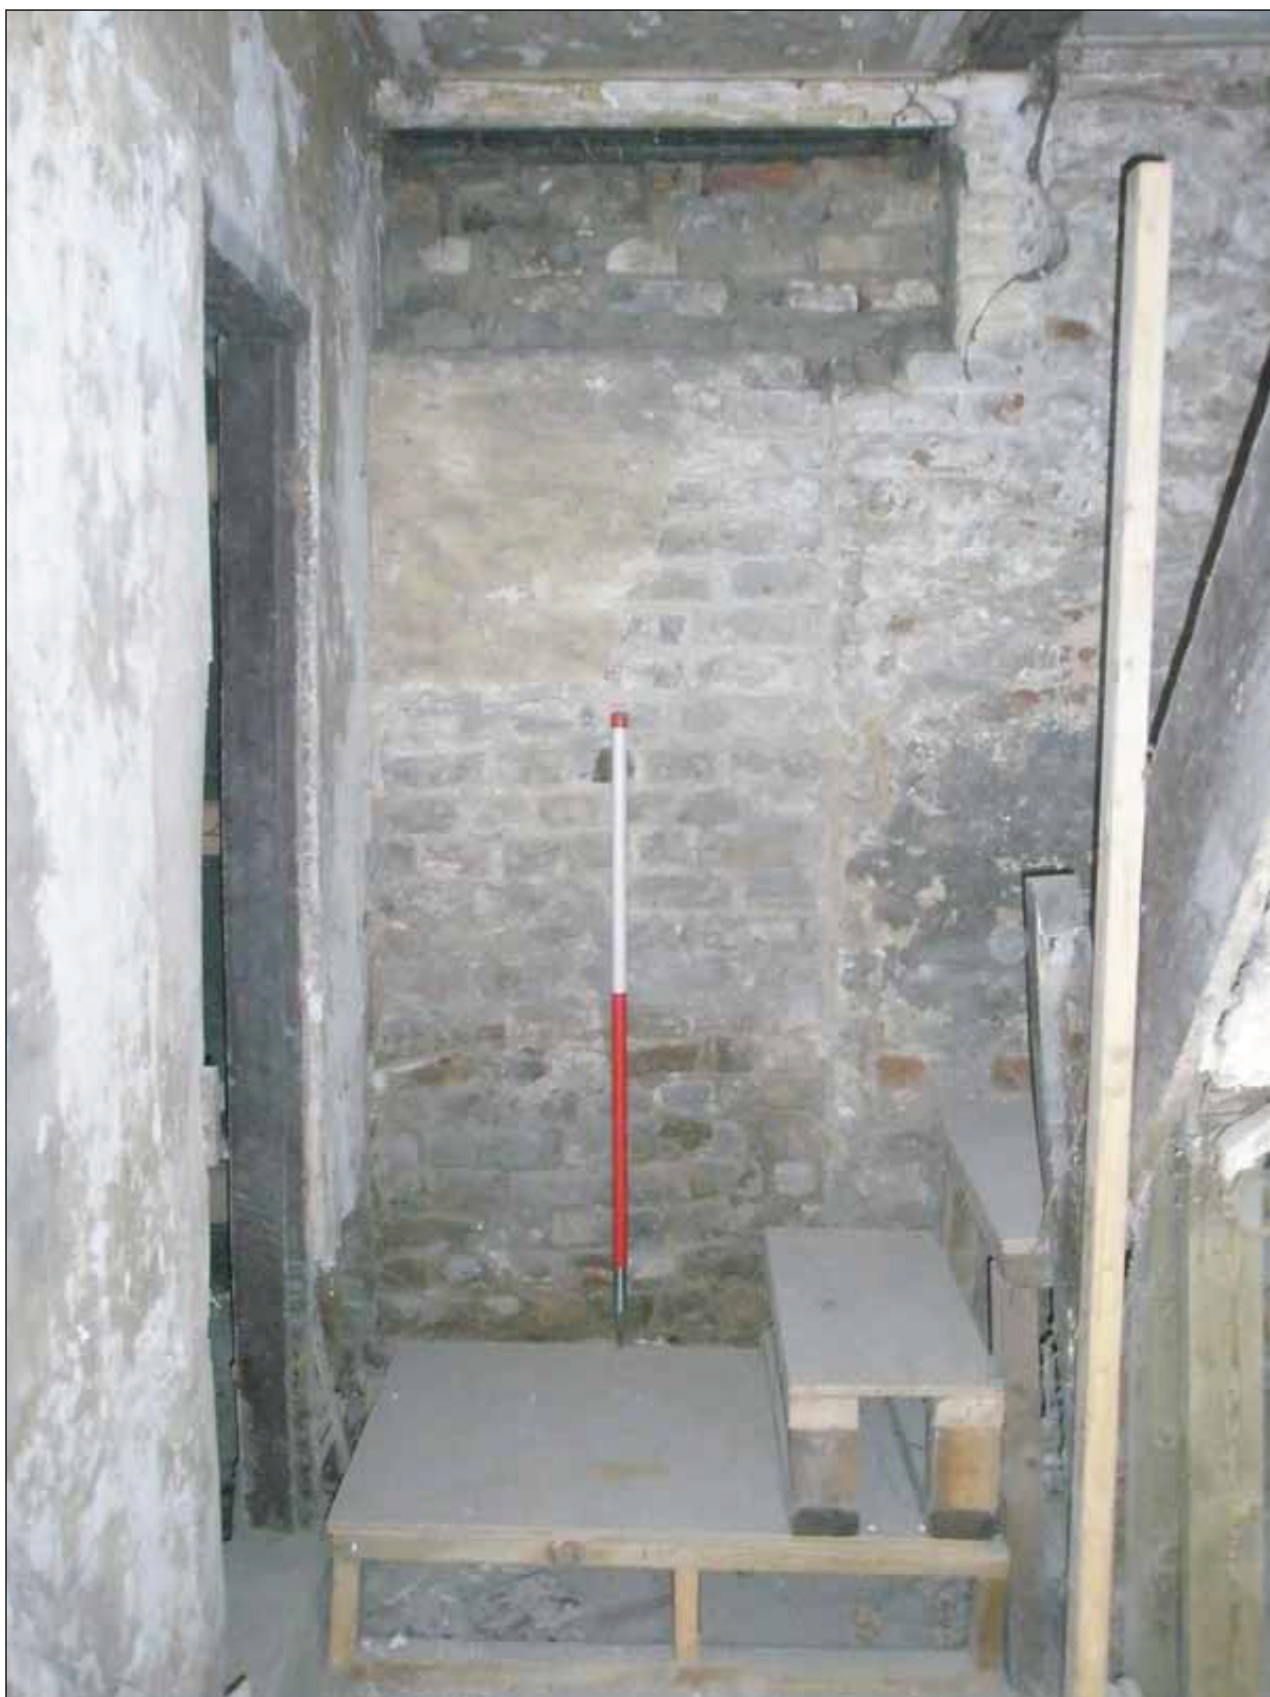
Plate 10: Blocked door in north wall of Room 3:1

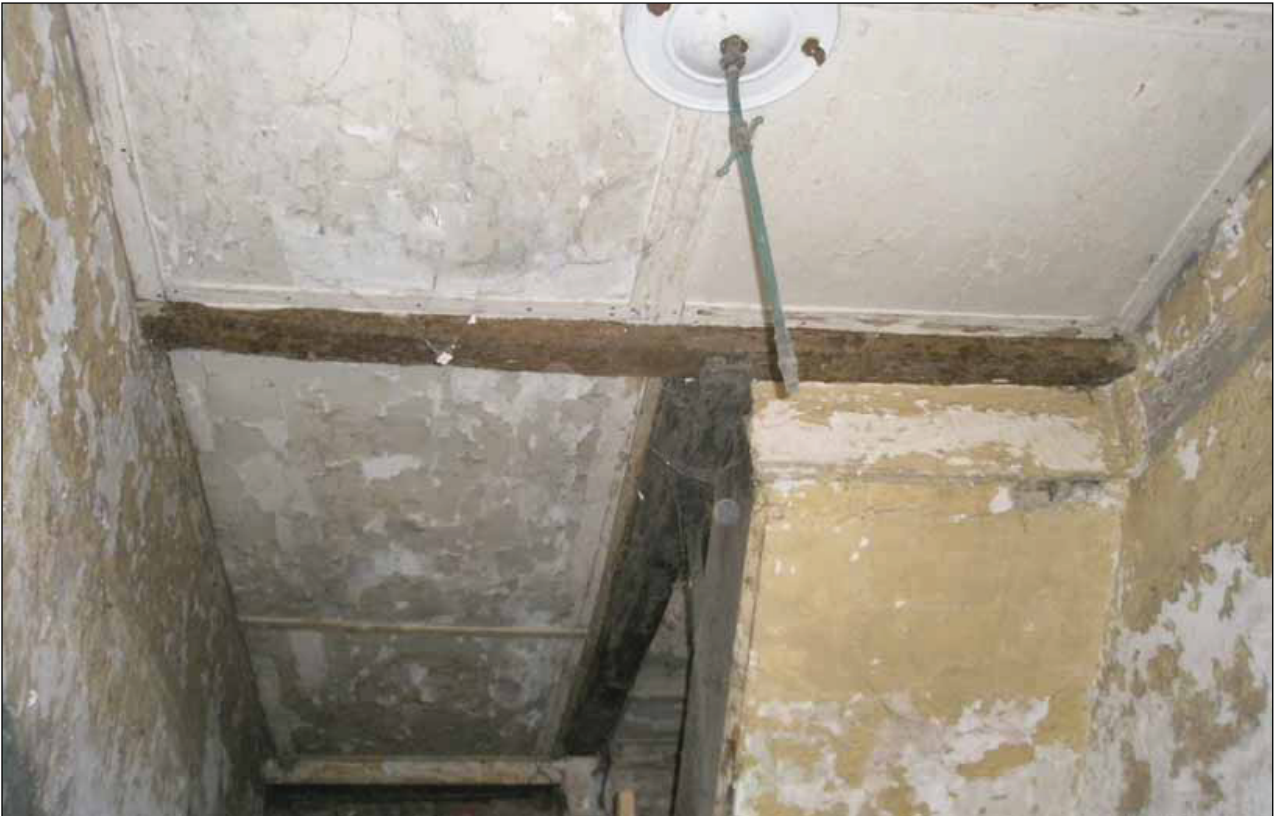
Plate 11: Ceiling of Room 3:1, from south

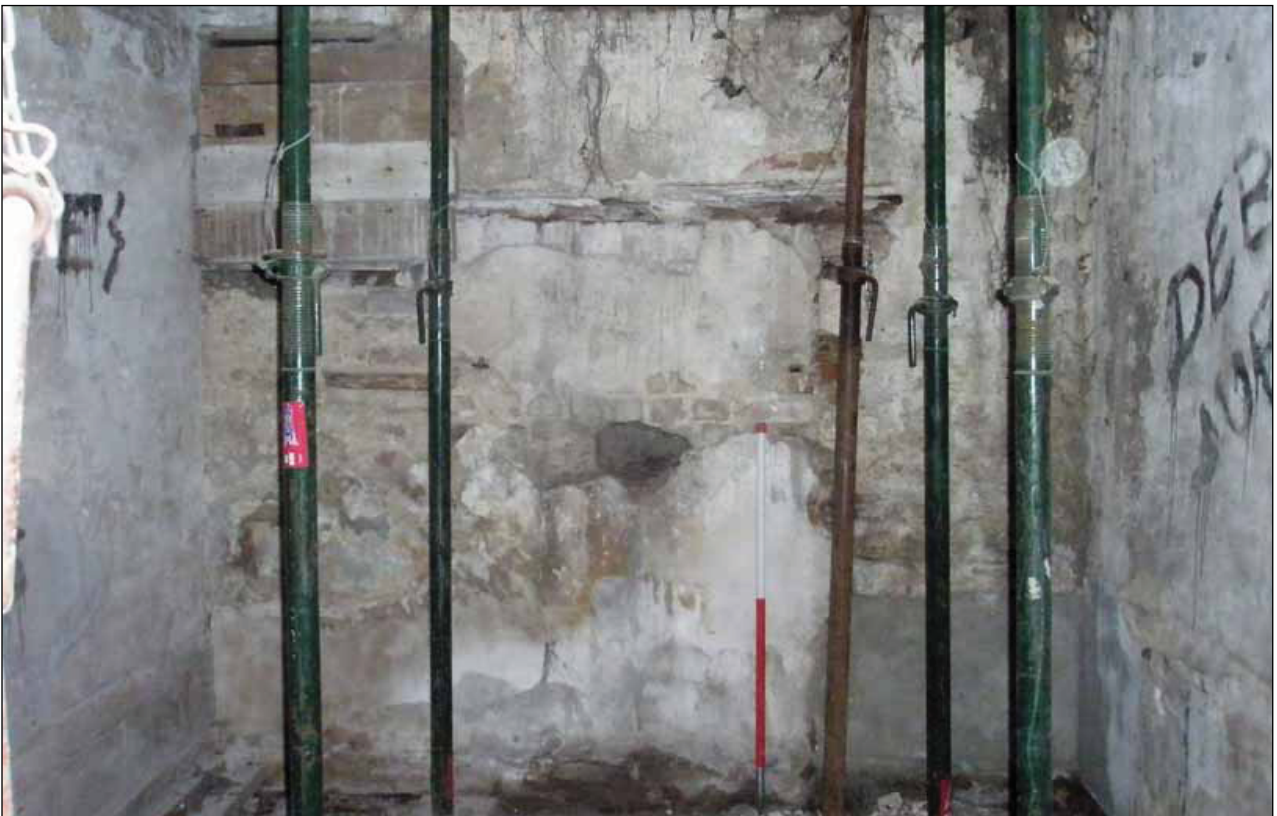
Plate 12: North wall of Room 3:2

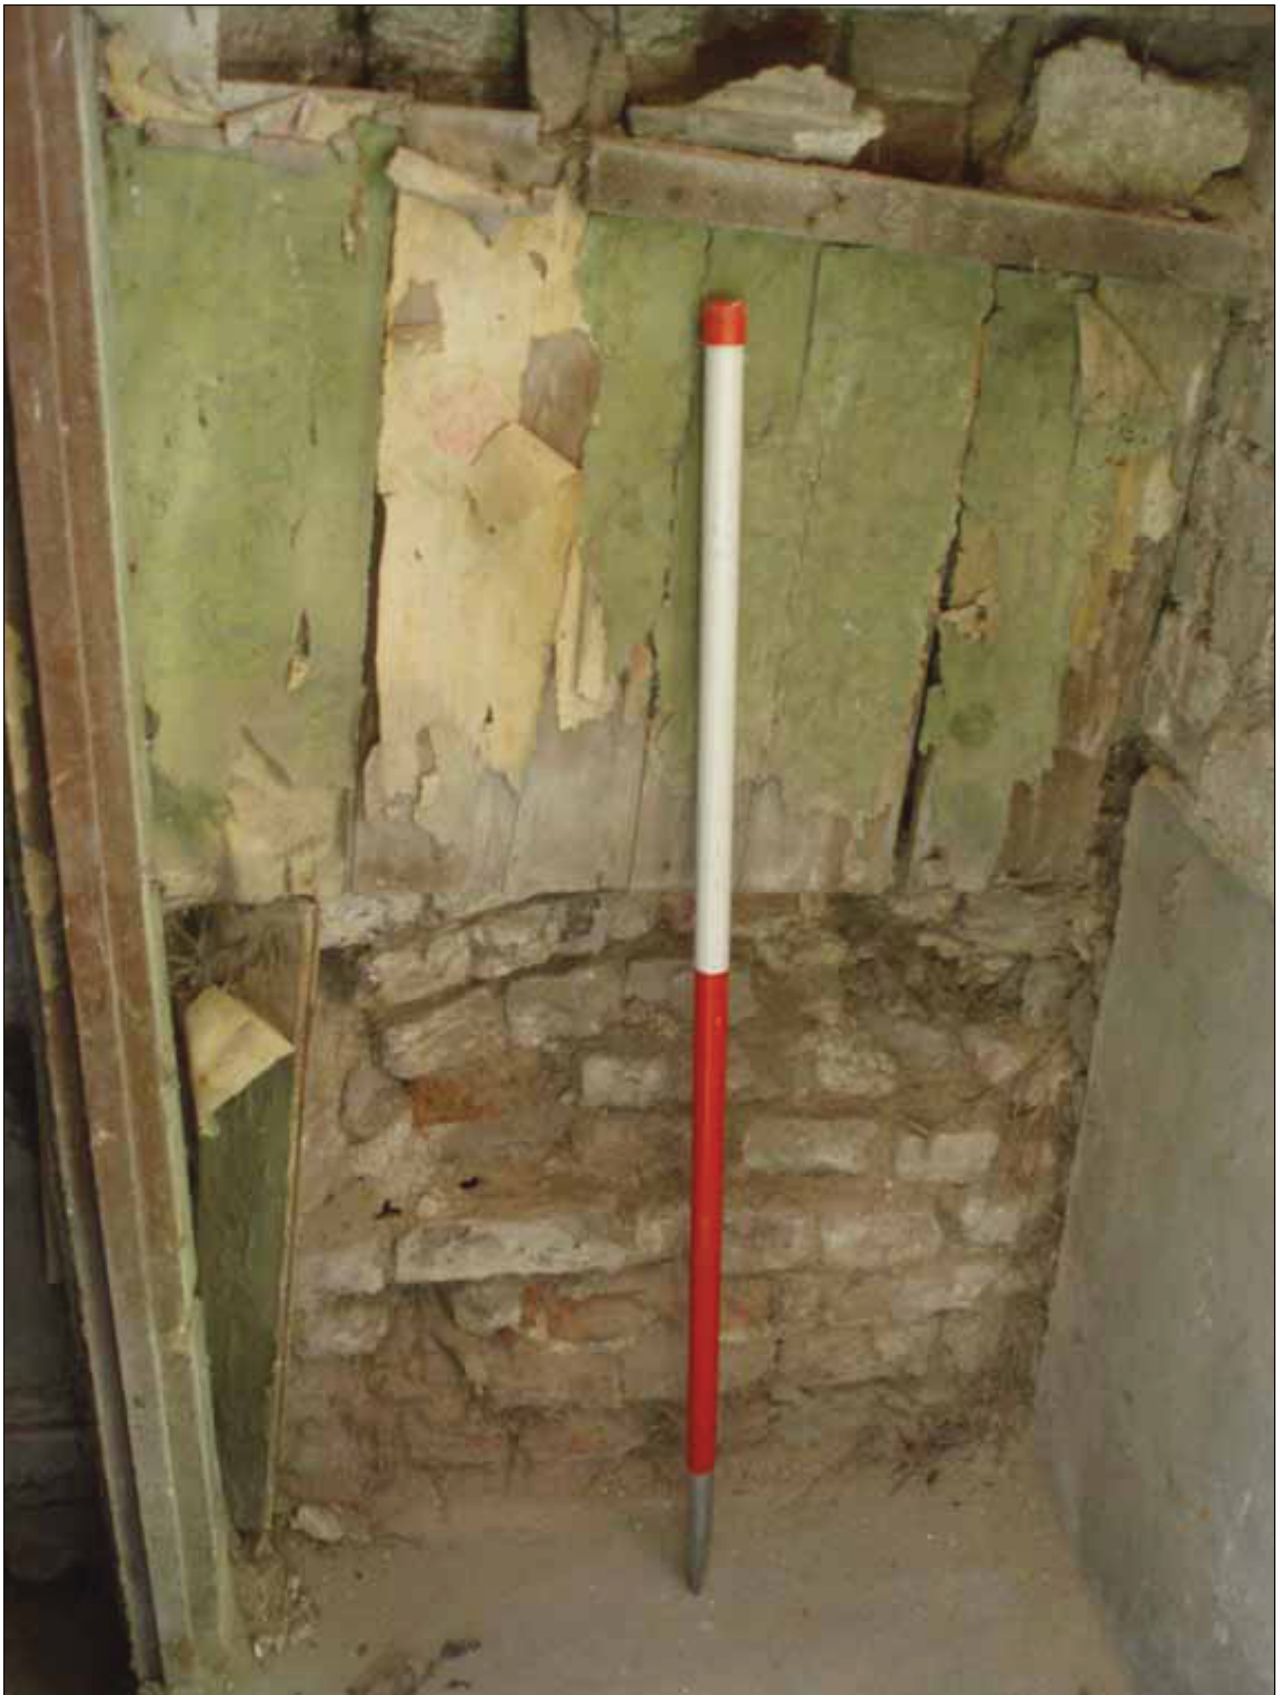
Plate 14: Curved brickwork behind panel in alcove to the south of the fireplace in Room 3:3, taken from north

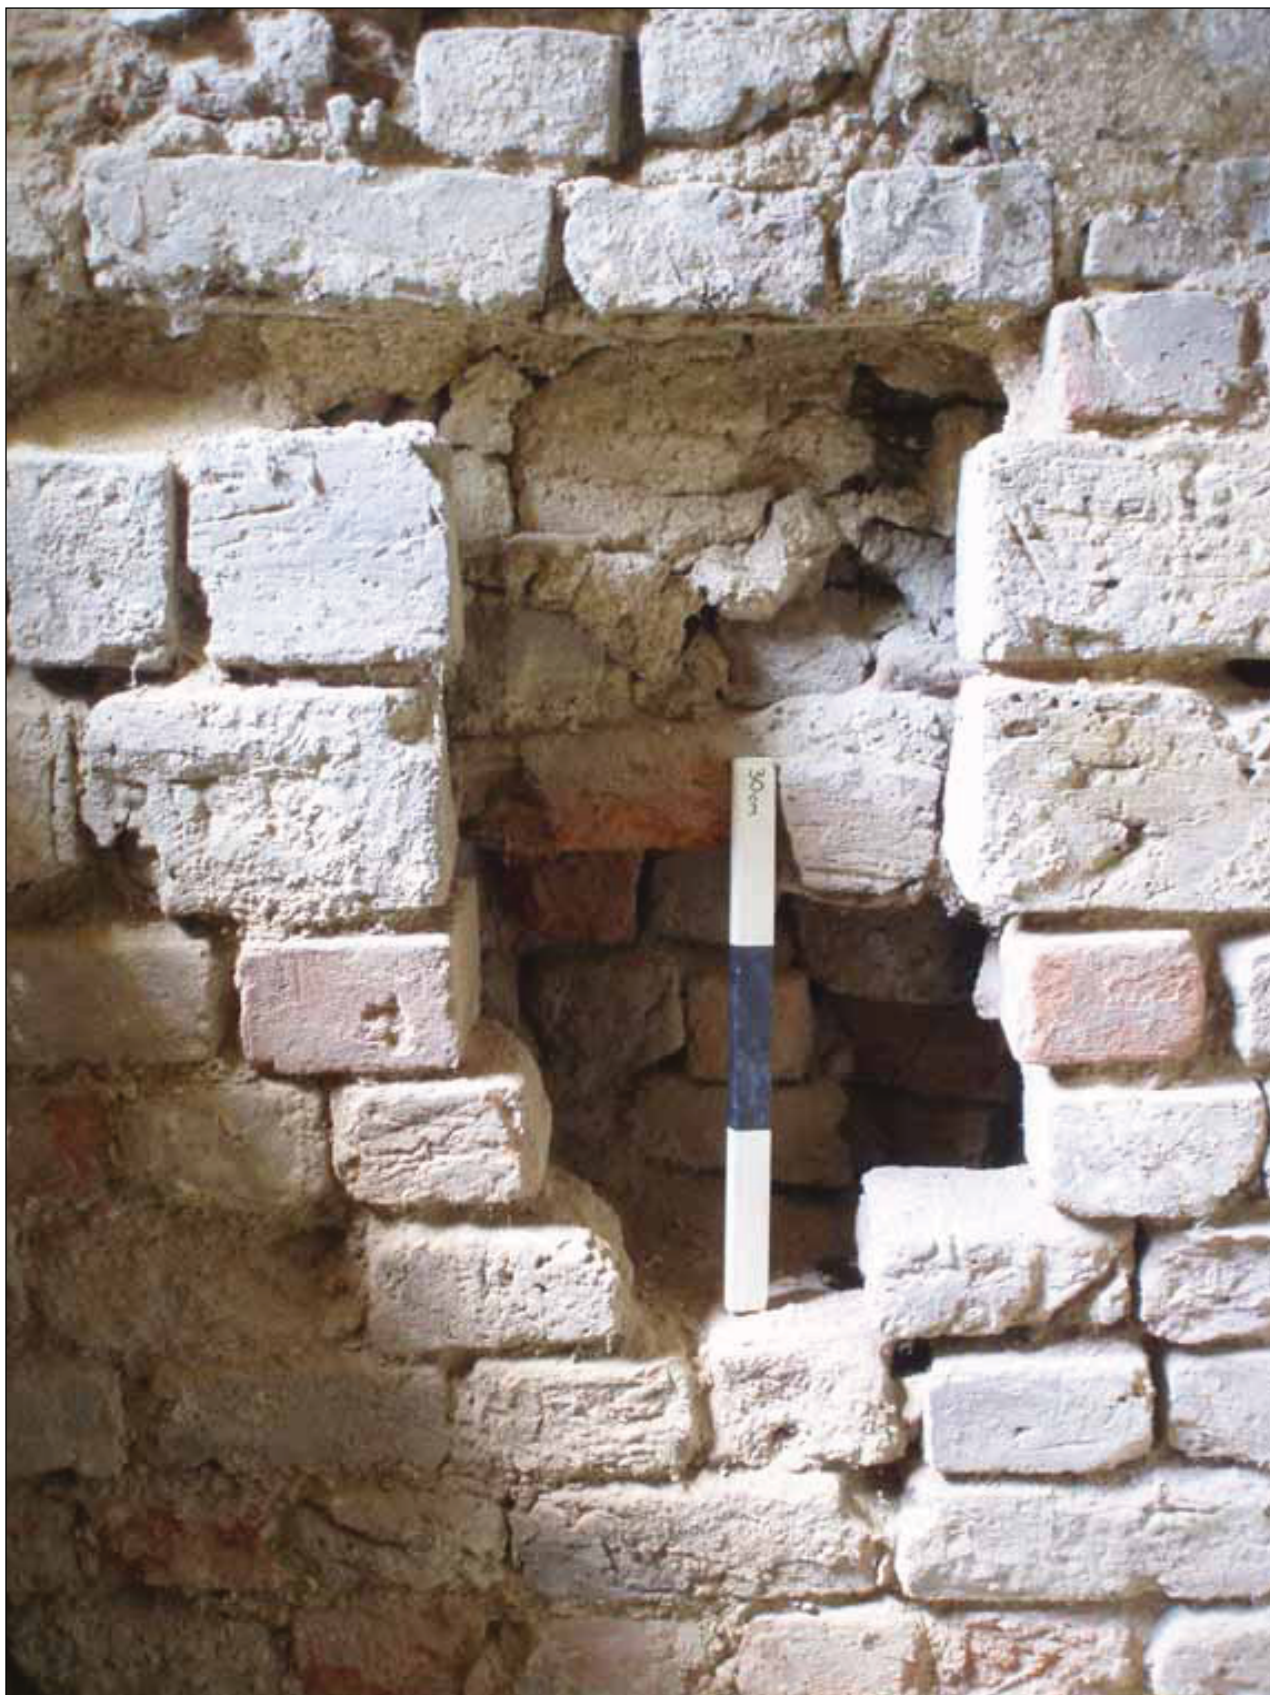
Plate 15: Blocked flue in chimney-breast in Room 3:3, taken from south

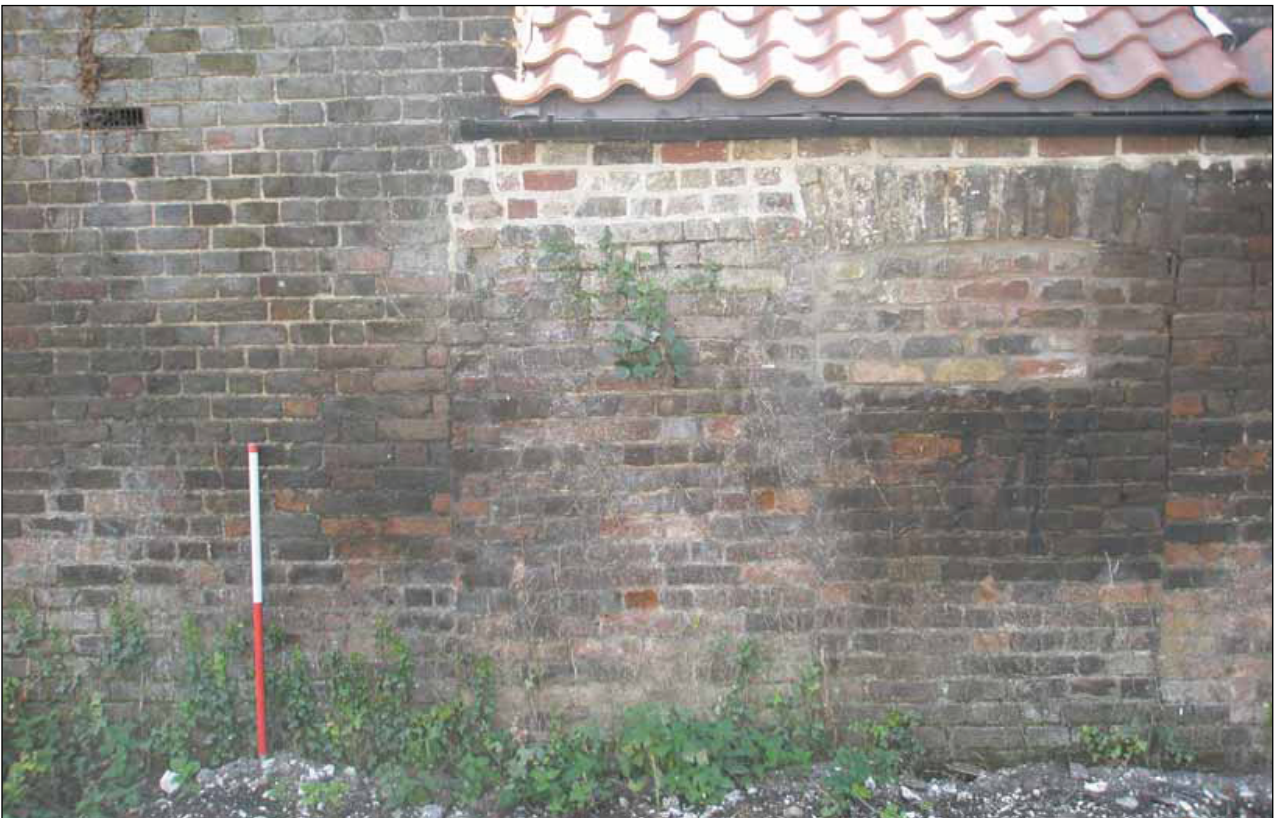
Plate 22: Blocked doorway in north facing elevation of Building 4

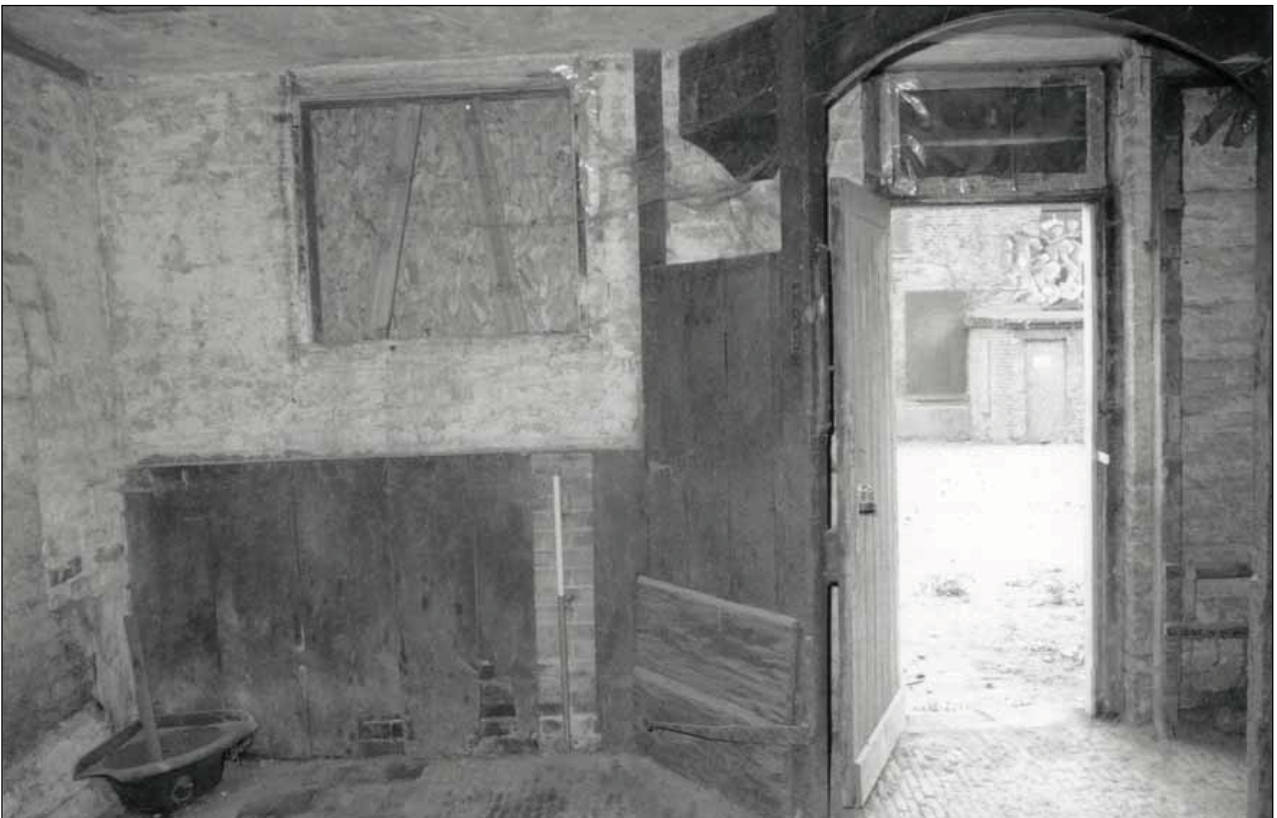
Plate 25: Re-positioned stall partition, Room 5:1, taken from north

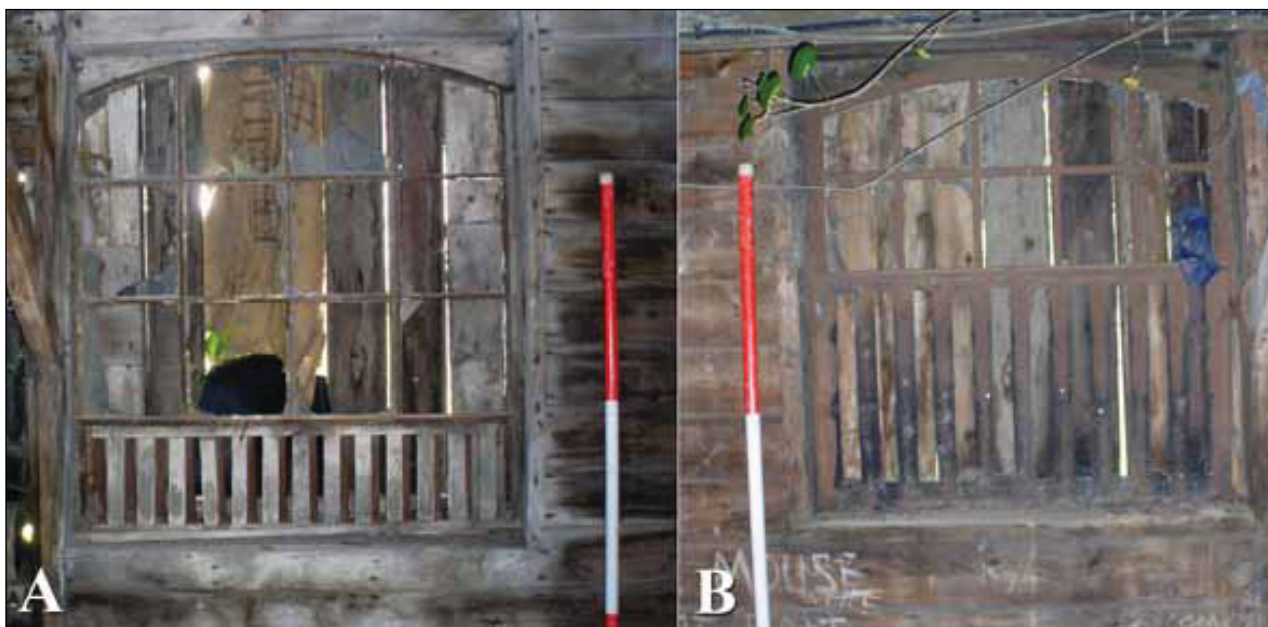
- 4.9.3 The granary has two windows which appear to use a type of cast iron window that pre-dates the construction of this building. They have a simple ventilation system (Plate 34) and are designed to fit a window with a segmental arched head and appear to be of early 19th century date. The windows do not fit the square headed openings of the granary windows particularly well. However, measurements for the stable windows show that it is possible that they were taken from the stables during a re-fit, or given the need for good ventilation, it is even possible that these windows originally come from the brew-house, and were taken from there when it was converted to accommodation and reused in this granary building. It would be difficult to confirm which building they come from as both Buildings 3 and 5 would have required good ventilation. Whilst the size roughly matches that of the current stable windows (Figure 8), it is also likely that the two ground floor south facing windows of Building 3 have been enlarged to increase its suitability for accommodation – this could possibly be confirmed by the removal of the pebble-dash on the south facing wall of Building 3.

Plate 34: Windows in Building 8, A) taken from west, B) taken from east

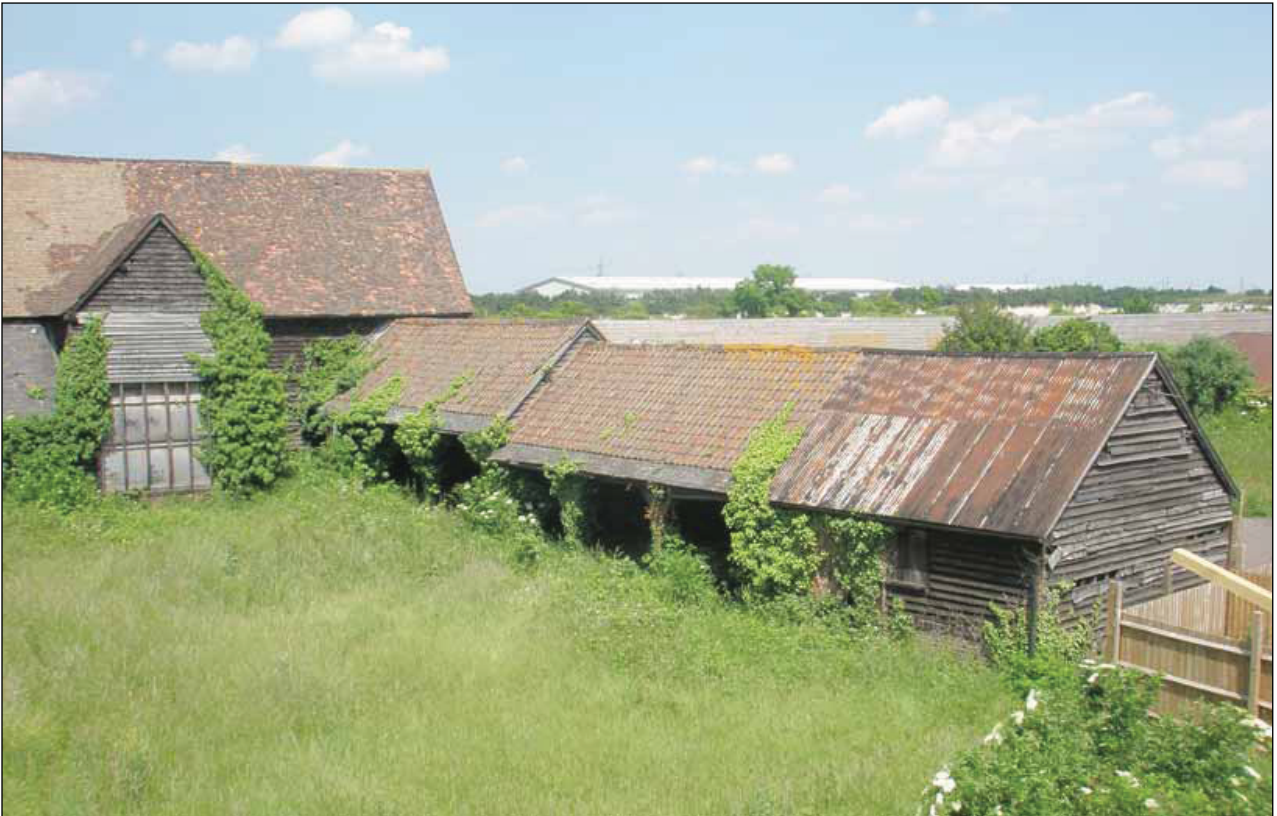
and 10, which is consistent with the design of cattle sheds to allow for the winter shelter of cattle whilst still allowing them access to the outside. It is possibly for this reason that the interior has been, at least partially, lined with weather-boards in order to keep out the draught. It was an adopted pattern to design a foldyard to face south to maximise sun, with the barn enclosing off the north side of the yard to protect from the wind, with a further side being enclosed and protected by the cattle sheds themselves (Brunskill 1999, 70). The prospect of the buildings original purpose being that of a cart shed is disputed again by the design as for various reasons cart sheds did not face the yard, but out towards the fields, road or track and also they would be generally be taller than cattle sheds to allow for large machinery/carts (Brunskill 1999, 35 and 193 and Peters 1981, 32/49). Building 7 is a prime example of this, opening as it does to the east completely in the opposite direction to the rest of the farm and in the direction where once there may have been fields. However, that is not to say that at some point Buildings 9 and 10 have not been used for the storage of carts/machinery, as clearly any evidence above ground for the pens has gone (Plate 35), as have any sign of the troughs that would likely have been in the sheds.

Plate 35: Buildings 8, 9 & 10, taken from south west

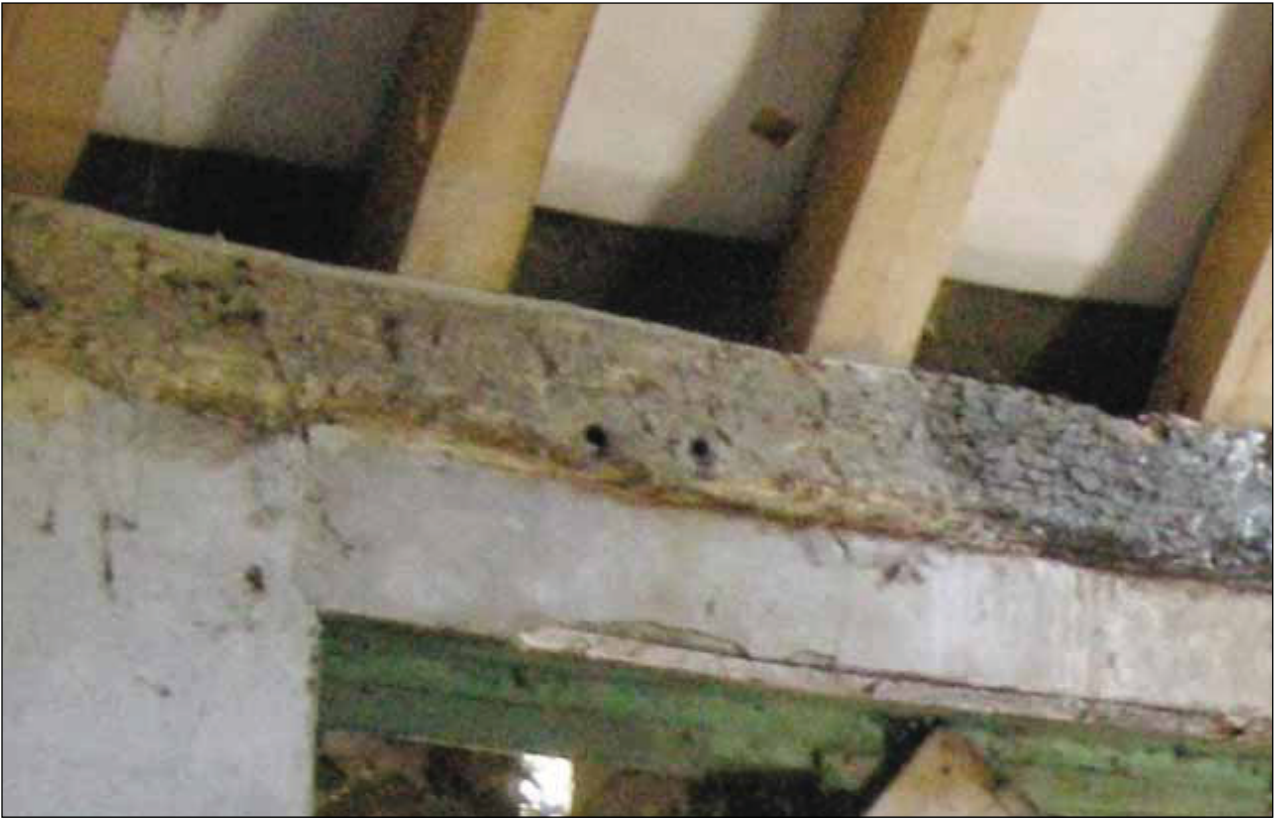
Plate 41: Peg holes in wall plate above window in south wall of Room 3:4
