The Ancillary Buildings Associated With High House, Purfleet, Essex

Historic Buildings Assessment

February 2009

Client: The Regeneration Practice

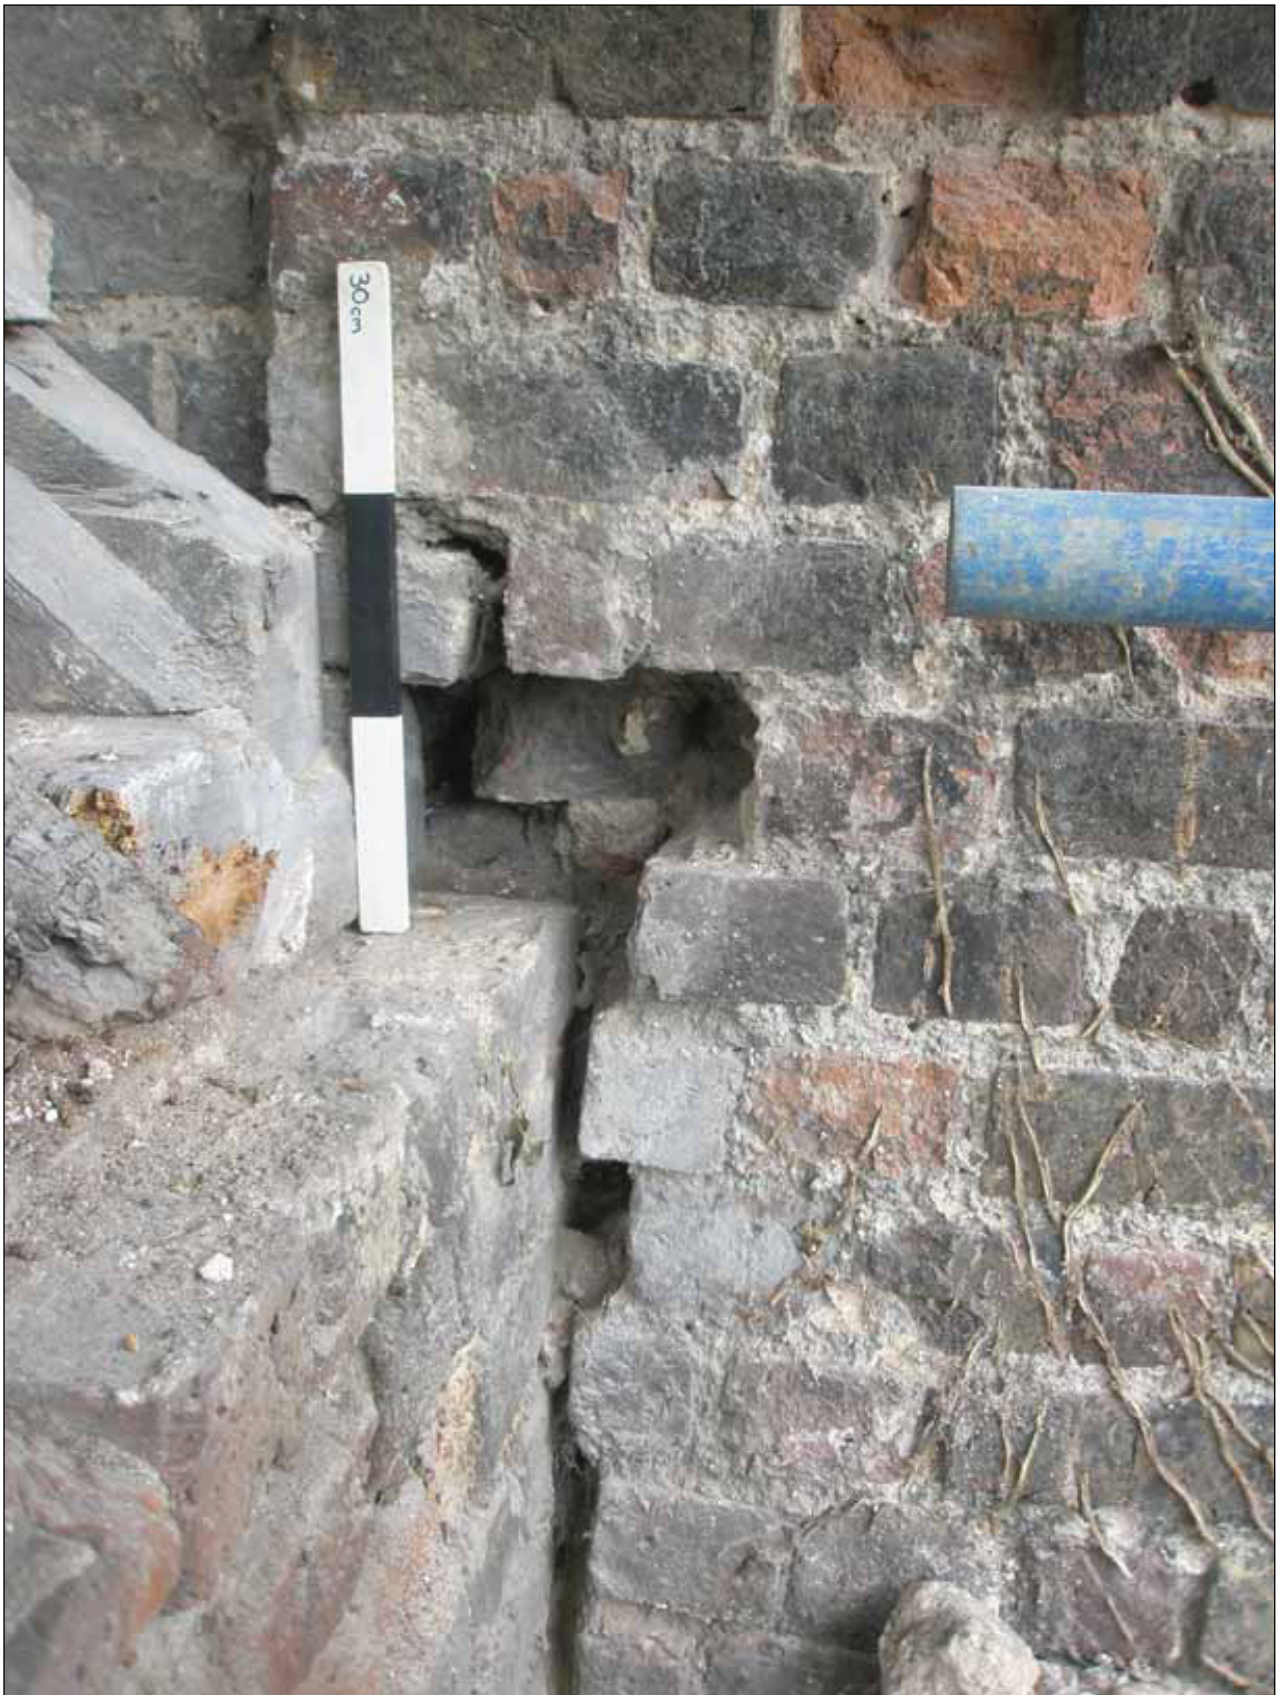
Plate 43: North wall of Building 4 embedded into east wall of Building 3, taken from north east

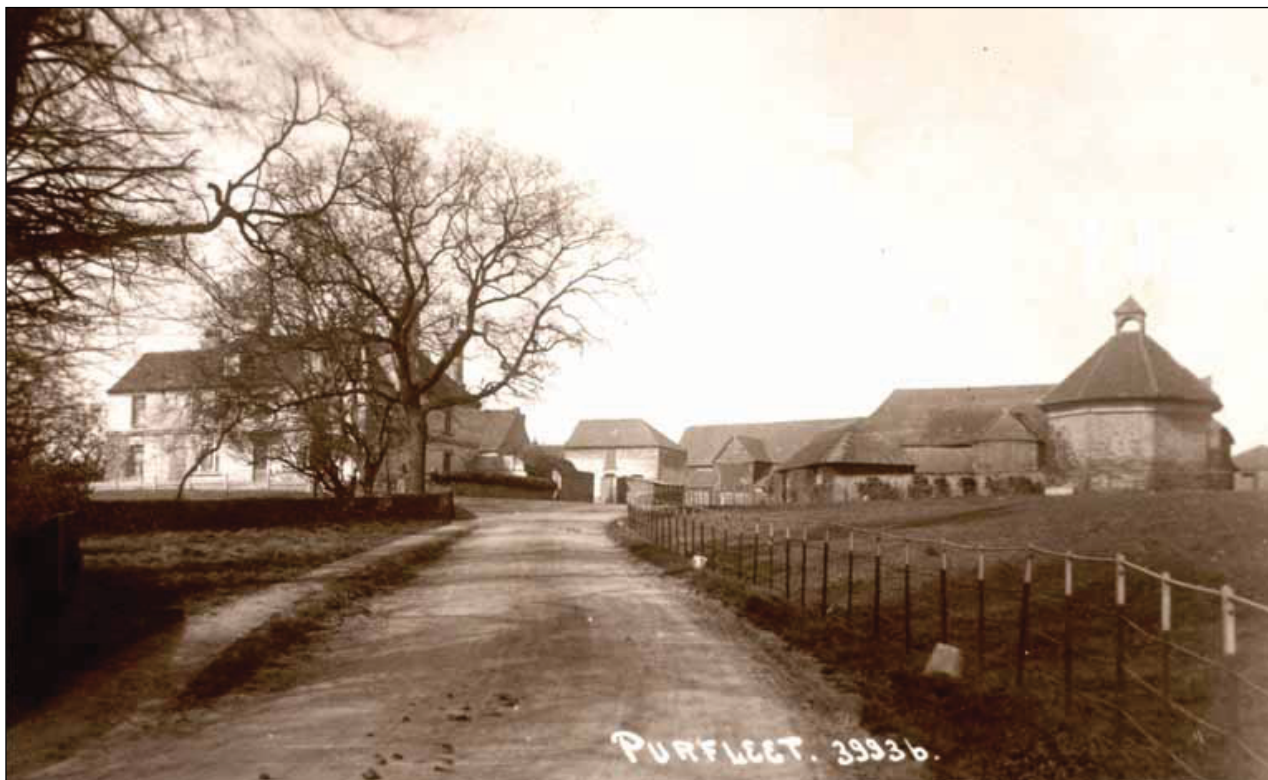
Plate 45: High House and associated buildings, post-card c.1900
