# Saw Shed, Lee Quarry, Bacup

### An Archaeological Recording and Monitoring Programme

By J.M. Trippier Archaeological and Surveying Consultancy

Part 2: Results

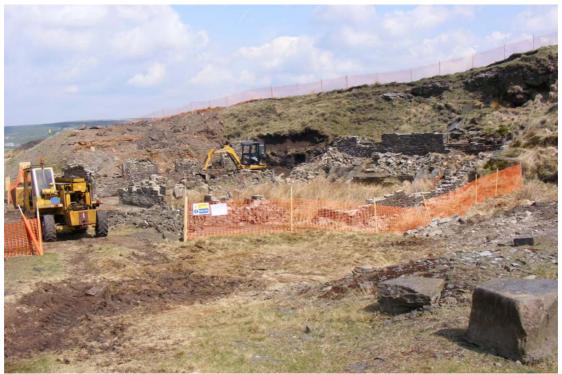
Plate 2: Beginnings of clearance work using mechanical diggers. The grass covered artificial mound has already been reduced.

- 7.1 Excavation and consolidation of the Saw Shed were carried out during the Spring and Summer of 2010. Prior to excavation the detail of the monument was largely obscured with fallen stone debris and associated material from the collapsed building although the two bays into which it was divided were clearly discernible (**Plate 1**). The excavation mainly comprised the removal of fallen stone debris from the collapsed building and associated material. This work was carried out by Paul Moore and John Bradford using mechanical diggers and dumper-trucks. However it was also necessary for them to carry out a considerable amount of this clearance by hand, particularly at the east end of the building where it was not possible for the machines to gain sufficient access (**Plate 2**).

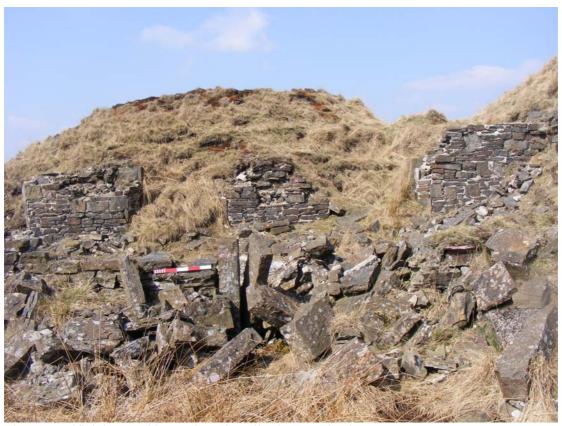
- 7.3 Two areas of particular concern were north and east walls of the building, both of which required further attention before clearance, could begin. It appeared that a considerable mound of material had been deposited against the outside of the former and was now causing it the buckle inwards (**Plate 3**). One of the first tasks therefore was to reduce this mound and relieve the pressure on the wall itself (**Plate 4**).

Plate 3: Artificial mound beyond north wall prior to reduction

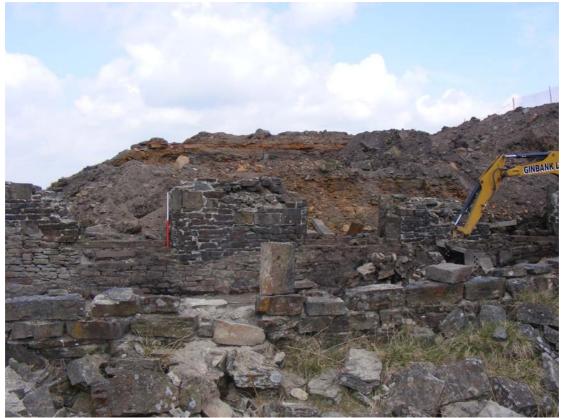
Plate 4: Artificial mound after reduction

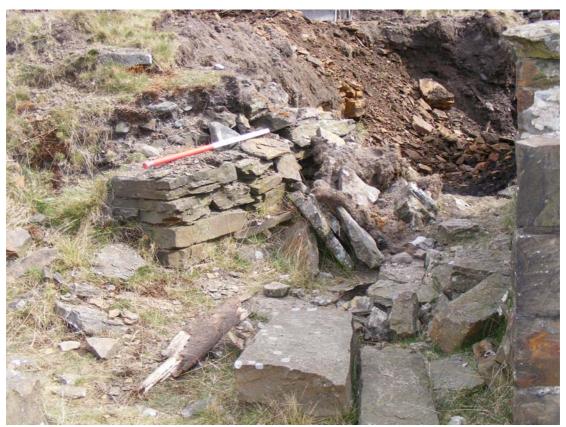
Plate 5: Base of artificial mound

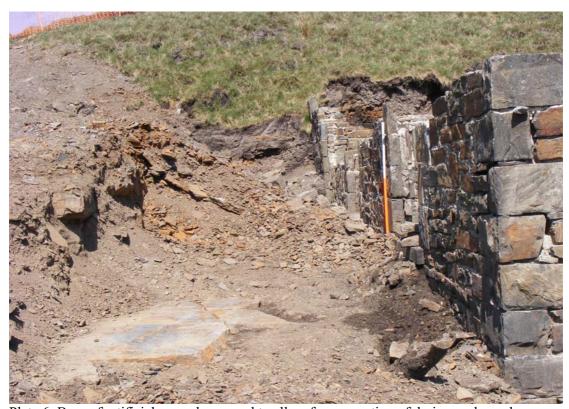
Plate 6: Base of artificial mound removed to allow for excavation of drainage channel

Associated with this was the excavation of a trench along the exterior of the north wall which was subsequently used to drain the rear of the site (**Plates 5 to 7**). A similar drainage trench was later excavated along the south side of the building (**Plate 8**). In order to excavate the northern drainage channel it was necessary to remove a manhole cover that had been produced from the quarried rock but left on the site (**Plate 9**). Below this was a dump from which was retrieved a large number of finds associated with the Sawshed and quarry workings (**Plate 10**).

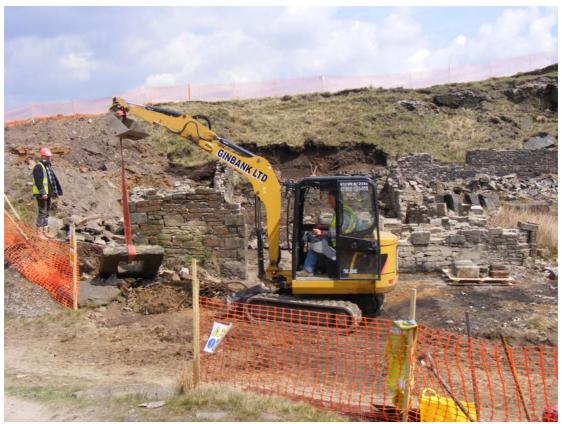
Plate 9: Removal of unfinished manhole surround to allow excavation of drain at base of artificial mound

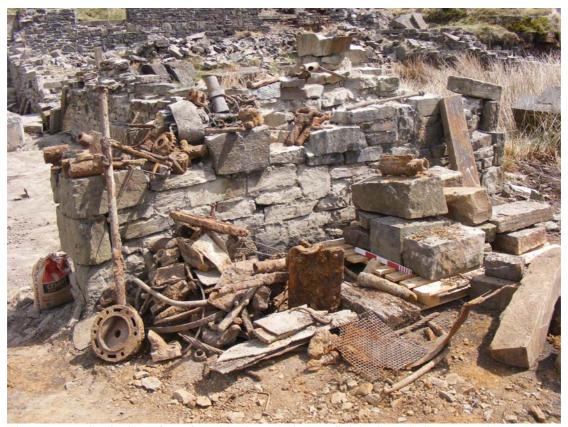
Plate 10: Mechanical artefacts found in dump below unfinished manhole surround

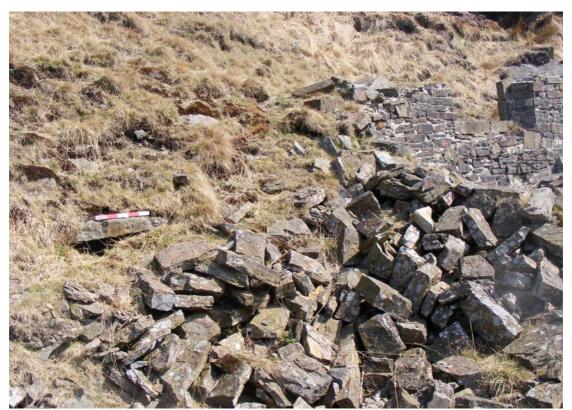
- 7.4 The other area of concern was the east wall of the Sawshed which had been built hard against the adjoining hillside. Fallen stone and vegetation were now overlying the ruined wall to such an extent that access for suitable conservation work was not possible (Plates 11 & 12). So again, this part of the hillside had to be removed and terraced both to relieve the pressure on the wall and to enable the conservation masons to proceed with their work. Because of the difficulties in getting machines into this restricted space this area had to be largely excavated by hand (Plate 13). The hillside itself was stabilised by the laying of large stone blocks behind the newly excavated wall (Plate 14).

Plate 12: Detail of rear (east) wall of north bay. Scale bar rests on lintel of aperture excavated on Plate 13

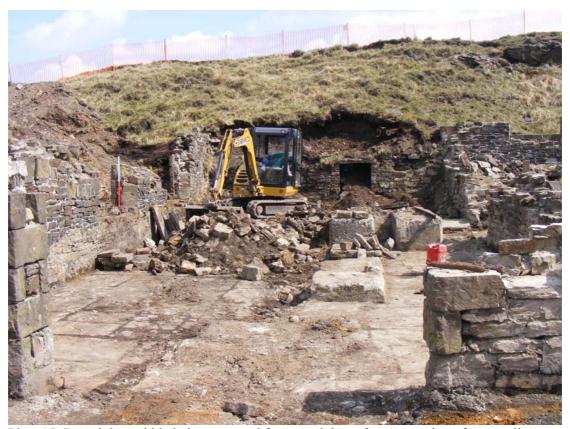
Plate 15: Remaining rubble being removed from north bay after excavation of east wall in Plates 13-14

- 7.6 Following clearance of the north bay by machine (Plate 15) it was possible for the conservation work to start. The conservation work was carried out by Anthony Walmesley and Duncan Goodenough. This work involved the resetting of existing in situ stone complemented with additional stone selected from the removed demolition material where needed to achieve satisfactory end product (Plate 16). It was occasionally necessary for the masons to slightly reduce wall levels in some places to produce a firm working plane but generally the existing and varied profile of the ruinous walls was maintained rather than engaging in any attempts at reconstruction. The reset stonework was mortared and pointed with a mix which was intended to replicate the original as closely as possible. Initially sand from Leighton Buzzard was used as on other projects (see Appendix 5 of original report) but this resulted in too yellow a mix (Plate 17) and a locally produced sand was used which produced much better results (Plate 18 & Appendix 4 of this report). The tops of the walls were filled with gravel (Plate 19) and then topped off with a convex concrete haunching laid on a layer of Terram (Plate 20). Concrete was chosen because it was readily distinguishable from the original wall formations but also so that the copings can be removed at any point in the future, returning the wall to its original form.

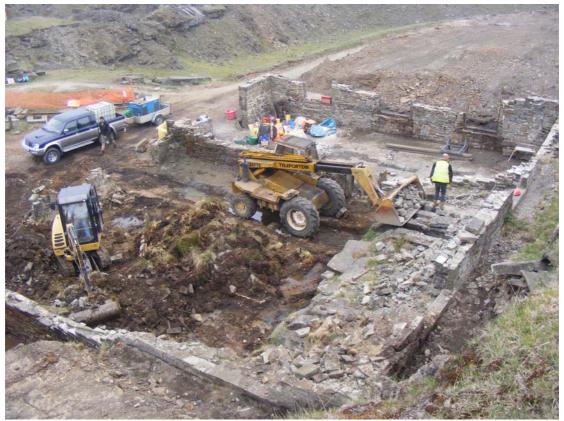
Plate 21: Work progresses on the removal of the overlying rushes in the south bay

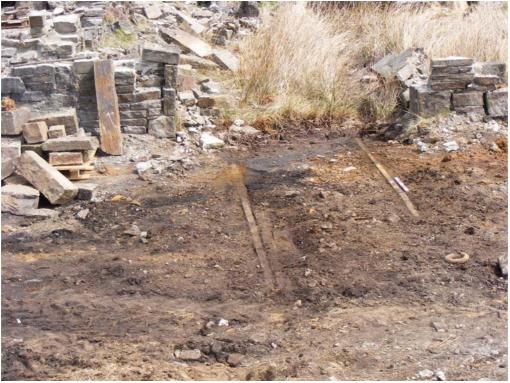
discovered early on in the clearing of the south bay was sets of rail lines which entered the shed from the west (**Plate 24**).

Plate 24: Rail lines discovered outside entrance to the south bay

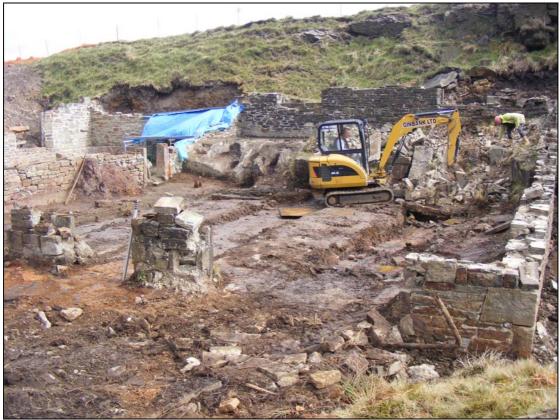
7.8 As excavation continued the floor surface of the south bay was uncovered. This proved to be the natural rock upon which had been laid longitudinal concrete pads or bases which ran almost the full length of the shed (**Plates 25 & 26**). At the rear (east)end of the shed was a line of large raised concrete blocks with sloping fronts which contained shallow grooves (**Plate 27**). Between the pads and the blocks a shallow channel was discovered which appeared to have acted as an open drain removing any standing water (of which there must have been prodigious amounts) via an outlet in the south wall. This drain has now been utilised for the same purpose (**Plate 28**). The blocking of this appears to have been the main reason for the boggy rush covered interior of the south bay.

Plate 25: Uncovering the concrete pads in the interior of the south bay

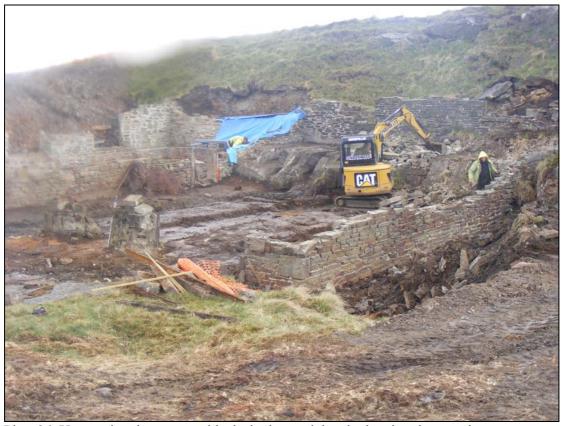
Plate 26: Uncovering the concrete blocks in the south bay in deteriorating weather

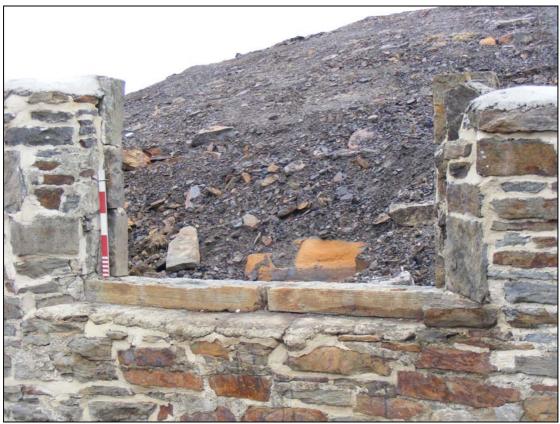
Plate 29: Window with splayed jambs in north elevation. NB in situ glazing pin towards top of photographic scale

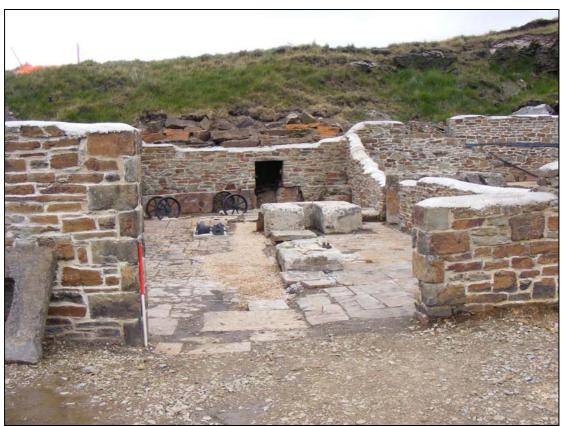
Plate 34: View of north bay from west showing concrete machine bases

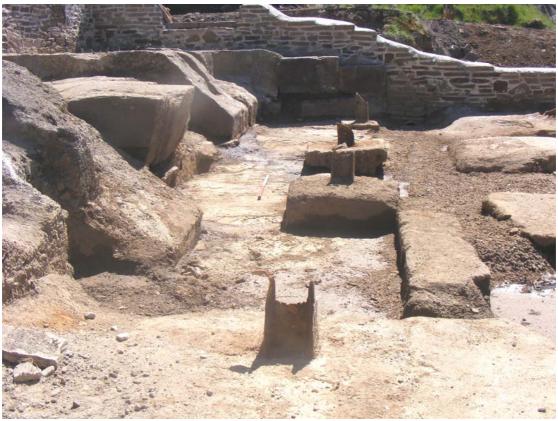
seems to support this conclusion. The base of an H-section stanchion, which presumably supported the roof of the saw shed, lies against the north side of one of these (Plates 33 & 34). A row of similar stanchion bases continues across the east end of the south bay (Plate 35). Initially these were encased in concrete (Plate 36) but this has now been removed. One of the roof trusses, which these stanchions would have supported, can be seen poking above the roofless sawshed on the front cover of the original report. A doorway between the north and south bays has also been reset. A pile of 'shot' was discovered in the south bay against the dividing wall just west of the reset doorway (Plate 37). This comprised steel particles that would have been used to increase the efficiency of the saw blades when cutting through the stone blocks from the quarry.

Plate 35: View of bases of roof stanchions in south bay
