Programme of archaeological work at Sheffield Lock, Burghfield, Kennet and Avon Canal, West Berkshire

17th June 2016 Revised 20th July 2016 Revised 24th August 2016

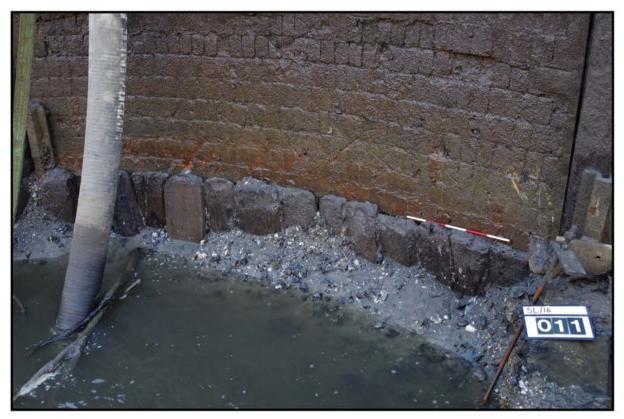
In one location it seems likely that the cill beam supporting the scallop wall had failed. The base of the scallop wall was reinforced using timber piles (context 011; Fig 4).

Fig 4: Context 011; timber piles following profile of scalloped brickwork

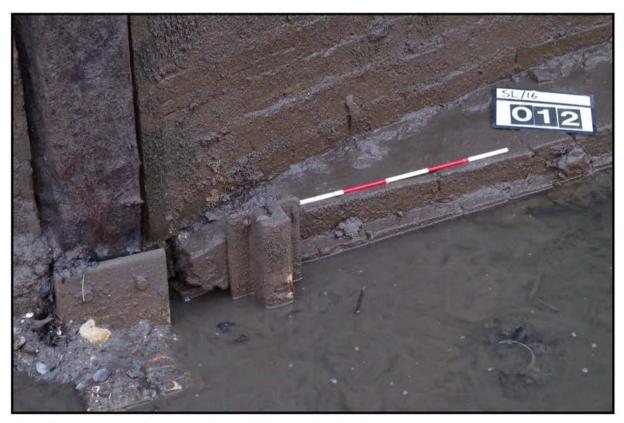
It was apparent that the mortice and tenon joints between the king posts and the transverse beams must have failed, or were believed to have failed, generally, around the lock. A number of metal brackets had been inserted to support this joint. These were not recorded specifically by this project but they may be seen in a number of the photographic figures (eg Figs 5, 11, 14, 15, 18, 32.2 and 33.2).

Fig 5: Context 012; early pattern rail, possibly part of turf lock

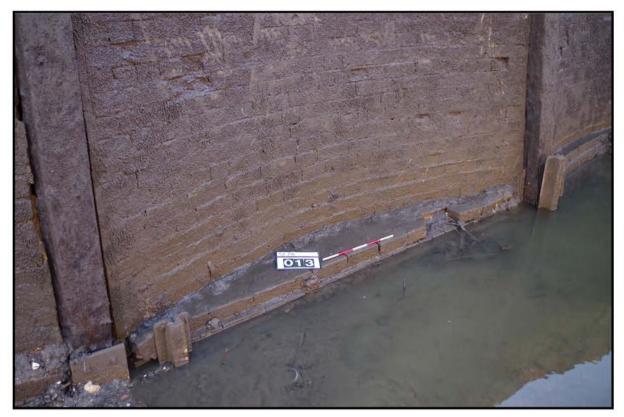
As had previously occurred (Phase 4) it seems likely that a cill beam supporting a scallop wall had failed. The base of the scallop wall was reinforced with brickwork (context 013; Fig 6).

Fig 6: Context 013; 'chord' of brickwork across scalloped brickwork

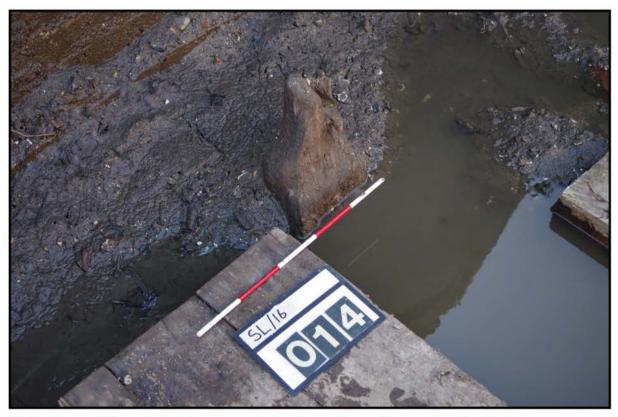
• timbers of various dimensions also protruded from the lock invert; (contexts 014, 019, 024, 027 and 028; Figs 7, 12, 17, 20 and 21).

Fig 7: Context 014; vertical timber forward of scallop wall, possible remains of turf lock

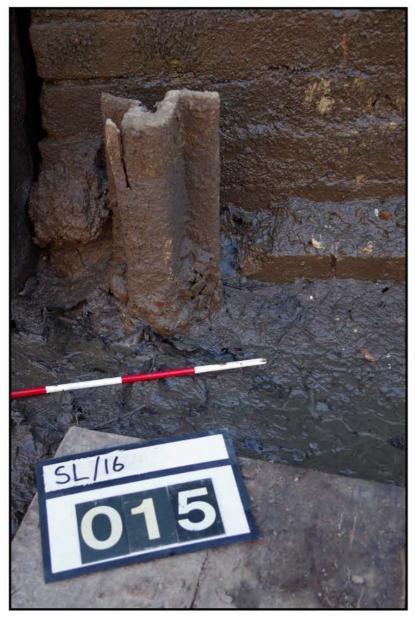
Fig 8: Context 015; early pattern rail, possible part of turf lock

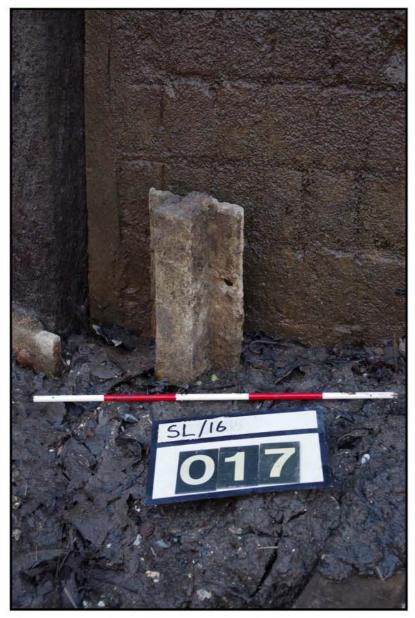
Fig 10: Context 017; early pattern rail, possible part of turf lock

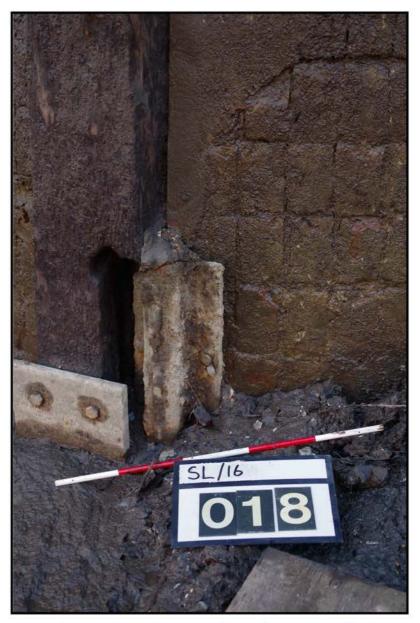
Fig 11: Context 018; early pattern rail' possible part of turf lock

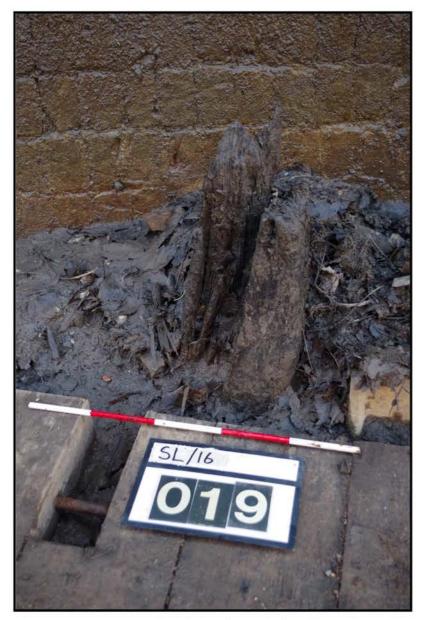
Fig 12: Context 019; vertical timber forward of scallop wall, possible remains of turf lock

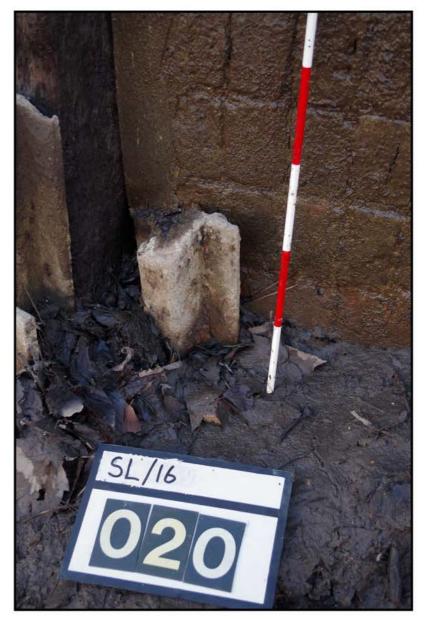
Fig 13: Context 020; early pattern rail, possible remains of turf lock

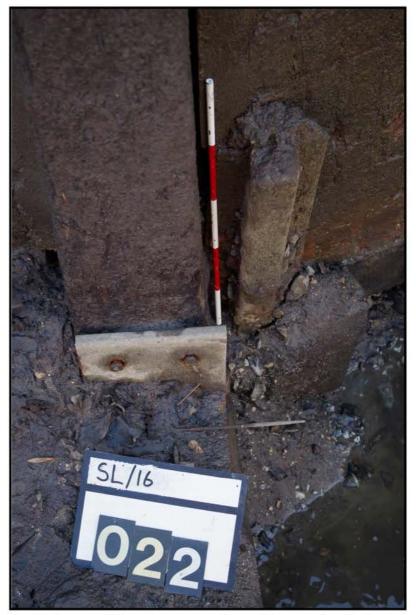
Fig 15: Context 022; early pattern rail, possible part of turf lock

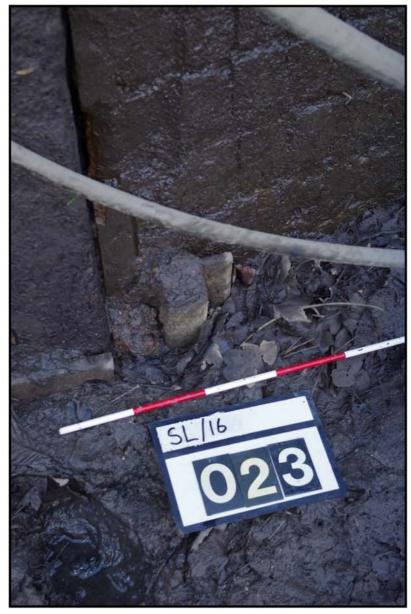
Fig 16: Context 023; early pattern rail, possible part of turf lock

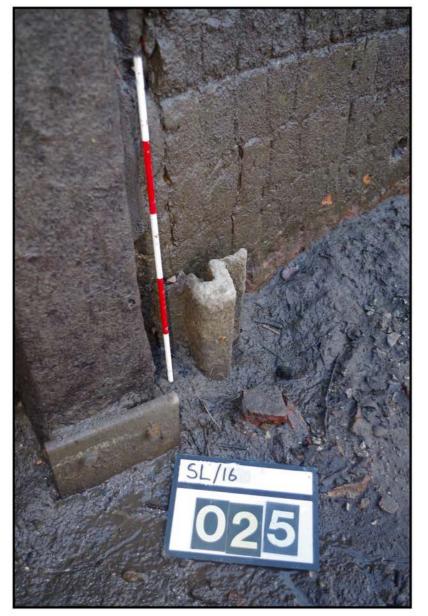
Fig 18: Context 025; early pattern rail, possible part of turf lock

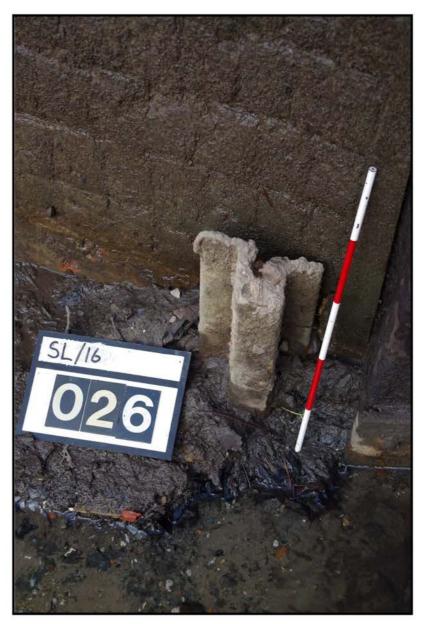
Fig 19: Context 026; early pattern rail, possible part of turf lock

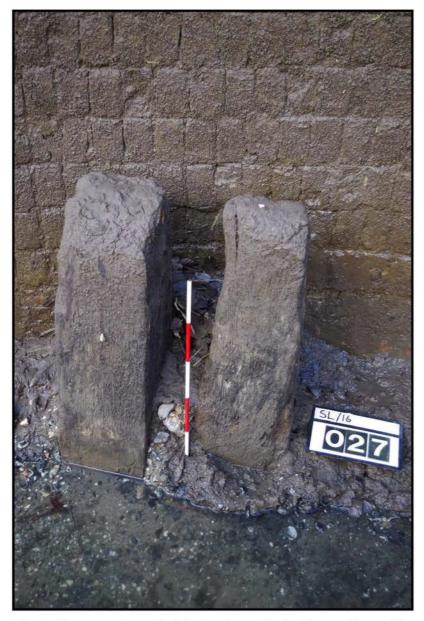
Fig 20: Context 027; vertical timber forward of scallop wall, possible part of turf lock

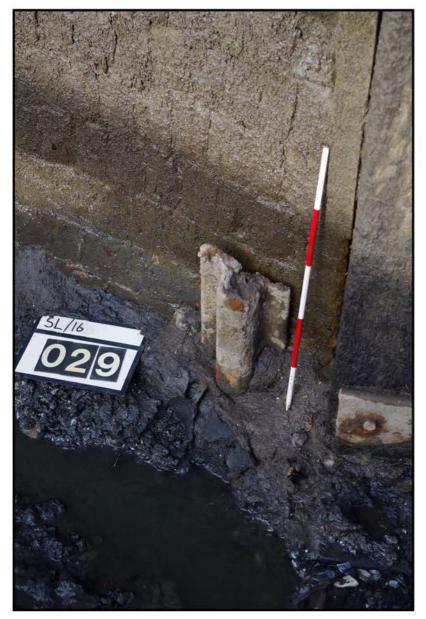
Fig 22: Context 029; early pattern rail, possible part of turf lock

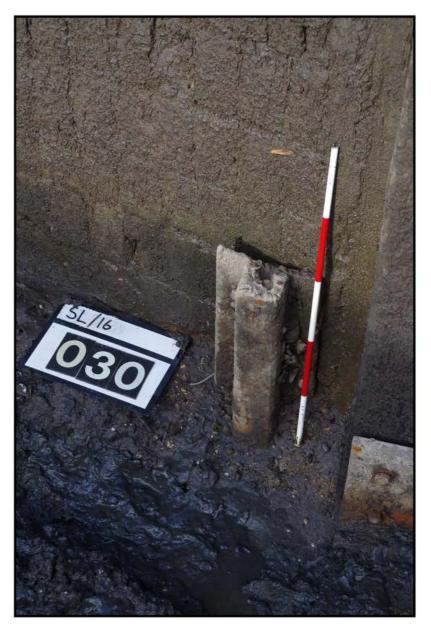
Fig 23: Context 030; early pattern rail, possible part of turf lock

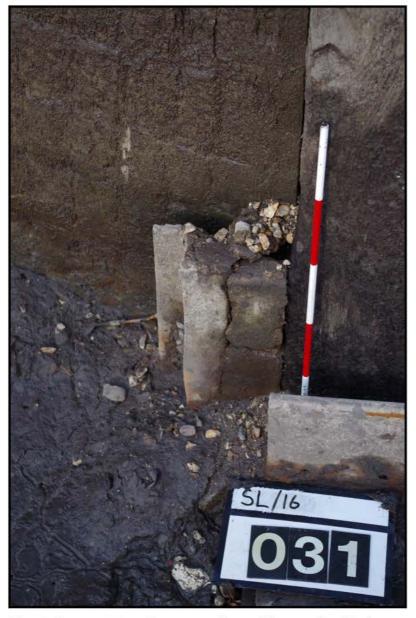
Fig 24: Context 031; early pattern rail, possible part of turf lock

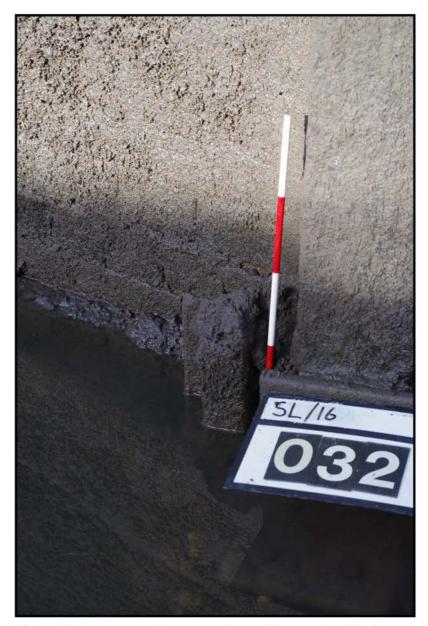
Fig 25: Context 032; early pattern rail, possible part of turf lock

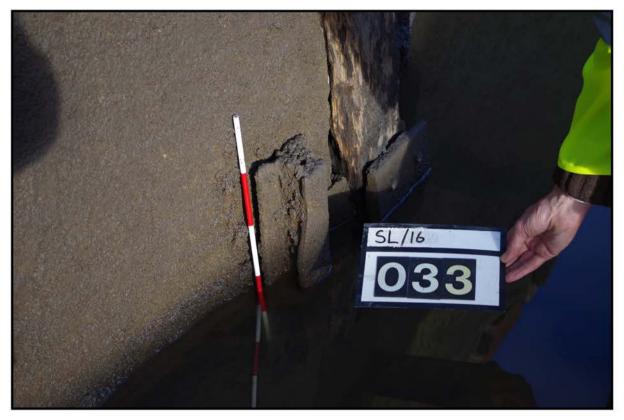
Fig 26: Context 033; early pattern rail, possible part of turf lock

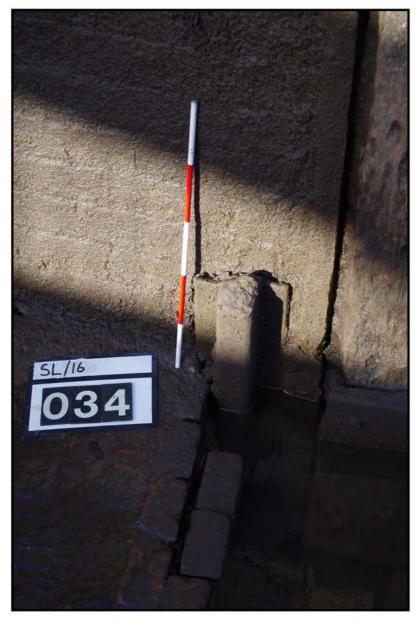
Fig 27: Context 034; early pattern rail, possible part of turf lock

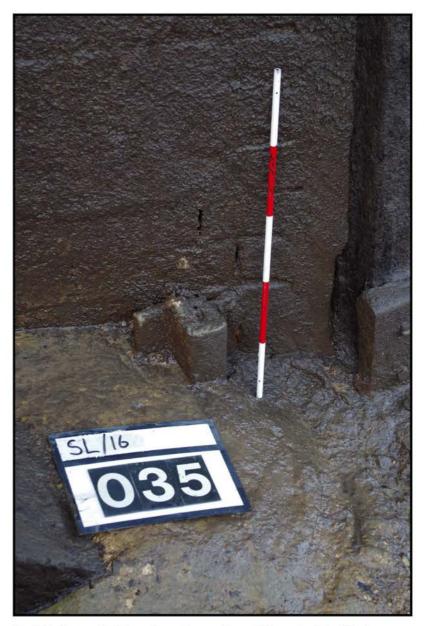
Fig 28: Context 035; early pattern rail, posible part of turf lock

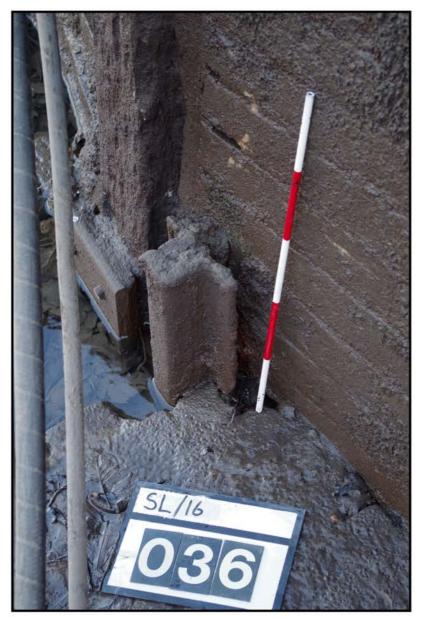
Fig 29: Context 036; early pattern rail, possible part of turf lock

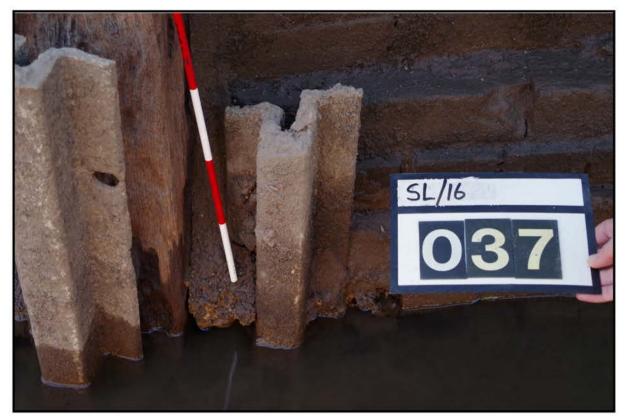
Fig 30: Context 037; early pattern rail, possible part of turf lock

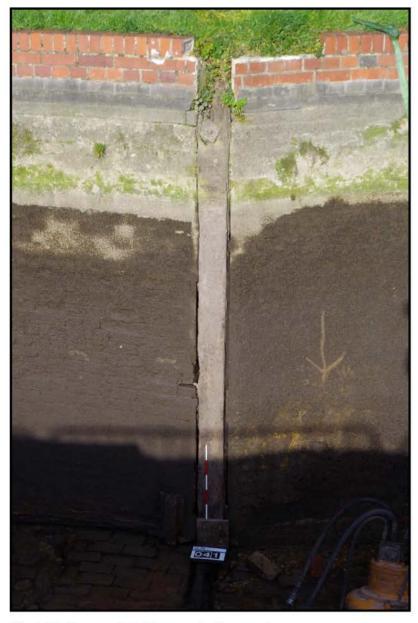
Fig 34.1: Context 041; king post before repair

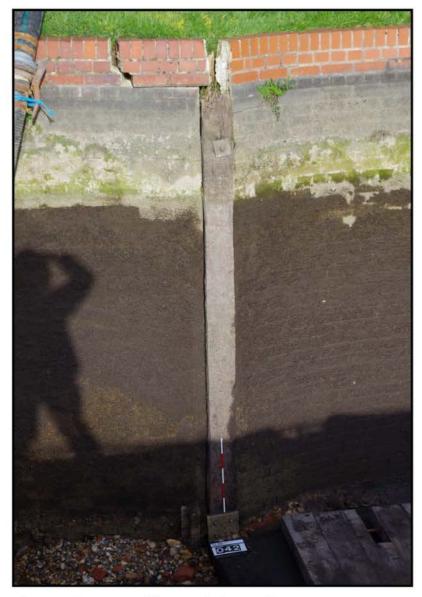
Fig 35.1: Context 042; king post before repair

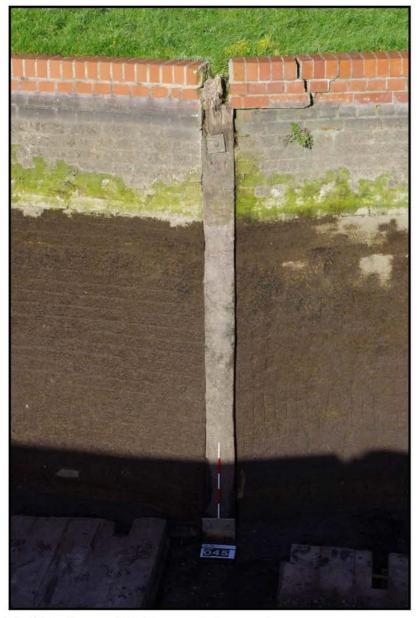
Fig 38.1: Context 045; king post before repair

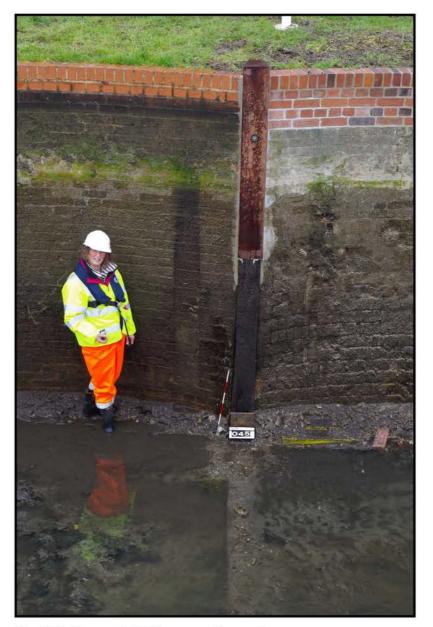
Fig 38.2: Context 045; king post after repair

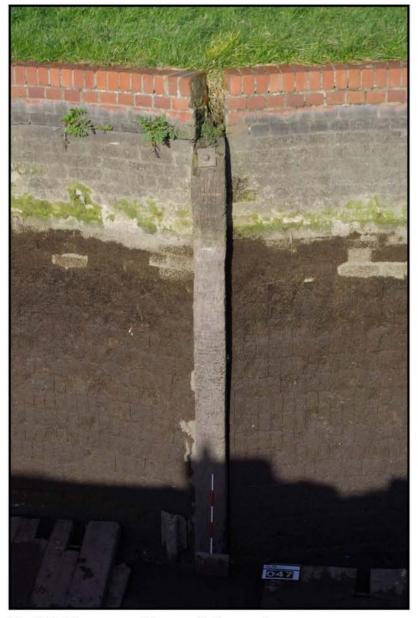
Fig 40.1: Context 047; king post before repair

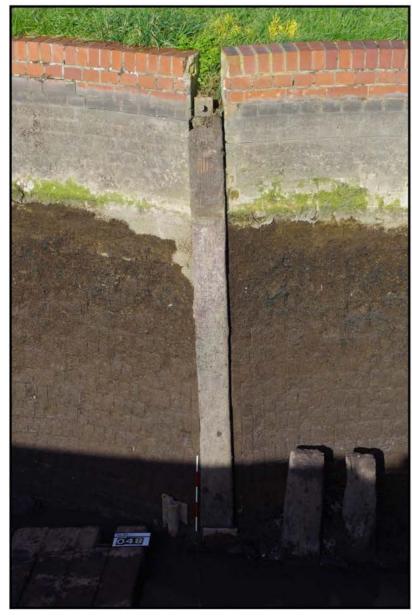
Fig 41.1: Context 048; king post before repair

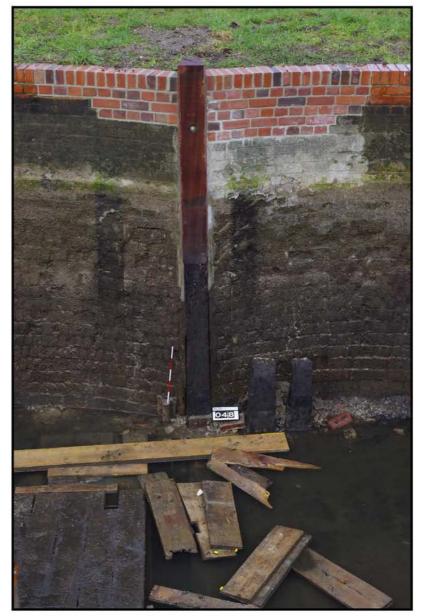
Fig 41.2: Context 048; king post after repair

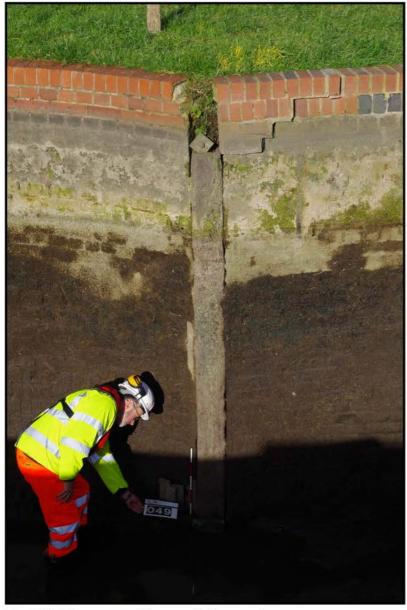
Fig 42.1: Context 049; king post before repair

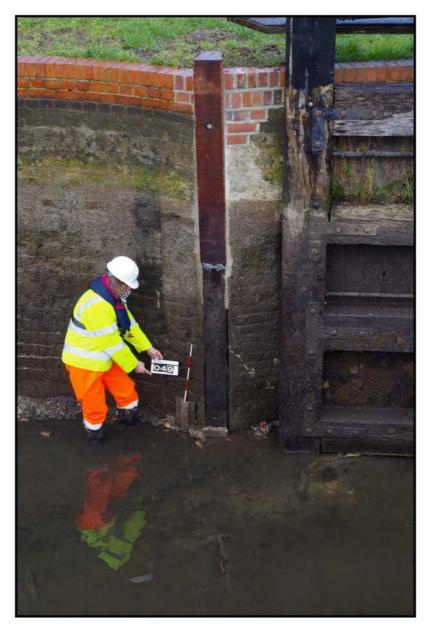
Fig 42.2: Context 049; king post after repair

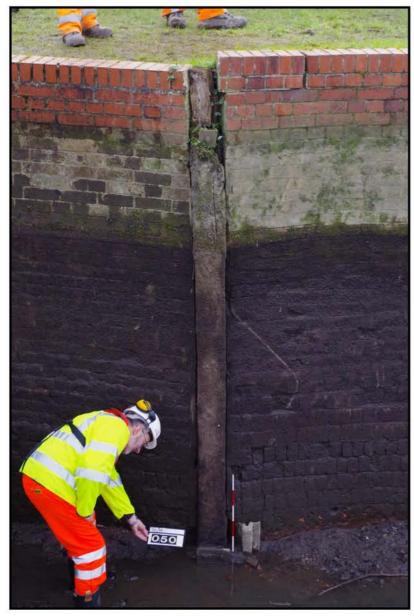
Fig 43.1: Context 050; king post before repair

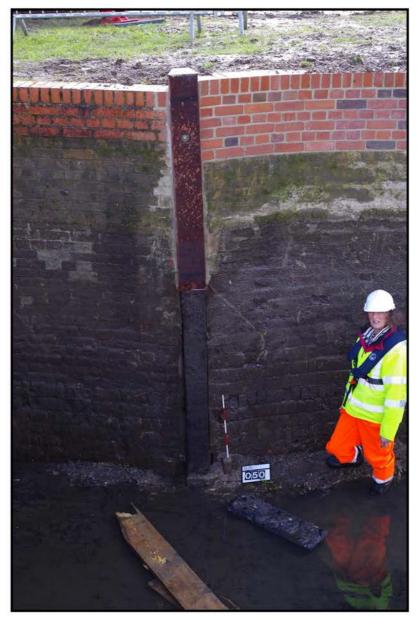
Fig 43.2: Context 050; king post after repair

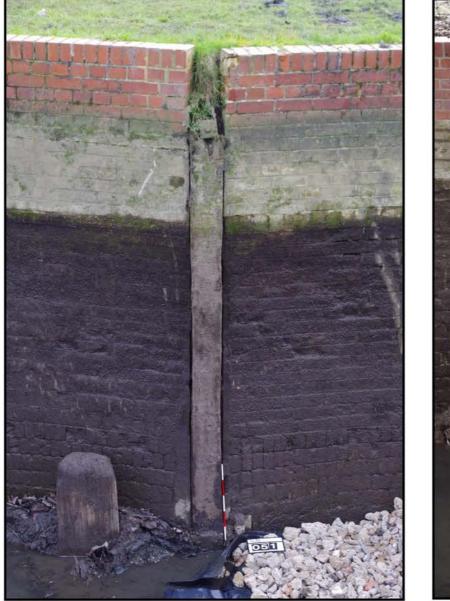
Fig 44.1: Context 051; king post before repair

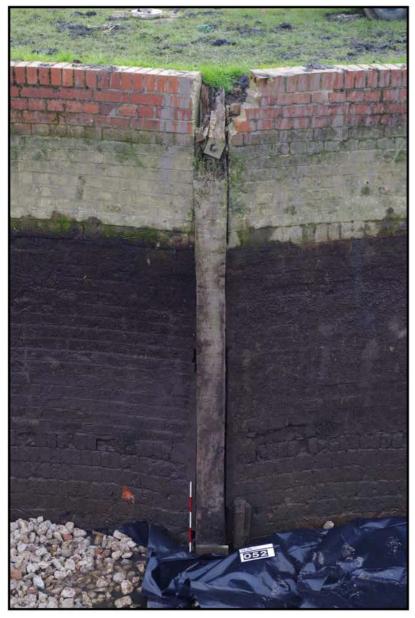
Fig 45.1: Context 052; king post before repair

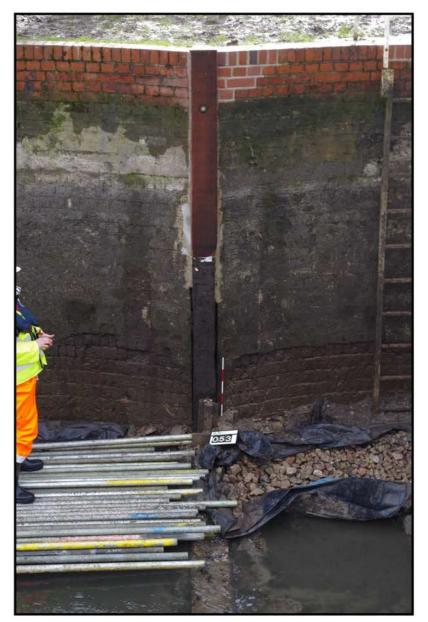
Fig 46.2: Context 053; king post after repair

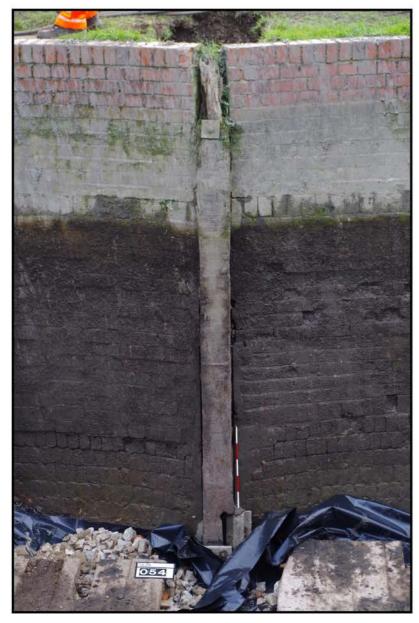
Fig 47.1: Context 054; king post before repair

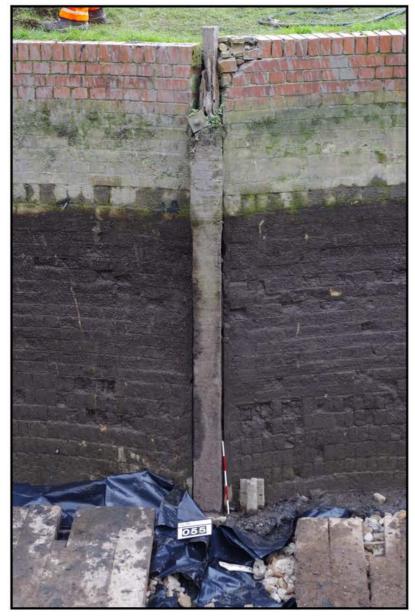
Fig 48.1: Context 055; king post before repair

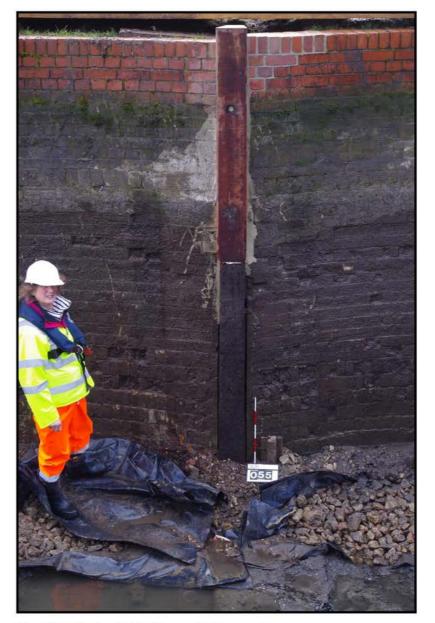
Fig 48.2: Context 055; king post after repair

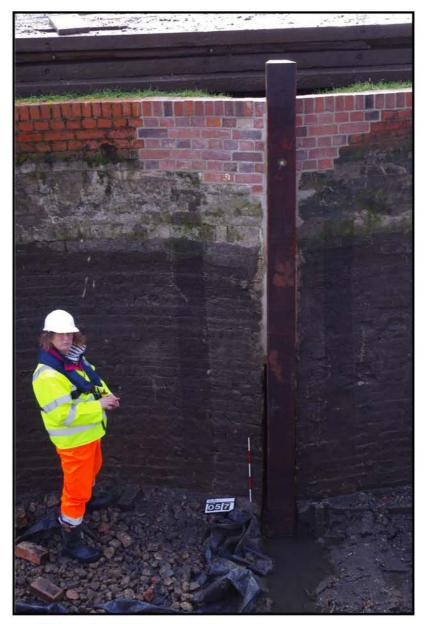
Fig 50.2: Context 057; king post after repair

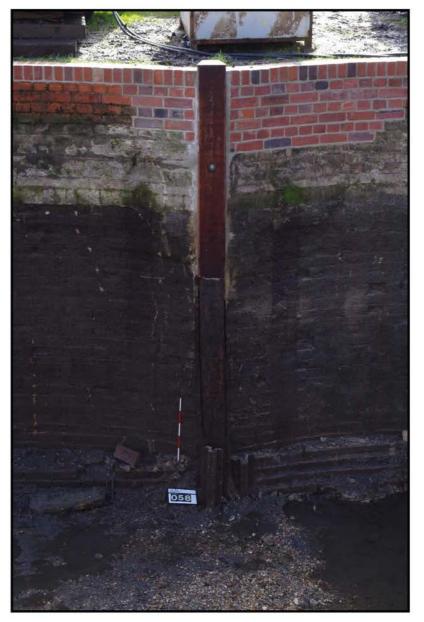
Fig 51.2: Context 058; king post after repair

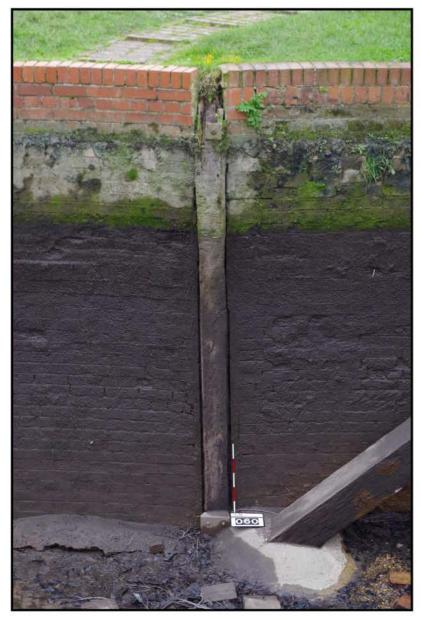
Fig 53.1: Context 060; king post before repair

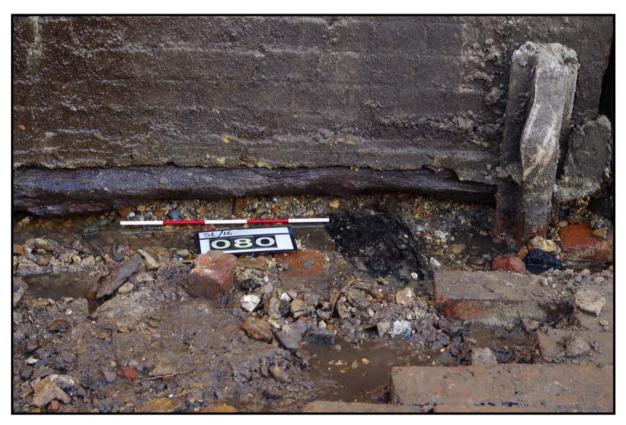
Fig 57: Context 080; cill beam supporting scalloped brickwork

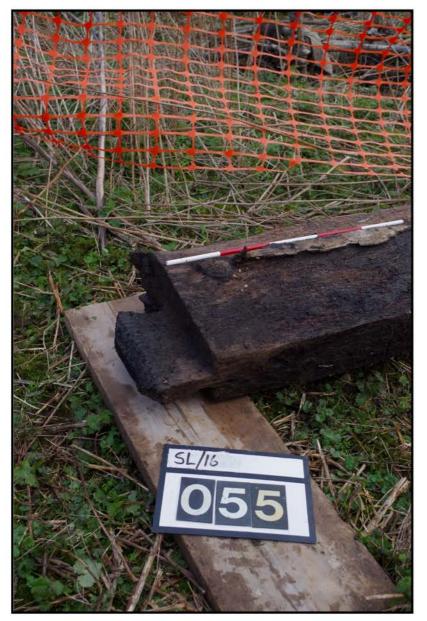
It was not possible to be certain but it appeared that the cill beams were halved into the transverse beams and the king post, whose tenon was offset (Fig 61), clamped the ends of the cill beams in place. A schematic, exploded drawing (Fig 3.6) demonstrates this.

Fig 61: Context 055; king post, detail of tenon

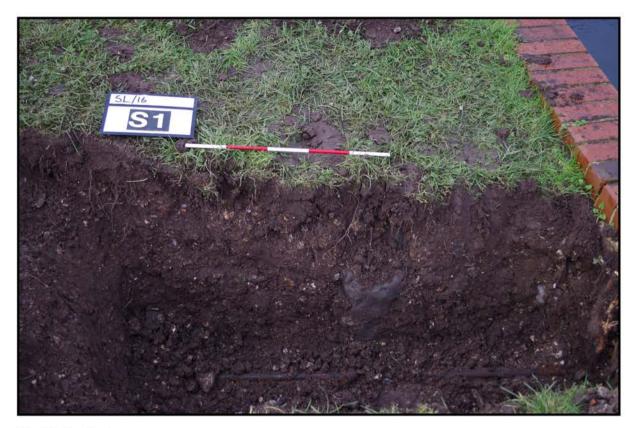
These were tenoned into the ends of the transverse beams (context 055; Fig 61) at a slightly oblique angle enabling the king posts to be erected to a batter (context 050; Fig 3.4). The top of each king post was secured with a ground anchor consisting of a metal bar (contexts 005, 010, 065, 071 and 075; Figs 3.2 and 3.3).

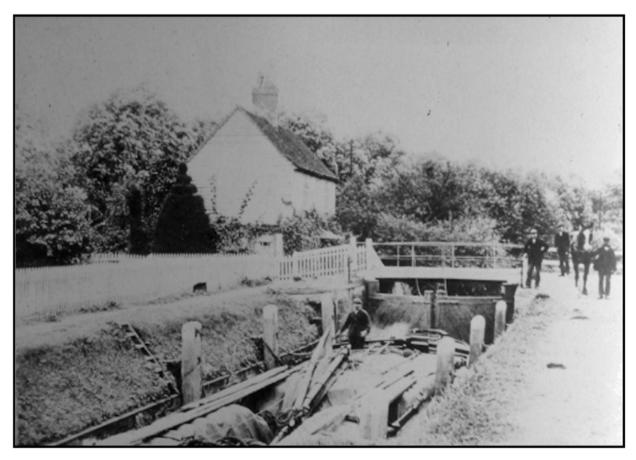
Fig 70.1: Lea and Stort Navigation, Sawbridgeworth Lock

Historic photographs of locks provide limited information. Two photographs of the Lea and Stort navigation (Figs 70.1 and 70.2) show what would now be called 'king posts', clearly serving the additional function of 'training piles'. The photographs are oblique and there is little to provide a scale of distance but it might reasonably be assumed that they lie at around 3m centres. On the Wey Navigation at Paper Court Lock (Fig 70.3) something more akin to a training 'fence' appears to have been provided but this might relate more to the anticipated size of craft at the time.
